# **Window and Glazing Exposure to Laboratory-Simulated Bushfires**

**Report to the Bushfire CRC**

Confidential CMIT Doc. 2006–205

**May 2006**

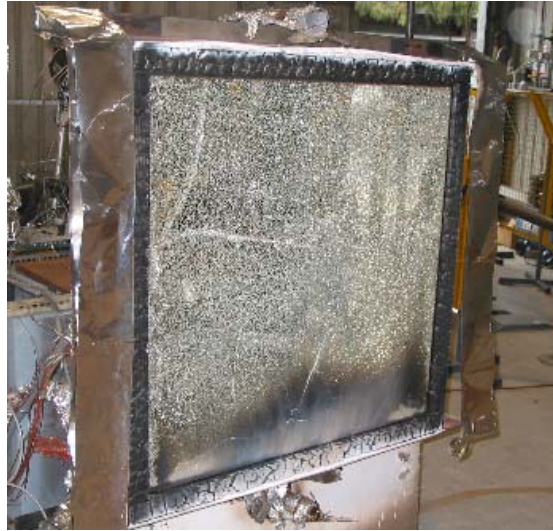
- Glass cracking (not necessarily glazing integrity breach) (see Figure 16).
- Flaming on the inside of the frame (see Figure 17).
- Glazing breach by shatter and thus glass displacement (see Figure 18).
- Glazing assembly breach by gaps 2 mm or greater opening within the glazing or between glazing and frame.

*Figure 16. Glass cracking.*

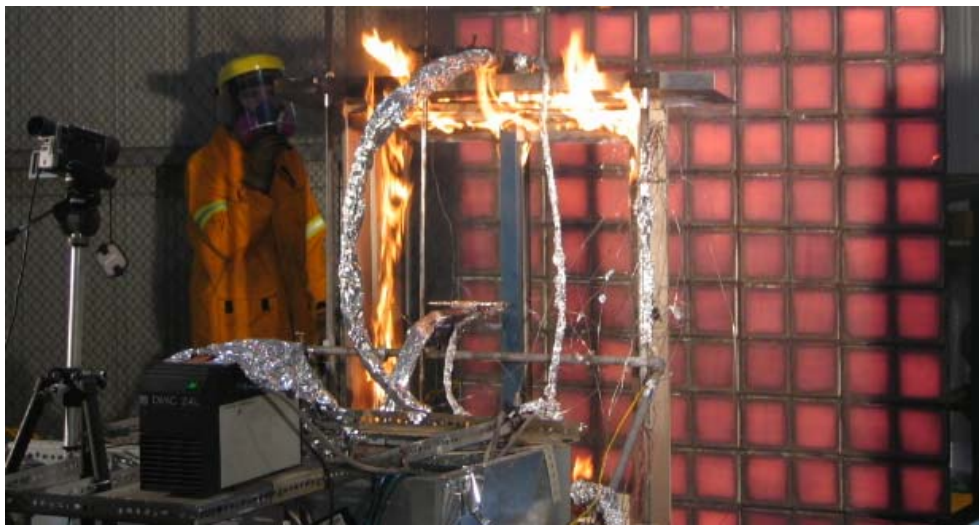
*Figure 17. Internal flaming.*

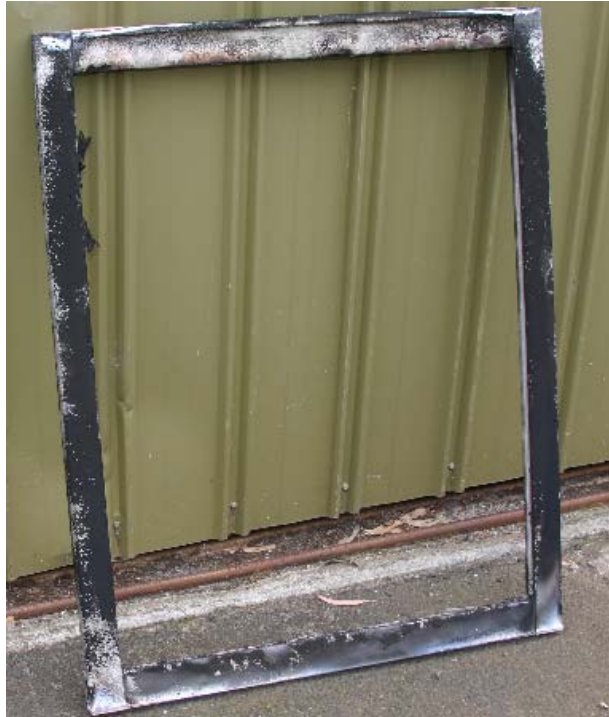
*Figure 18. Glass shatter.*

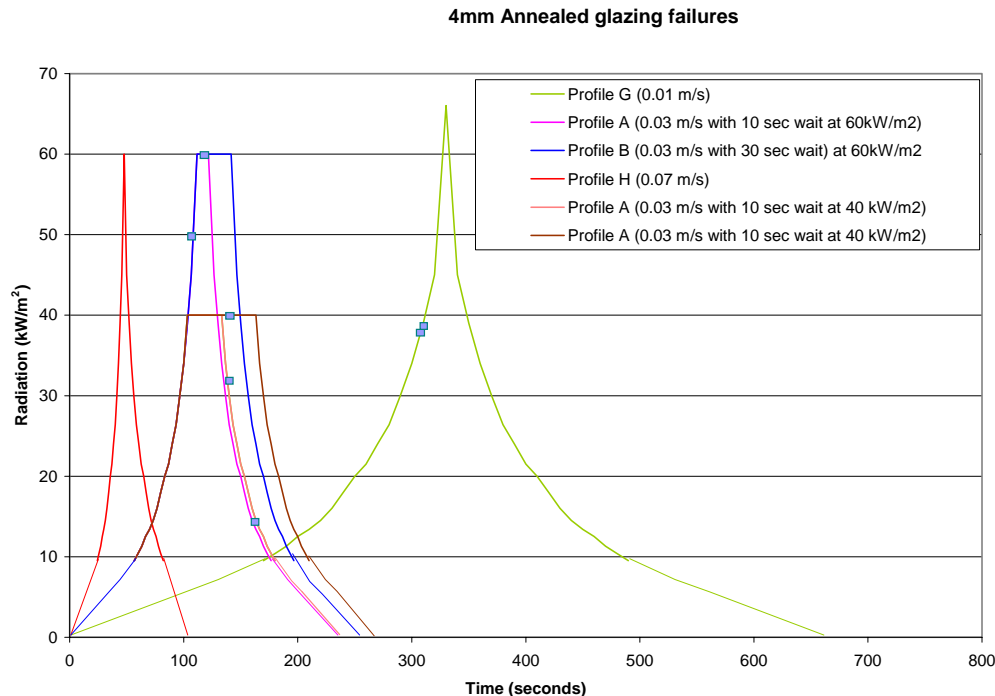
*Figure 19 Radiation profiles with 4mm Annealed glazing failures*

Figure 19 shows a summary of the range of profiles used, the dots on these curves represent the point of failure for each exposure if a failure occurred, for more detail data refer to appendix A. The faster the radiation profile the less likelihood the specimen will fail. No specimens at the fastest speed of 0.07 m/s failed. This is because there was insufficient time for thermal transfer of heat into the glass creating the stresses that cause failure and interestingly no thermal shock failure observed.

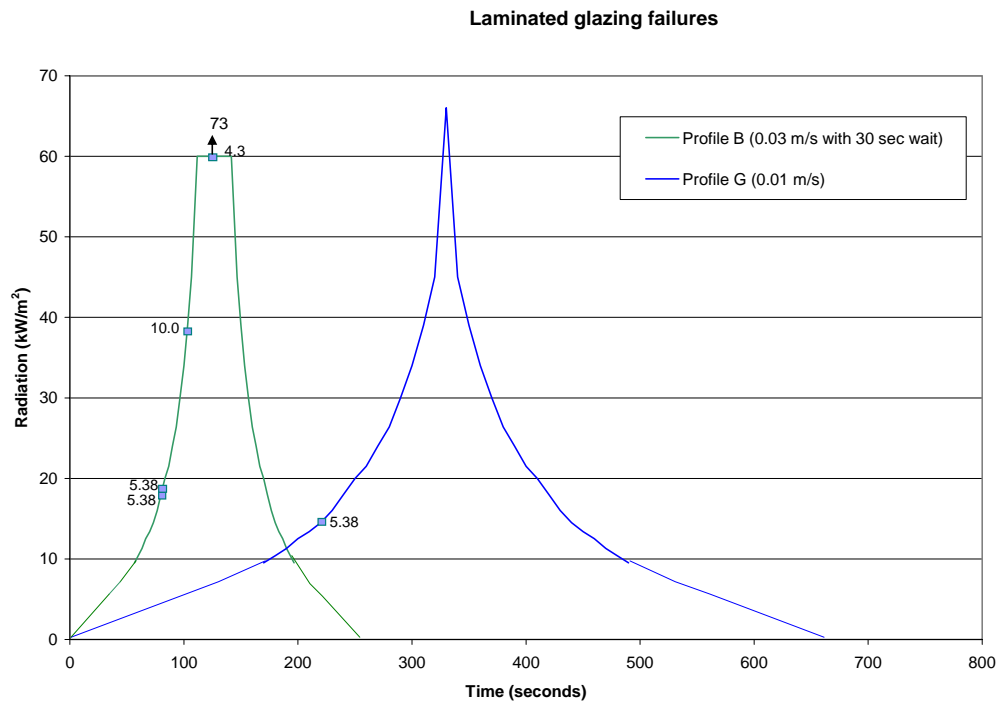
mechanical stresses that broke the bond between the glass layers, and this stress was transferred to the outer edge of the glass, compounding the effect of thermal load on glass breakage.

*Figure 20 Radiation profiles v. Laminated glazing failures*

Two radiation profiles B and G at 0.03 and 0.01 m/s respectively were carried out in this small data set, refer to figure 20, the points on the graph depict different point of failure and are labelled according to thickness. With the data set not being larger it is difficult to draw too many conclusions.

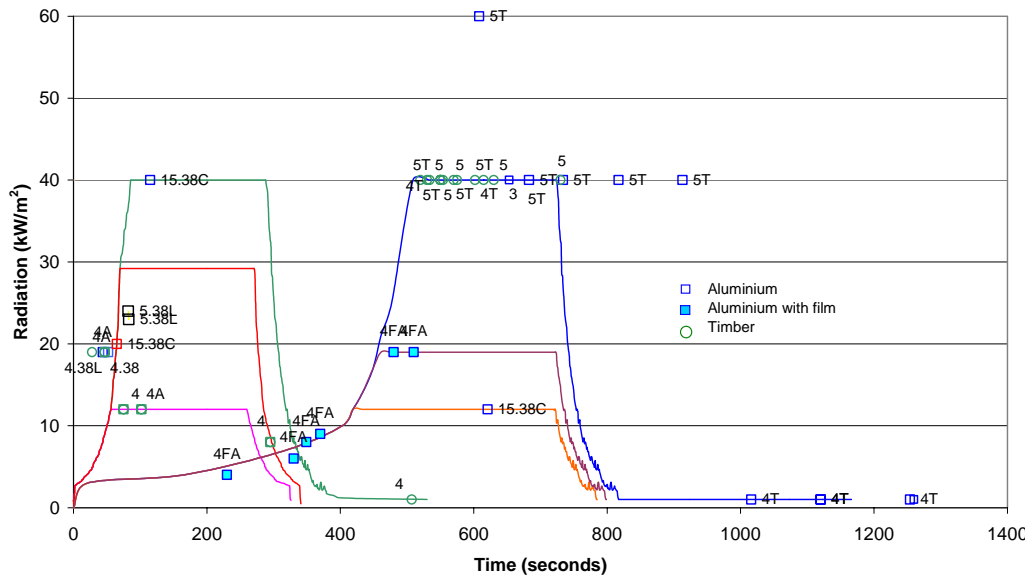
Figure 21 shows the results of framed experiments versus the radiation profiles used. As can be seen, 5 mm toughened glass was the best performer, with many tests reaching 40 kW/m<sup>2</sup> and those in aluminium frame fail on cool down or well after the tests are finished and are not represented here on this graph.

Figure 21. Radiation profiles versus framed glazing failure.

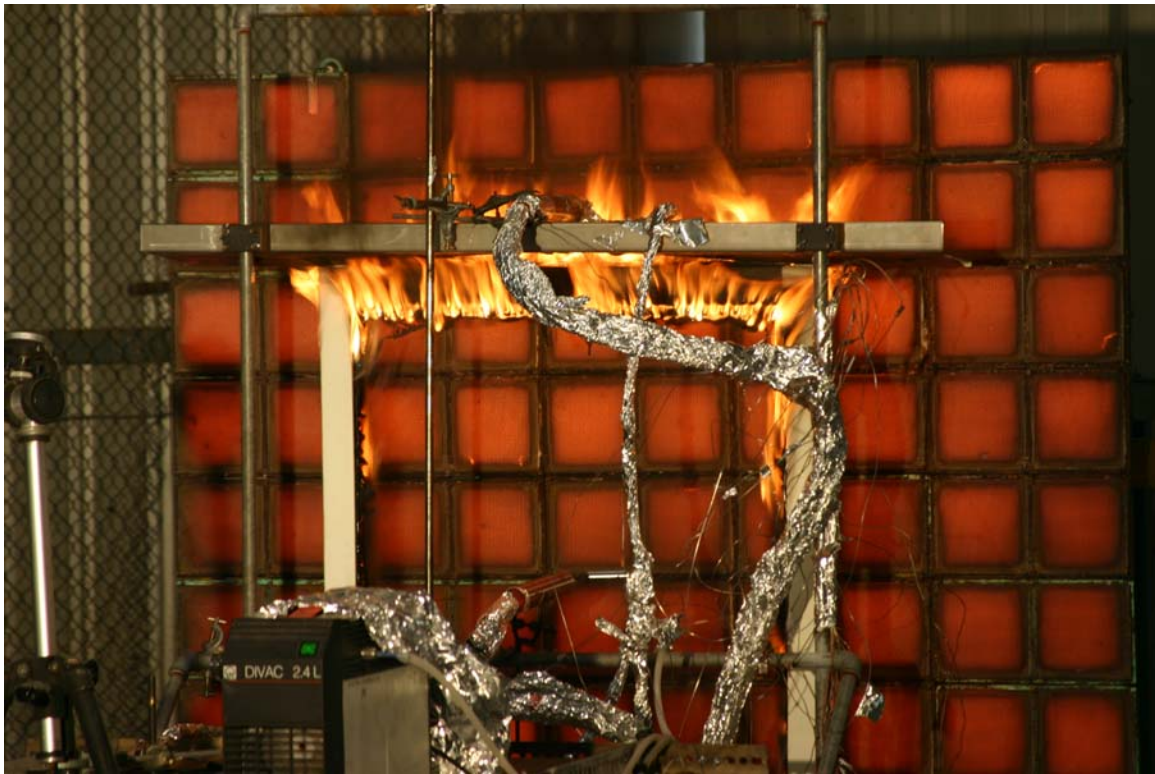
*Figure B1. Flaming of rubber beading – Trend 6.*

Trend 6 failed in much the same way as Trend 5, but showed a second failure mode. This second failure mode occurred in some other tests using toughened glass. The glazing did not fail during the test cycle, but shattered on cooling. In this case, it was 300 s after the test was completed and was a surprise to all. This type of failure highlights a safety issue that can occur after the firefront has passed. This raises the question that if this failure mode is acceptable, then what duration after the firefront passes is this deemed acceptable?

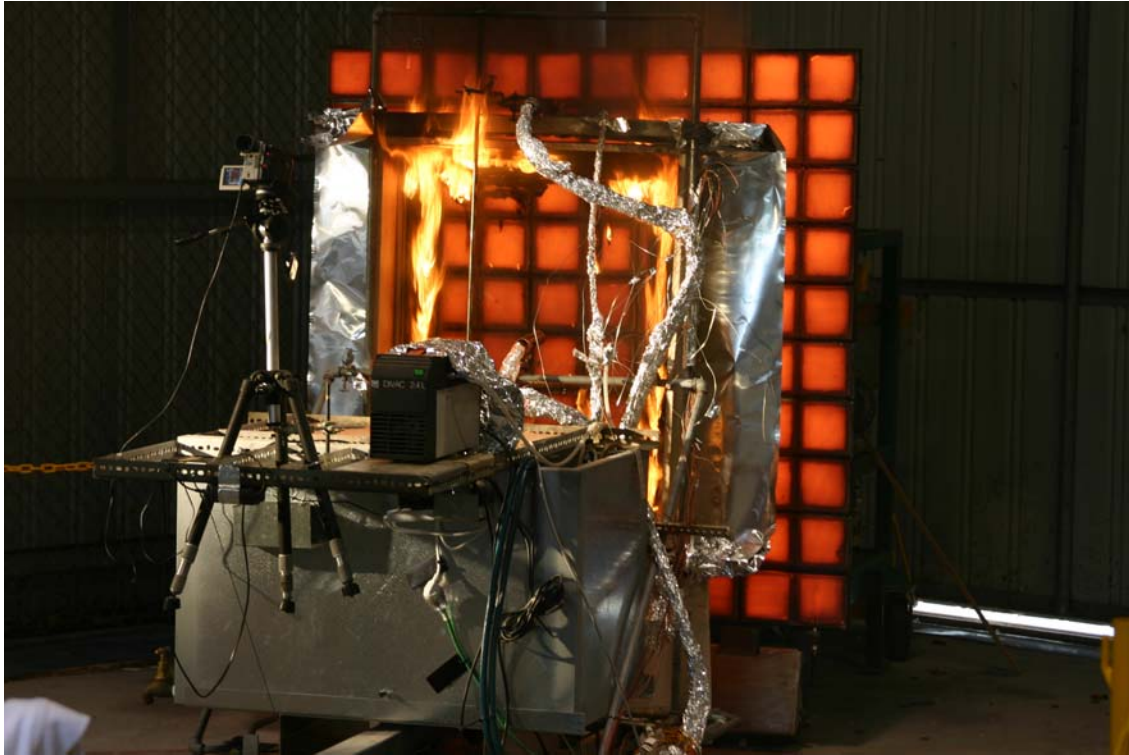
*Figure B2. Flaming of seals – Trend 8.*

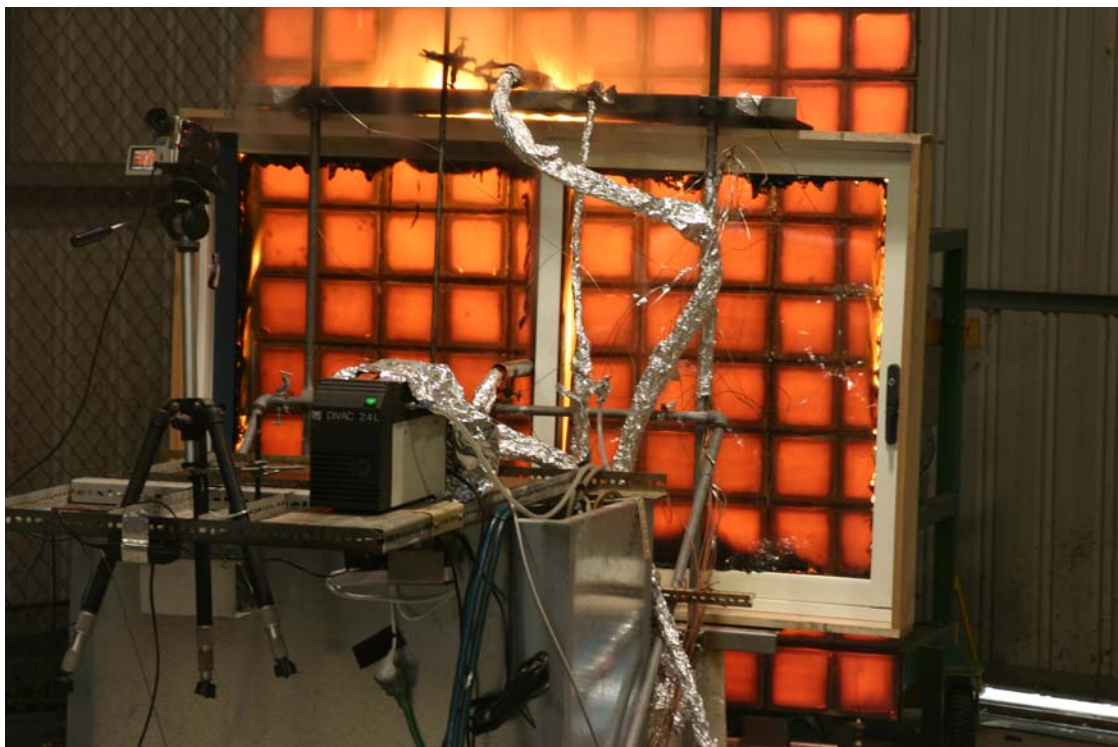
*Figure B3. Flaming of double light unit – Trend 10.*

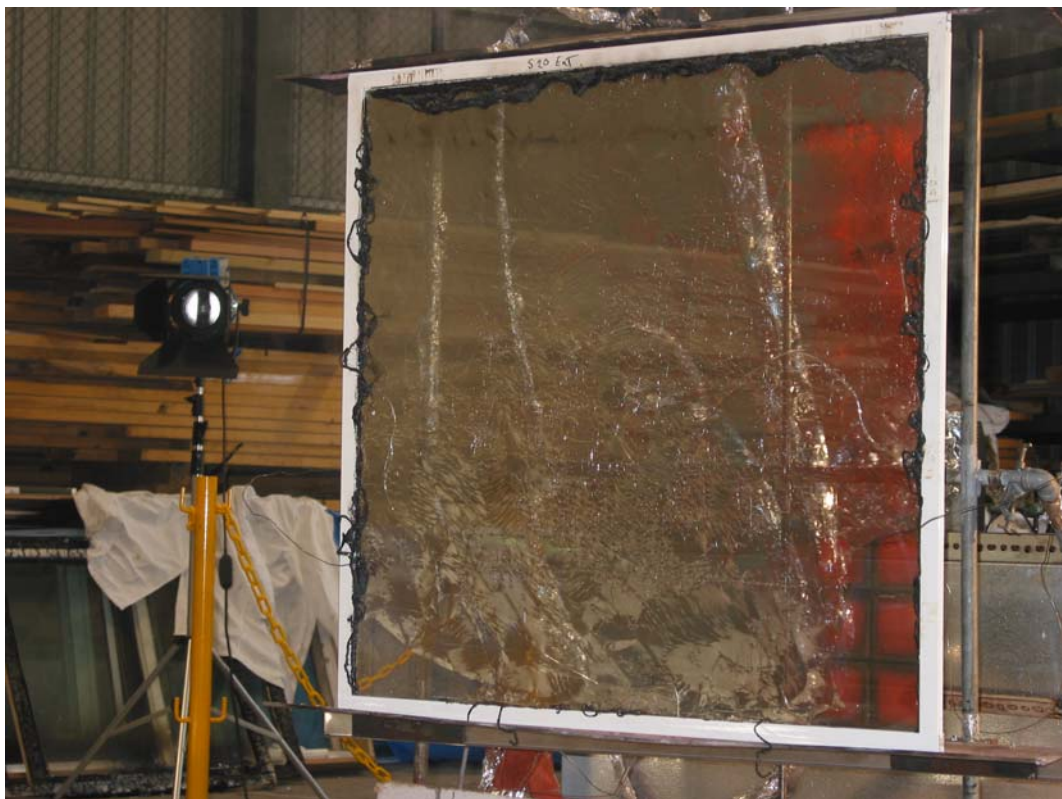
Figure B5 shows a standard failure mode for a film-coated aluminium window. The change in opaqueness of the films occurred in all tests as the plastics and other compounds that are incorporated in the film broke down on heating. In the figure, it can clearly seen where the film has peeled back from the edge at the bottom left corner of the window. This photo (from Film 11) also shows that the glass stayed intact in its frame even though the rubber beading melted.

*Figure B5. Film shrink back during radiation exposure.*

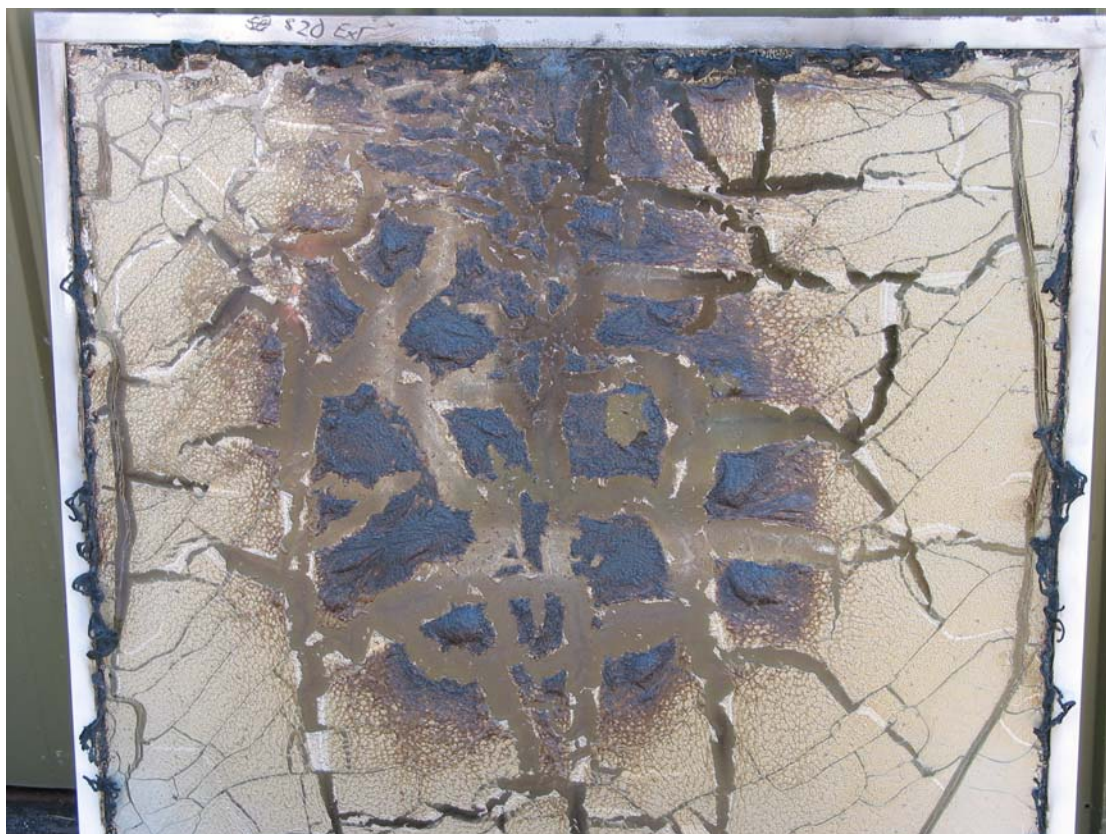
*Figure B6. Crazing of metallic film after radiation exposure and cooling.*
