Doc CMIT--2006-206

HOUSE FIRE SPREAD, AN INVESTIGATION – GULGONG NSW

Report to Bushfire CRC

March 2006

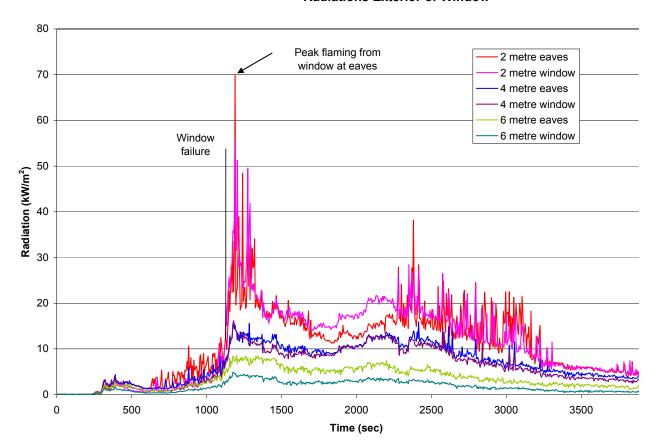
Figure 13. Radiation v. time during experimentation.

Immediate spikes in data occurred after window failure. Peak radiation and temperature occurred 80 sec later as the fire within the room intensified with the ingress of fresh air. Peak radiation 2 metres from the window centre was 55 kW/m^2 with a temperature of $223 \, ^{\circ}\text{C}$. At this time peak radiation at eaves was $70 \, \text{kW/m}^2$ with a temperature of $400 \, ^{\circ}\text{C}$.

Radiation measured during the experiment, see Figure 13, shows sustained periods of radiation in excess of 25 kW/m². The radiation measurement at 2 metres from the window exceeded 25 kW/m² for a duration of 145 seconds..

If another house with external timber features, timber fence or other combustible material was placed at 2 metres from the window, ignition of that material would most likely occur in the presence of a pilot flame. Peak radiation was 55 kW/m^2 at this position with temperatures exceeding $300 \, ^{\circ}\text{C}$.

At eaves height the peak radiation was almost 70 kW/m² which would pose potential threat to tall structures within 2 metres e.g. water tanks and power or phone lines.

Radiation levels at 4 and 6 metres from the window peaked at 16 kW/m² for short periods and without sustained exposure and pilot flames present it is unlikely that if a fence was present at these distances that it would ignite and flaming would occur.

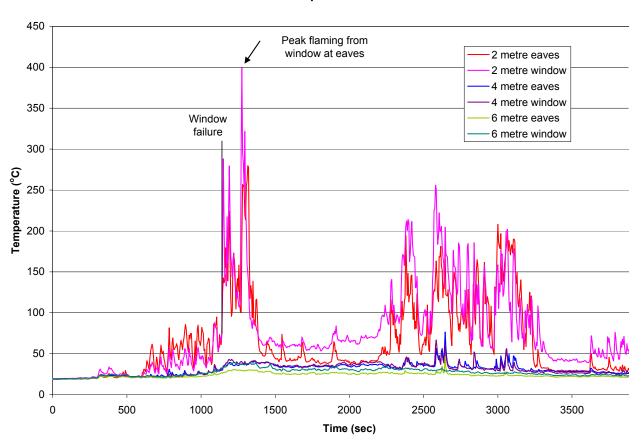
Figure 14. Temperature v. time during experimentation.

Radiation and temperature reduces after this peak as available fuel lessens. The rise in radiation and temperature after approximately 2200 sec occurs when the walls have burnt sufficiently to expose the internal house structure.

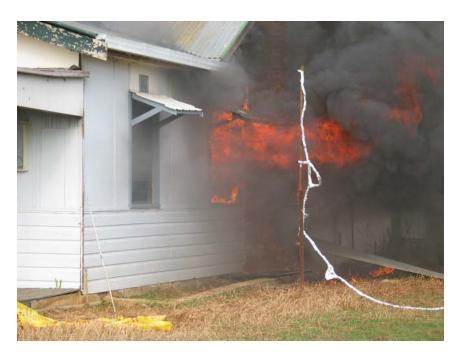
Figure B3. Depth of flames through lounge room window. These flames are much larger than that for bedroom 1, given the room is of a greater volume and has more fuel. This photo is indicative of the extent flames can protrude from a building in this case approximately 4 metres.

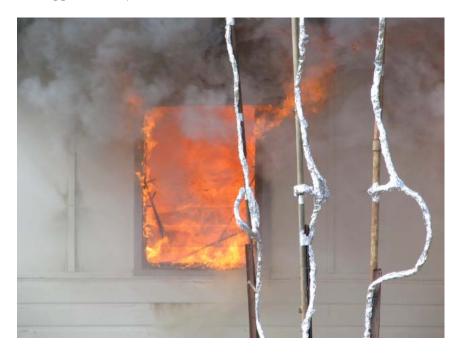
Figure B4. Flames beginning to emerge from bedroom 1 window, most louvres still in place.

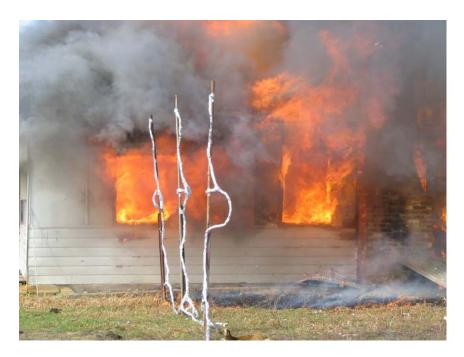
Figure B5. Fire well established in Bedroom 1

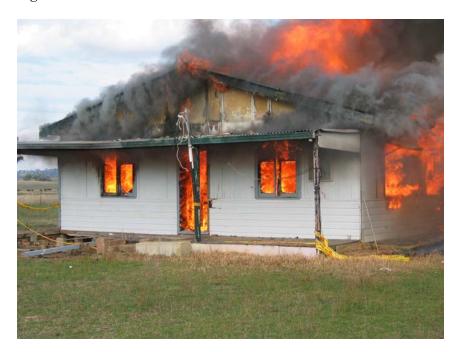
Figure B6. House totally involved

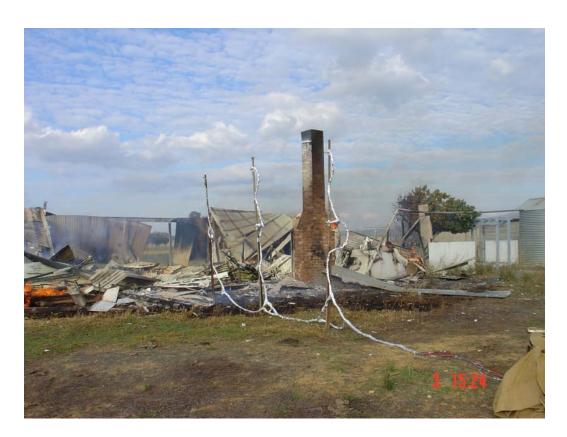
Figure B7. Aftermath of the fire
