**RESEARCH AND INVESTIGATION INTO THE
PERFORMANCE OF RESIDENTIAL BOUNDARY
FENCING SYSTEMS IN BUSHFIRES**

**Report to
BlueScope Steel Limited**

**CSIRO Manufacturing & Infrastructure Technology
Fire Science & Technology Laboratory
Bushfire Research**

April 2006

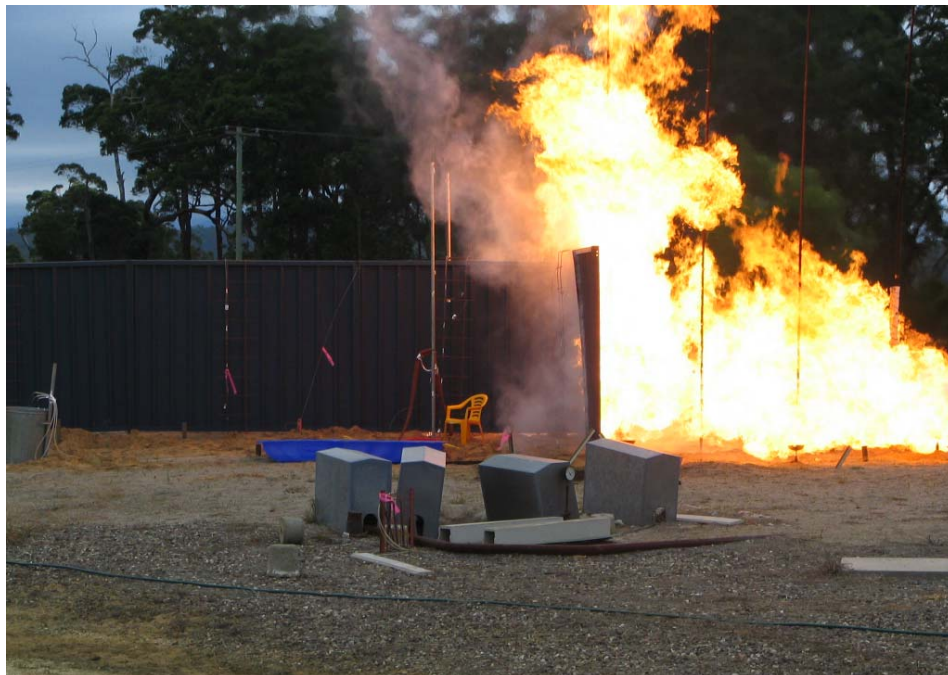
The pre-radiation stage burners were turned on at the start of Experiment 1. After 6 minutes panels A, B and C were producing significant amounts of smoke. At 7:10 (min:sec) flame immersion stage burners were turned on and flames impinged on the outside of panels A, B, C and D, with flames rolling over the top of the fencing (see Figure 3). Smoke production at the inside of these panels immediately increased. At 7:40 flame immersion burners were turned off. At 13:00 pre-radiation burners were turned off and the experiment ceased.

Figure 3. Experiment 1 – flame immersion exposure of traditional COLORBOND steel fencing.

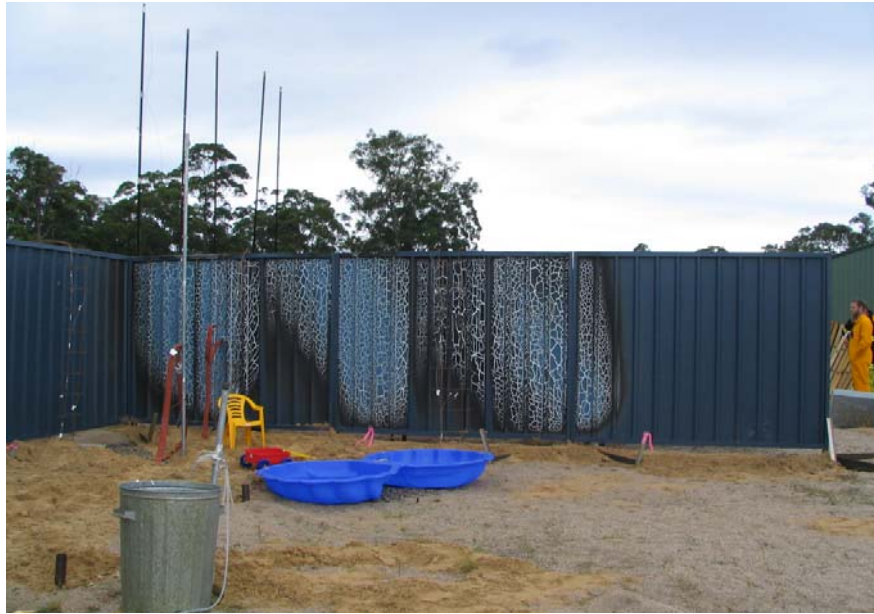
During the experiment the fencing structure did not sustain any flaming. The COLORBOND steel coating on both sides of panels A, B, C and D were scorched and crazed (see Figure 4). All fencing panels were still standing, however there was slight buckling of the panels that produced small openings at the joints between panels A–B and B–C. There was no damage to the simulated residential building or any of the plastic play equipment.

Figure 4. Experiment 1 – inside view of (left to right) panels D, C, B and A at end of experiment.

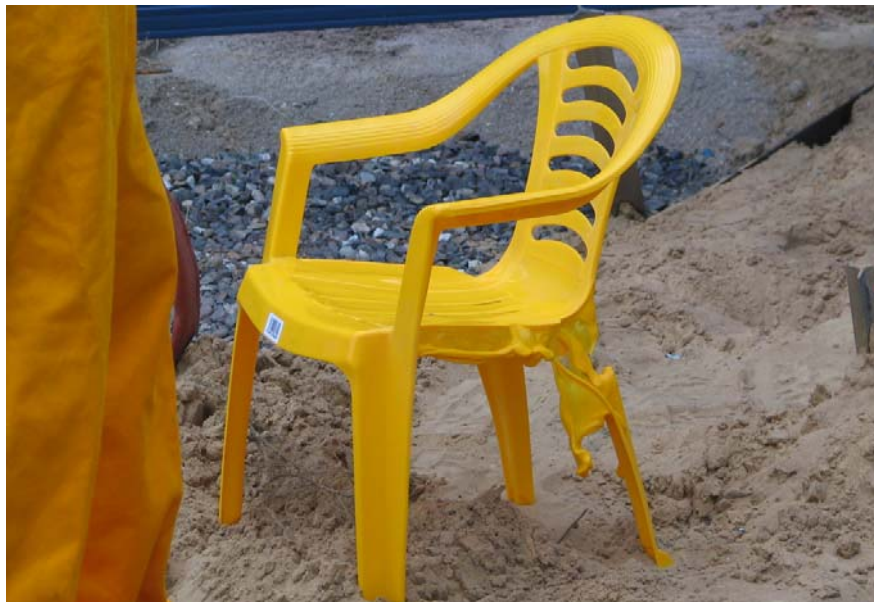
Flame immersion stage burners were turned on at the start of the experiment, with flames impinging on panels A, B, C and D. After 1 minute the rear of these panels was producing significant smoke and small flames were observed to intermittently lick between panels A–B, B–C and C–D in the corner. The experiment continued in this manner until the flame immersion burners were turned off at 30:00 minutes. Damage sustained to the fencing was much the same as for Experiment 1 with no major structural damage and only minor buckling at the panel joints. The simulated residential building, plastic play equipment and polypropylene chair (see Figure 5) were only superficially damaged.

Figure 5. Experiment 2 – heat-affected polypropylene chair.

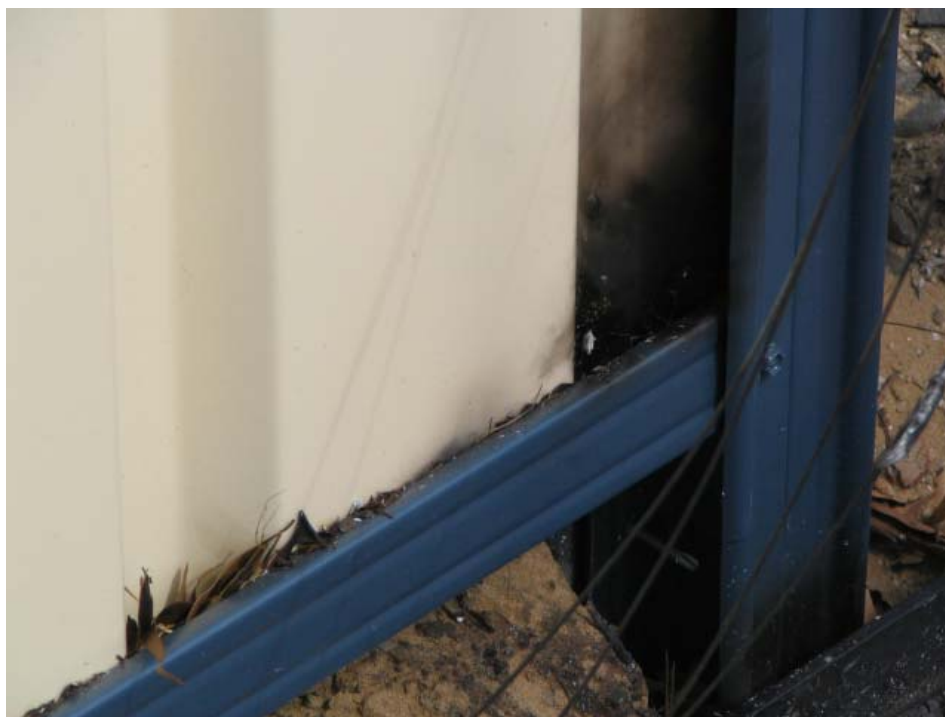
The experiment commenced with the lighting of the litter at the base of the fencing on the north-eastern side of panels A, B and C, followed by the north-facing panels. Five minutes of pre-radiation followed this ignition. During this phase the litter continued to smoulder but as would be expected no ignition of the fencing was observed (see Figure 6). By the 7:00, full immersion was under way. The experiment concluded after 10:00 with minimal structural damage observed, however there was crazing and surface coating loss to the exterior surfaces of panels A, B, C and D.

Figure 6. Experiment 4 – leaf litter effect on COLORBOND steel fencing.

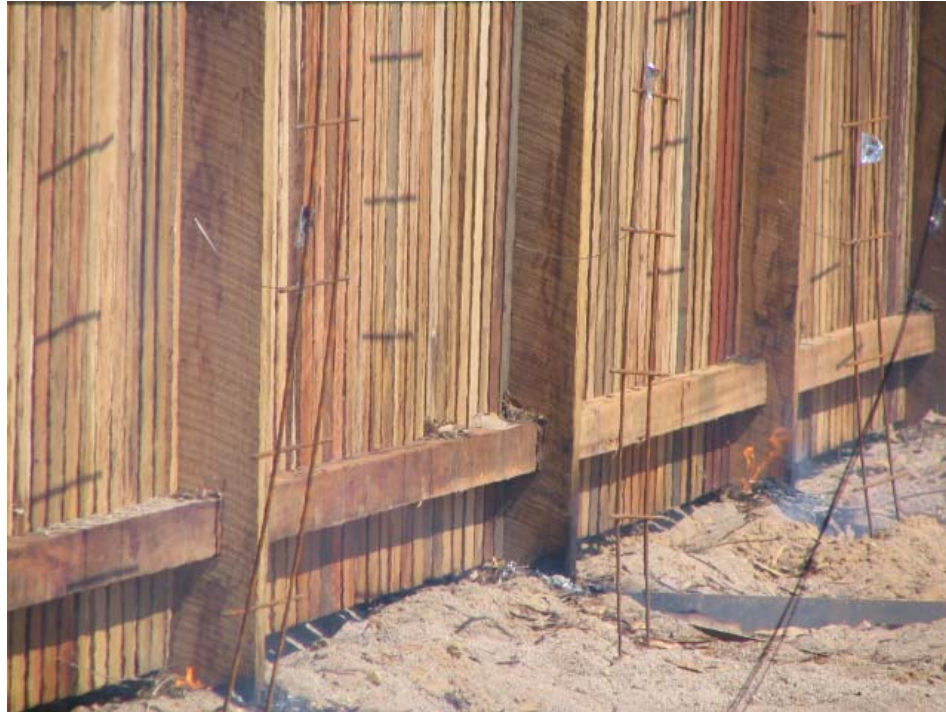
Leaf litter was ignited along the base and rails of all fencing panels. Most of the leaf litter flamed and then smouldered without any significant involvement of the hardwood. At one location where flames from leaf litter impinged on the bottom of the palings, light surface flaming at the base of the palings occurred (see Figure 7). However, this flaming ceased as the leaf litter burnt out. There was no significant damage to the fencing, play equipment, chair or simulated residential building.

Figure 7. Experiment 5 – leaf litter ignition of capped open paling hardwood fencing.

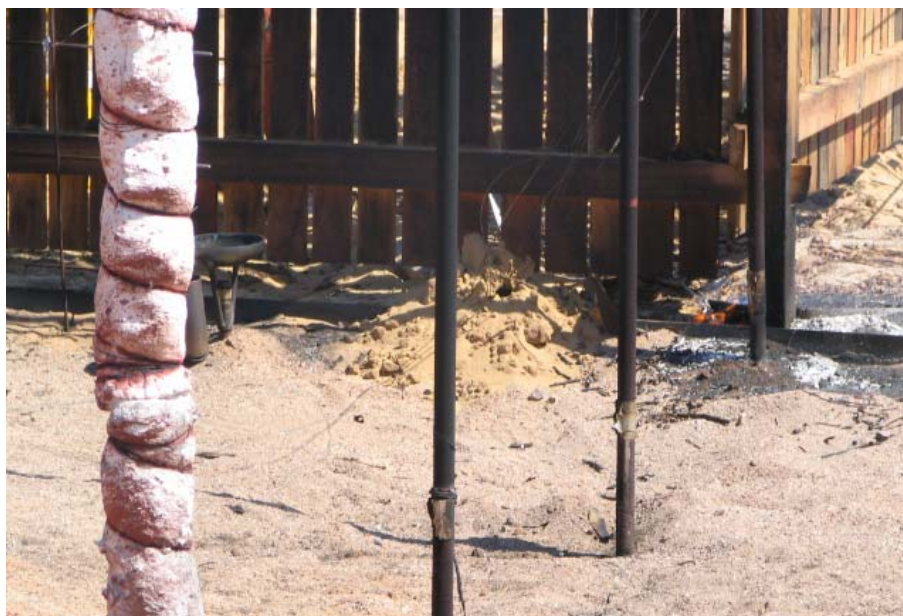
Leaf litter was initially ignited along the base of panels C, B and A, followed by the longer side panels D, E, F, G and H. At 1:20 the pre-radiation burner stage was turned on and the pre-radiation exposure began. At this stage only smouldering of leaf litter was observed with no real involvement of the hardwood. During the pre-radiation exposure no flaming or smouldering of the fencing was observed. At 9:00 pre-radiation stage burners were reduced to very small flames. At this time some limited smouldering of the fencing at the corner was observed. At 10:00 all burners were turned off and the experiment was ceased. There was no significant damage to the fencing, only scorching of the outside of panels A, B and C (see Figure 8).

Figure 8. Experiment 6 – leaf litter and pre-radiation of capped open paling hardwood fencing.

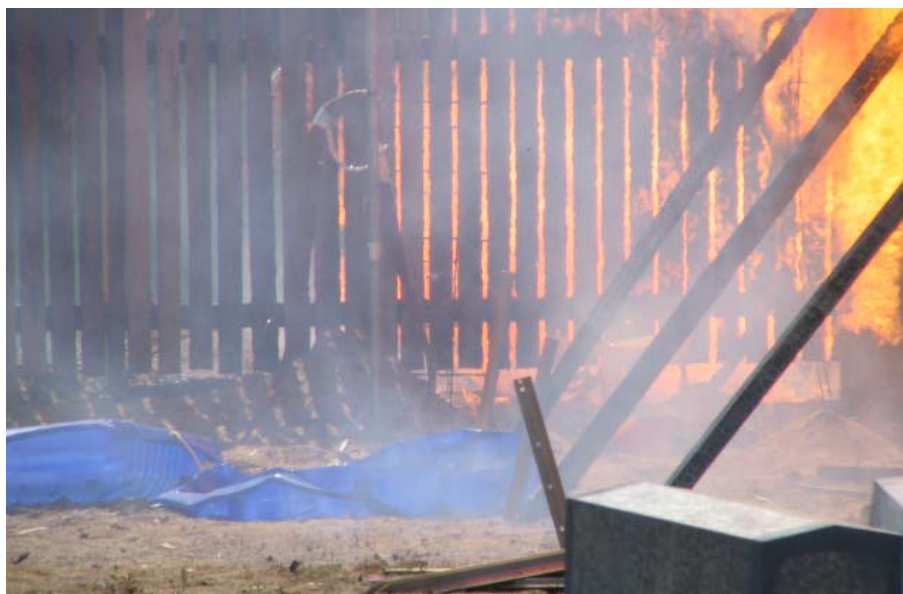
This experiment commenced with the ignition of the pre-radiation burner stage, followed within 30 seconds by the full flame immersion burners. Panels B, C and D ignited almost instantly, with flame extending about 2 m into the air and penetrating through the fencing, damaging the play equipment (see Figure 9). Flame spread to panels A and E was observed, but the majority of the damage was confined to the panels directly exposed to the flame. The flame exposure concluded after 5:40 and the fencing was allowed to burn. During this period flame continued to spread slowly away from the corner until 22:00, when what was remaining of panel B, C and D collapsed.

Figure 9. Experiment 7 – flame immersion exposure of capped open paling hardwood fencing.

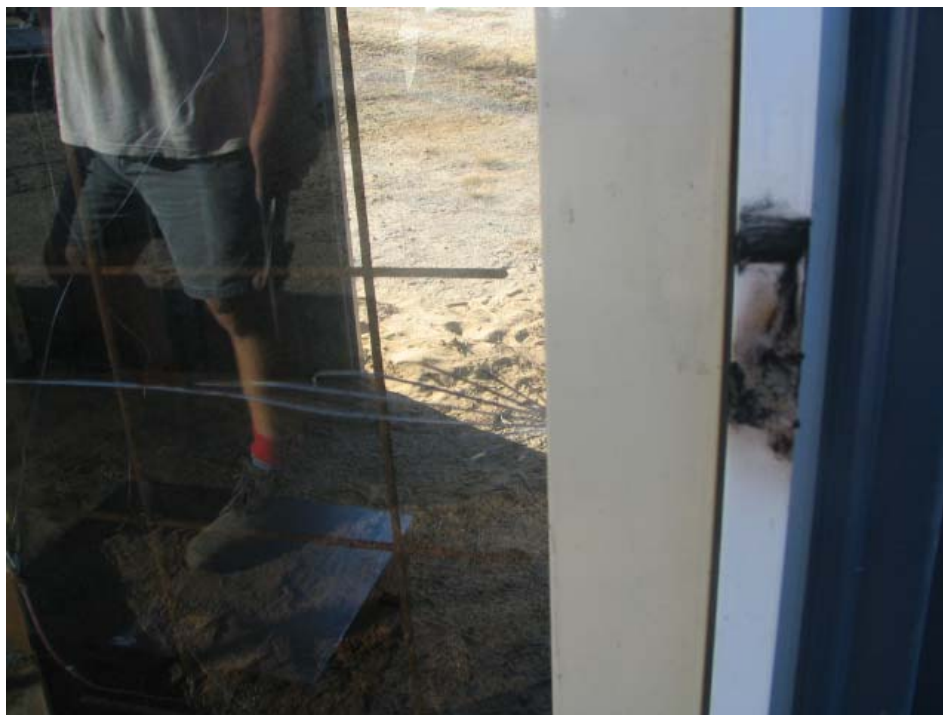
Inspection of the resulting damage revealed that window 2 in the simulated building had cracked in the top right-hand quarter (see Figure 11). The entire fencing except for panels A and B had either collapsed or been consumed.

Figure 11. Experiment 8 – cracked window 2 after leaf litter ignition of closed paling treated pine fencing.

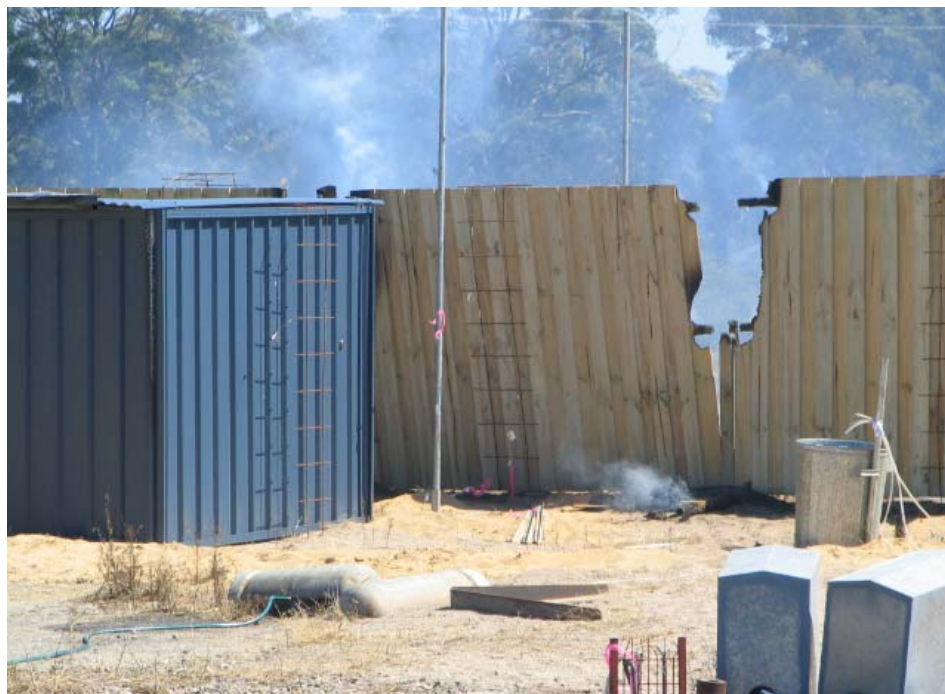
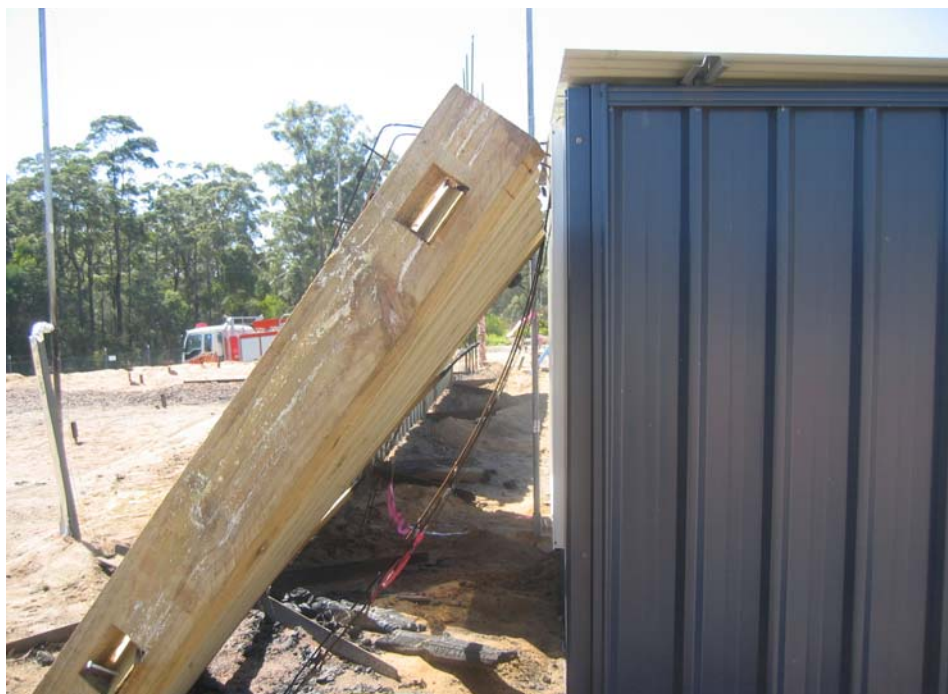
causing major structural damage to the fencing along the north-facing panels (see Figure 12). This damage caused the fencing to fall onto the simulated house, smashing window 2 (see Figure 13). This observation is of particular importance as in a real bushfire scenario, total house loss would be imminent unless immediate suppression occurred.

Figure 12. Experiment 9 – pre-radiation exposure of closed paling treated pine fencing.

Figure 13. Experiment 9 – pre-radiation exposure of closed paling treated pine fencing.

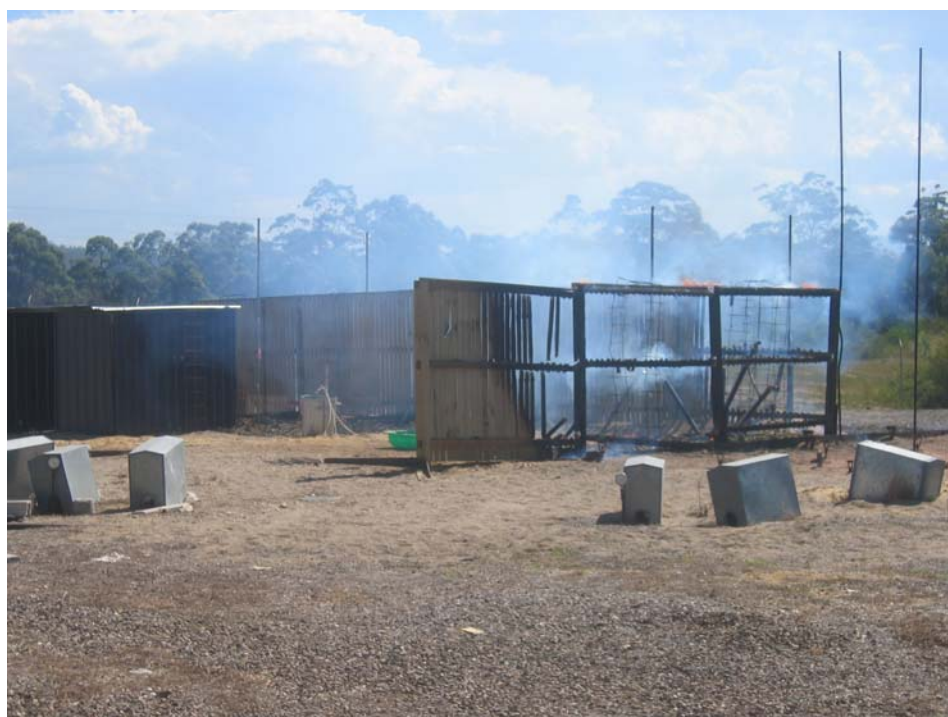
Flame spread was observed along the fencing in both directions away from the corner, and severe damage was observed to the directly exposed areas. The fencing appeared to be consumed in the area where flame contact occurred. The experiment concluded with panels A, B, C, D and E being destroyed (see Figure 14), along with the children's play equipment. Burning was ongoing at the time of experiment termination, and it was likely that these flames would have consumed all fencing panels.

Figure 14. Experiment 10 – flame immersion exposure of capped open paling treated pine fencing.

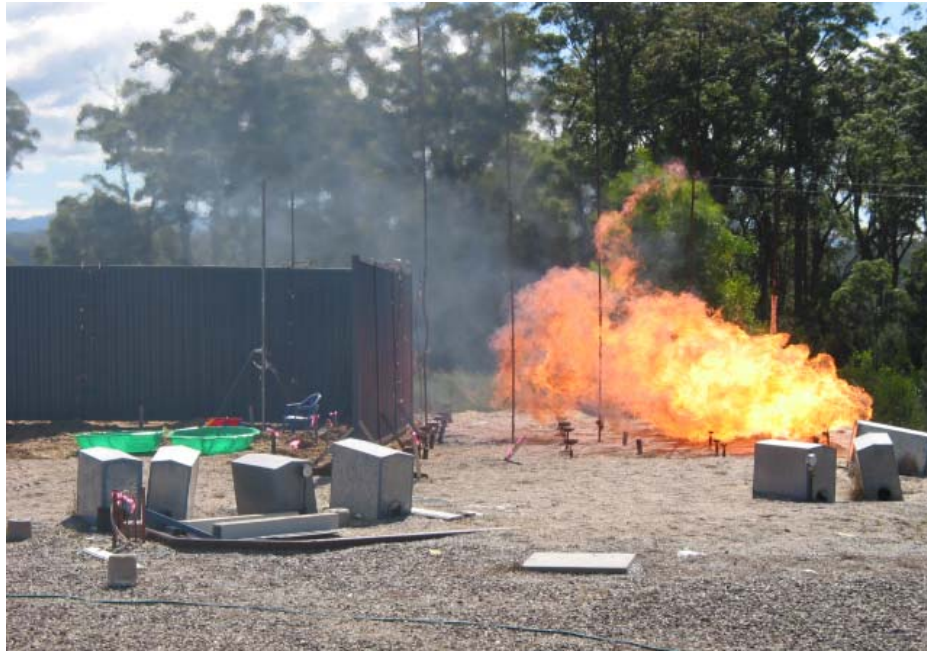
The experiment commenced with the ignition of the pre-radiation burners. At 1:30 the burners were increased in intensity to 10 kW/m^2 . The fencing showed no signs of deterioration at this point. At 5:00 radiation was increased to 30 kW/m^2 , still with no visible impact on the fencing (see Figure 15). No flame contact was observed. The experiment concluded after 9:00 with no structural damage to the fencing.

Figure 15. Experiment 11 – pre-radiation exposure of COLORBOND steel fencing with sawtooth profile.

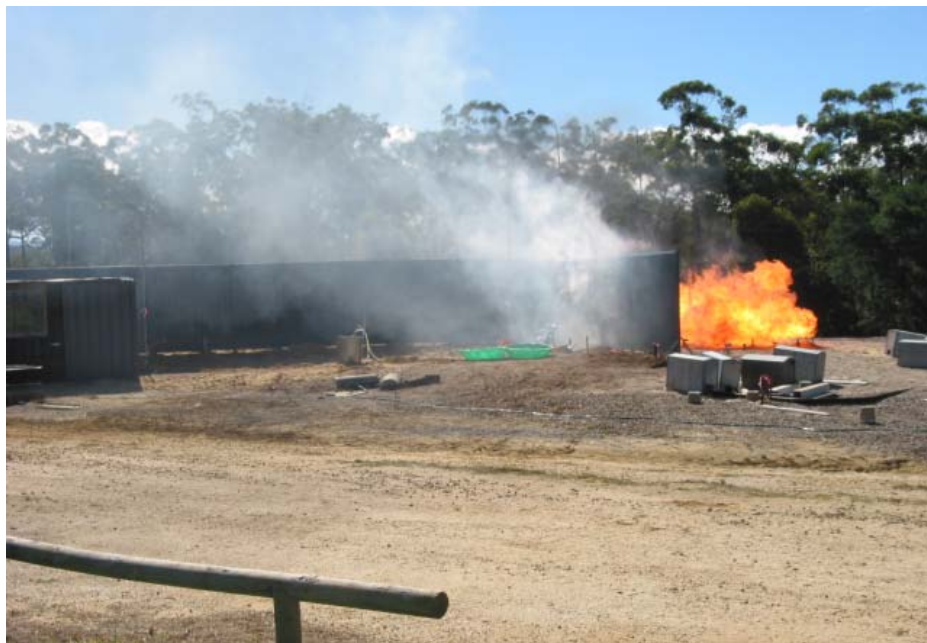
The pre-radiation burners were ignited and their output was increased to 10 kW/m^2 at 2:00. No flame contact was observed to this point. Radiation was increased to 30 kW/m^2 , and at 5:20 some flame contact was observed, resulting in smoke generation by the contacted panels (A, B and C) (see Figure 16). Radiation was reduced after 7:00 and the experiment concluded at 9:00. No flame penetration was recorded and the fencing remained structurally sound.

Figure 16. Experiment 12 – pre-radiation exposure of COLORBOND steel fencing with sawtooth profile.

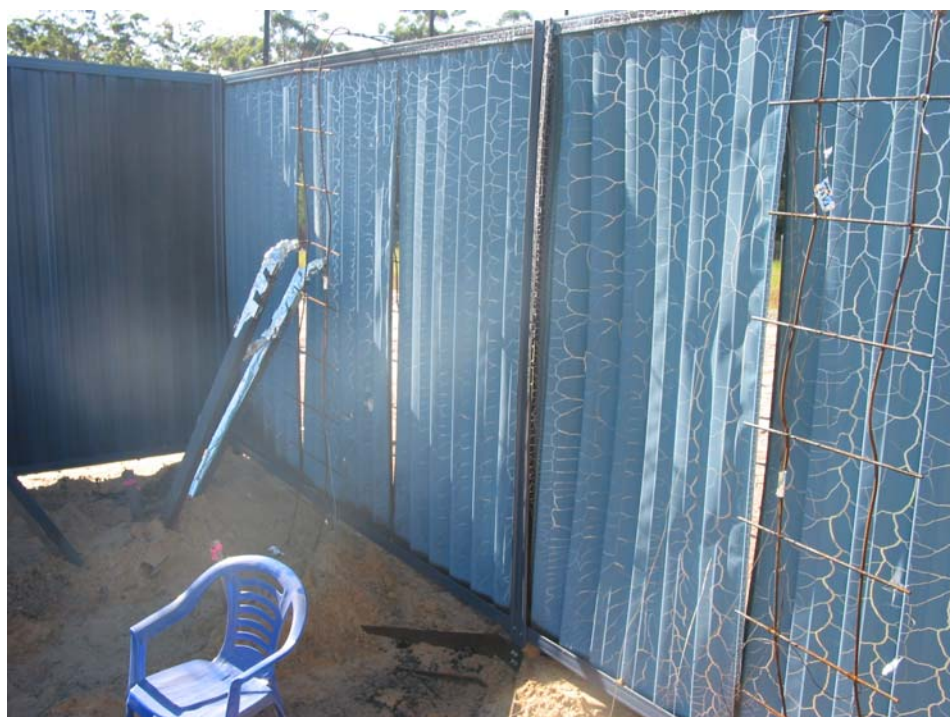
The experiment was initiated with the ignition of the pre-radiation burners. After 3:00 the radiation intensity was increased to 10 kW/m². No flame contact was observed until an increase in wind speed laid the flames down. Ignition of the remaining pre-radiation burners at 6:00 produced a further increase in the flame size and intensity, causing some smoke emission from the fencing. At 7:00 the flame immersion burners were ignited, covering the fencing in flame. These flames penetrated under, over and, to a small degree, through small gaps between the fencing panels, although they did not cause major structural damage. Smoke was being generated and there appeared to be a slight bowing of the fencing at panel B, directly above a burner. The experiment concluded with the fencing remaining structurally sound, but there was extensive damage to the surface coatings of the fencing. Small gaps had also developed at the joints between panels A, B, and C (see Figure 17).

Figure 17. Experiment 13 – flame immersion exposure of COLORBOND steel fencing with sawtooth profile.

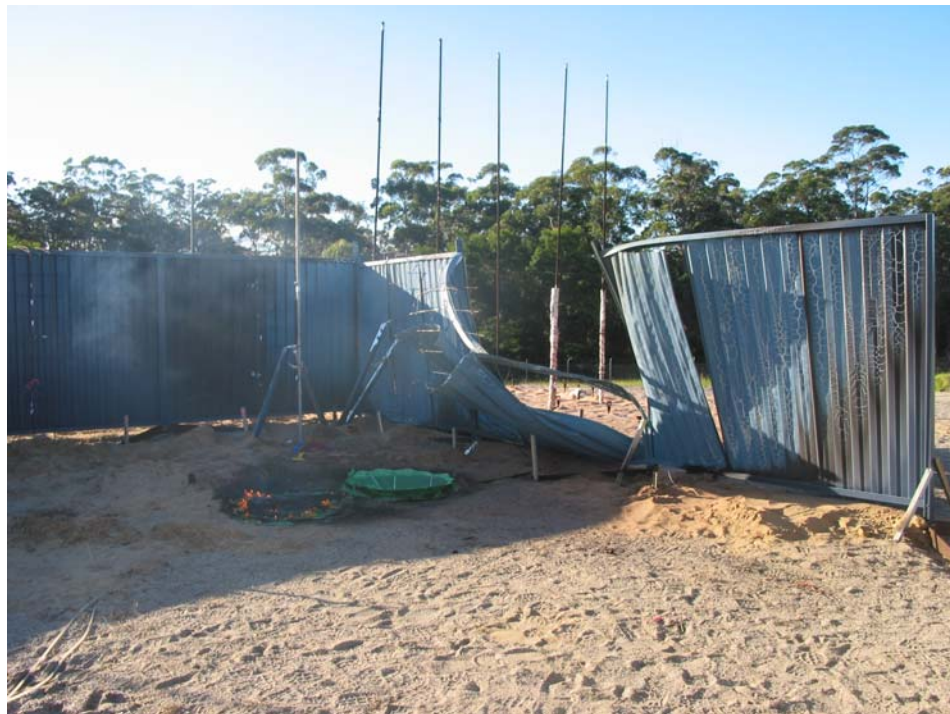
much more severe. At 4:00 panels A and B began to lean backwards away from the burners and at 5:20 panel B collapsed back at a 45° angle, with flames extending 3 m diagonally across the yard. At this time all the plastic play equipment had already melted and the molten seat and chair had ignited. At 7:00 the molten plastic pool ignited. At 8:00 the burners were turned off and the experiment ceased due to the observed collapse (see Figure 18).

Figure 18. Experiment 14 – structural exposure of COLORBOND steel fencing with sawtooth profile.

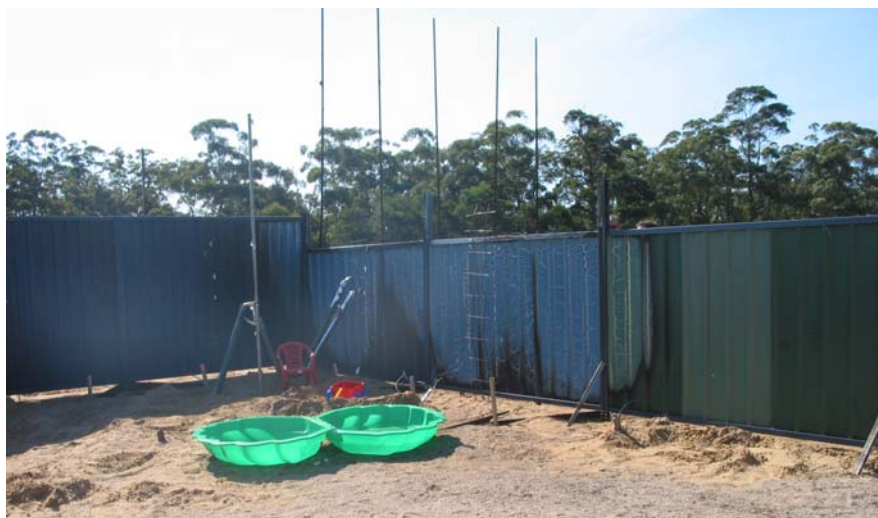
There was no structural damage to the fencing, however the coatings on both sides of panels A, B, C and D was scorched and crazed. There was no damage to the simulated residential structure or plastic play equipment (see Figure 19).

Figure 19. Experiment 15 – flame immersion exposure of traditional 1.5 m high COLORBOND steel fencing.

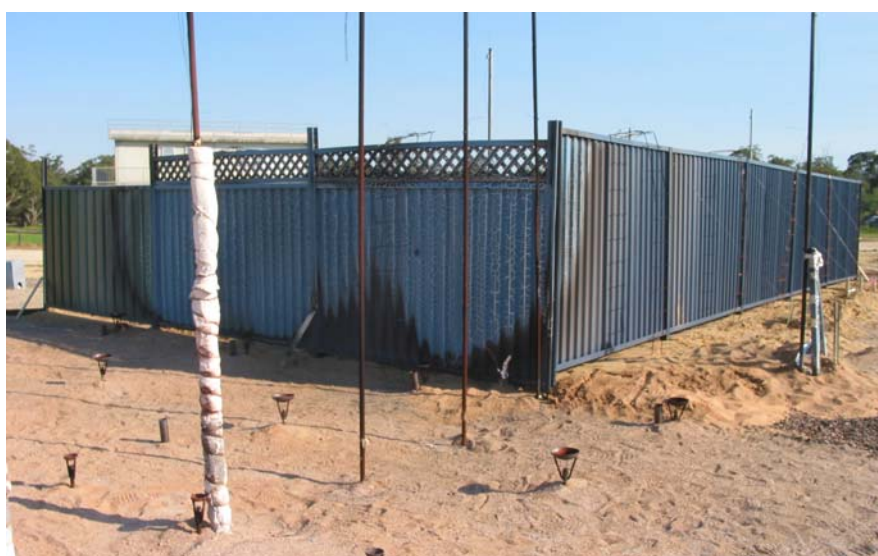
The damage was similar to that for Experiment 15, with only scorching and crazing of the COLORBOND coating (see Figure 20).

Figure 20. Experiment 16 – flame immersion exposure of 1.5 m high COLORBOND steel fencing with lattice top.

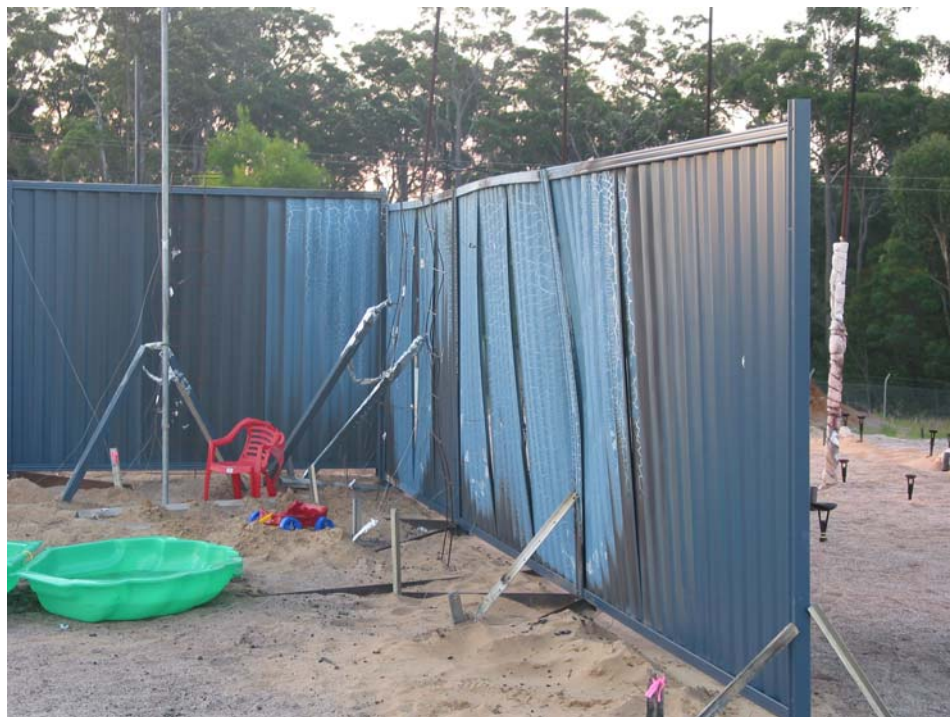
The flame immersion burners were turned on at the start of the experiment, with flames impinging on panels A, B, C and D. The rear of these panels began emitting smoke from this time. After the first minute of exposure the panels had slightly buckled at the joints between panels A–B, B–C and C–D, with small flames licking through the openings. However, the fencing remained standing and did not sustain any further structural damage throughout the exposure. The flame immersion burners were turned off at 30:00. There was no damage to the simulated residential building, but there was some damage to the plastic chair and toy trailer (see Figure 21).

Figure 21. Experiment 17 – structural exposure of COLORBOND steel fencing with sawtooth profile.

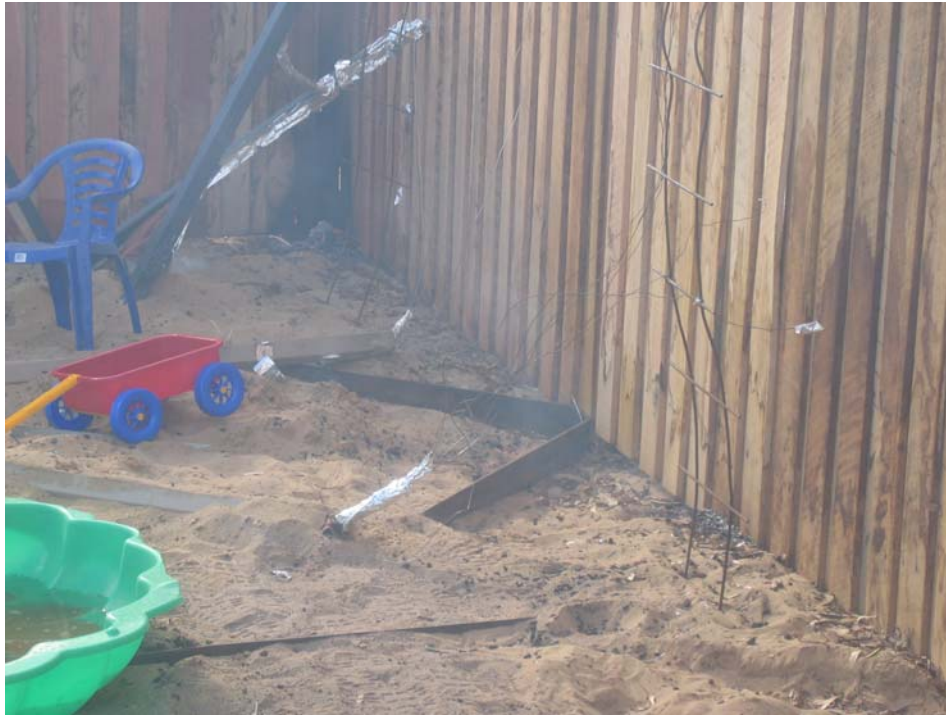
At 2:00 smoke from smouldering leaf litter was evident, but no flaming of the timber could be observed. At 2:30 small flames from the leaf litter at the inside fencing corner were observed, but with limited involvement of the hardwood. The flames extended from the base to 0.5 m high. By 4:00 the flaming had extinguished with smouldering of corner and post continuing (see Figure 22), and by 10:00 smouldering had ceased. There was no significant damage to the fencing except for minor charring at the base of the corner.

Figure 22. Experiment 18 – leaf litter ignition of closed paling hardwood fencing.

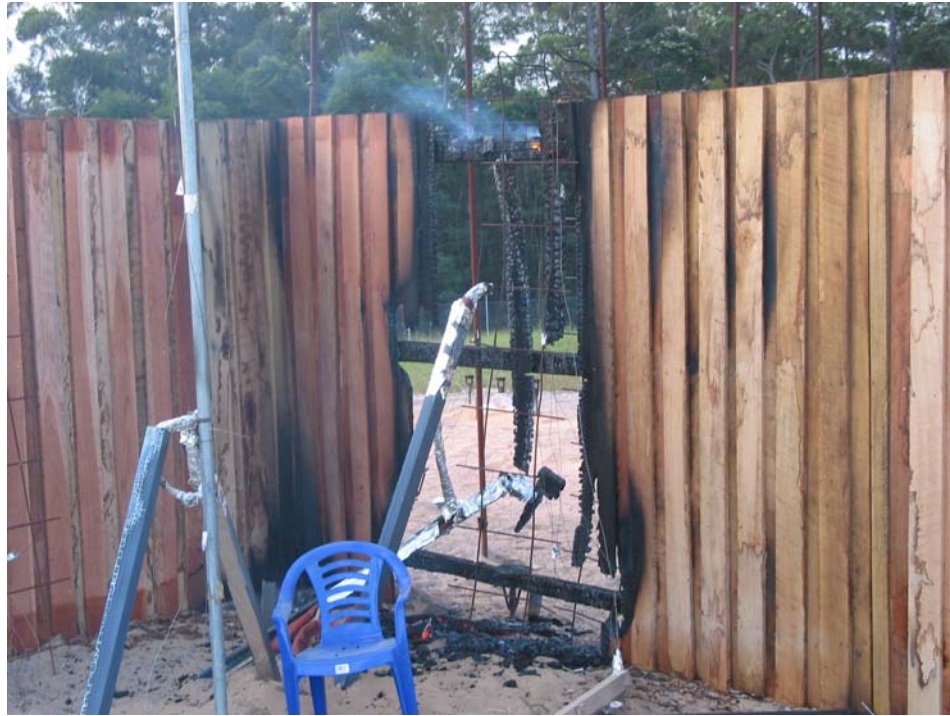
At the start of the experiment, a small amount of smoke was still being produced by the smouldering leaf litter from the previous experiment. More leaf litter was distributed and ignited along panels D, E, F and G. Leaf litter was also ignited along panels A, B and C. At 1:50 the pre-radiation burners were turned on. By 8:00 the pre-radiation burners were at their peak, and leaf litter and fencing timber on the outside of the corner started flaming, extending above the top of the fencing. At 9:30 flames from the pre-radiation burners were reduced and the flames at the corner decreased. By 10:00 a lot of smoke was coming from the corner, but there were no visible flames. The pre-radiation burners are turned off at 11:00 and the corner continued smoking. By 18:00 there were flames visible at the base of the corner on the inside, and by 25:00 these flames have grown to extend to the mid-height of the fencing. By 38:00 the flames reached the top of the fencing and had spread very slowly laterally from the corner along panel C. By 45:00 the palings had burnt out in the corner, extending halfway along panel C. From this point, the flames decayed with no further significant spread until all flaming ceased at 70:00 and the experiment was ceased. There was no resulting damage to the simulated residential building or the play equipment. There was no collapse of the fencing, but flaming had led to the consumption of all palings in the corner intersection of panel C and D, extending half way along panel C (see Figure 23).

Figure 23. Experiment 19 – leaf litter and pre-radiation exposure of closed paling hardwood fencing.

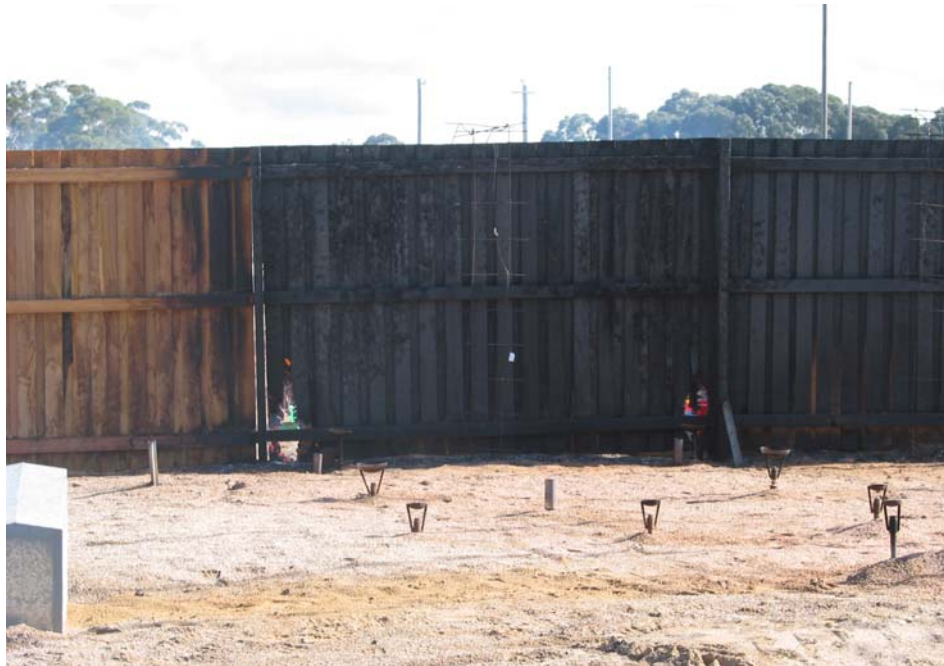
There was no significant resulting damage to the fencing except for scorching of the outside of panels A, B and C (see Figure 24). No significant flaming had been sustained. There was no damage to the simulated residential building, plastic play equipment or chair.

Figure 24. Experiment 20 – flame immersion exposure of closed paling hardwood fencing.

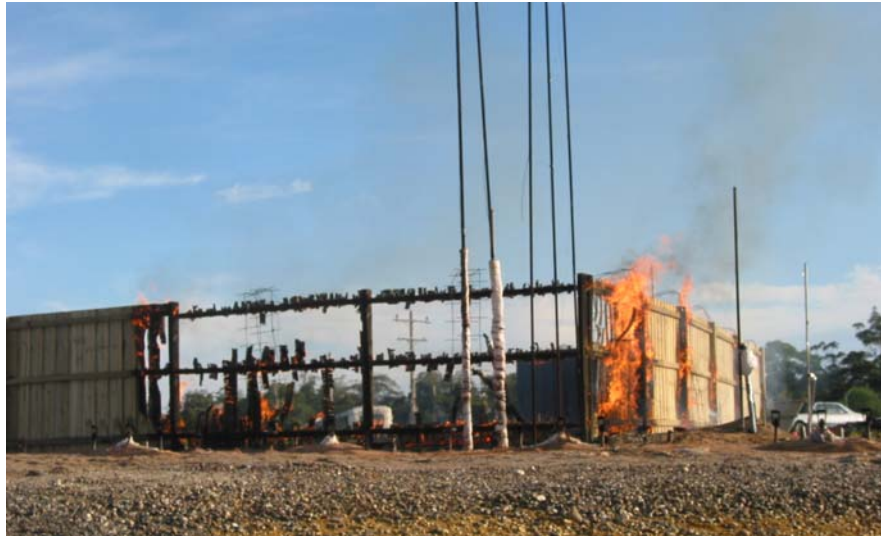
Leaf litter was ignited along fencing panels D to H, as for experiment 20. At 1:32 the pre-radiation burner stage was turned on. By 3:40 there was smoke from smouldering leaf litter and treated pine along the length of panels D to H. At 5:30 flaming of the fencing timber was observed at the outside of the corner at panels C and D, and by 6:00 the flames extended to the top of the fencing. By 7:00 flames began spreading laterally along the outside of panels C and D from the corner, and by 7:40 flaming extended along the entire outside of panel C and halfway along the outside of panel D. At 8:30 the flame immersion stage burners were turned on, with flames 4–5 m high leaning towards the fencing. The outside of panels B and C instantly became involved in flame. At 9:00 the immersion burners were turned off, but were still bleeding from supply lines. At this time most palings on panel C had been consumed, leaving a large hole. However, most of the panel D palings were still intact. The outside of panel B was still flaming at mid-rail height. At 10:00 flaming was observed at the intersection of panels D–E and E–F, and panels B and C were flaming on both sides. By 11:00 flames at the intersection of panels D–E and E–F extended to the top of the fencing. At 11:10 the pre-radiation burners were turned off and panels B and C continued flaming. By 12:00 the majority of the palings in panels B and C were burnt through with charred rails and posts still standing, and most of panel D was involved in flame (see Figure 25). By 14:00 flaming of panels A, B and C had ceased, but flaming at other points on the fencing continued. At 15:40 panel D collapsed and the paling at the intersections of panels D–E and E–F had been consumed. At 18:30 panel E collapsed. At 26:00 panel F collapsed. At this stage panels G and H adjacent to the window were flaming. At 34:00 panel G collapsed outwards away from the simulated building. Panel H continued flaming and collapsed onto the simulated building at 47:00. At 49:00 the window that the burning fencing was leaning against broke. This appeared to be due to thermal stress as burning timber was in direct contact with the window. At 60:00 the remaining smouldering material was suppressed and the experiment was stopped.

Figure 25. Experiment 21 – flame immersion exposure of closed paling treated pine fencing.

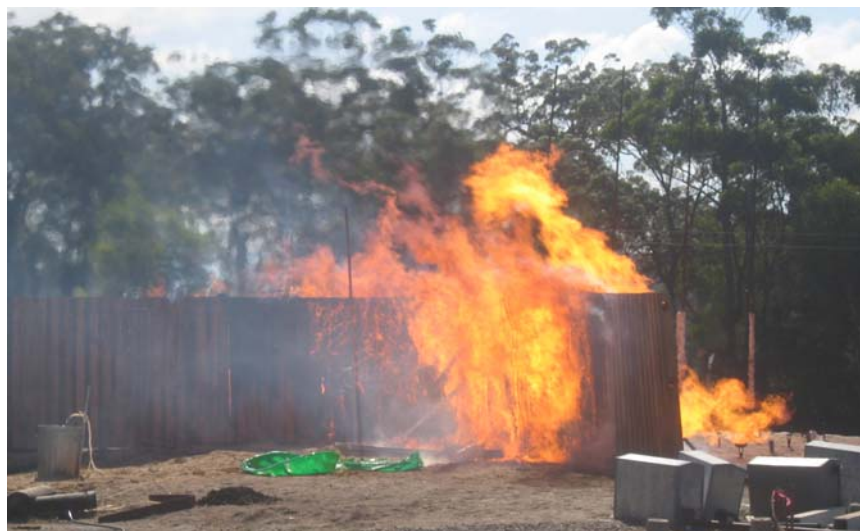
The immersion stage burners were turned on at the start of this experiment. Flames immediately impinged on the outside surfaces of panels B and C, with flames penetrating through the palings and emerging from the rear of the panels (see Figure 26). After 30 seconds of this exposure the rear of panels B and C began producing significant amounts of smoke. The burner flames leaned towards the fencing and impinged on most of the outside of panel D due to the prevailing wind. At 2:20 mast 1 on the grid softened and fell over due to the high temperatures. By 4:00 the majority of the rear of panels B and C were involved in flame.

Figure 26. Experiment 22 – structural exposure of closed paling hardwood fencing.

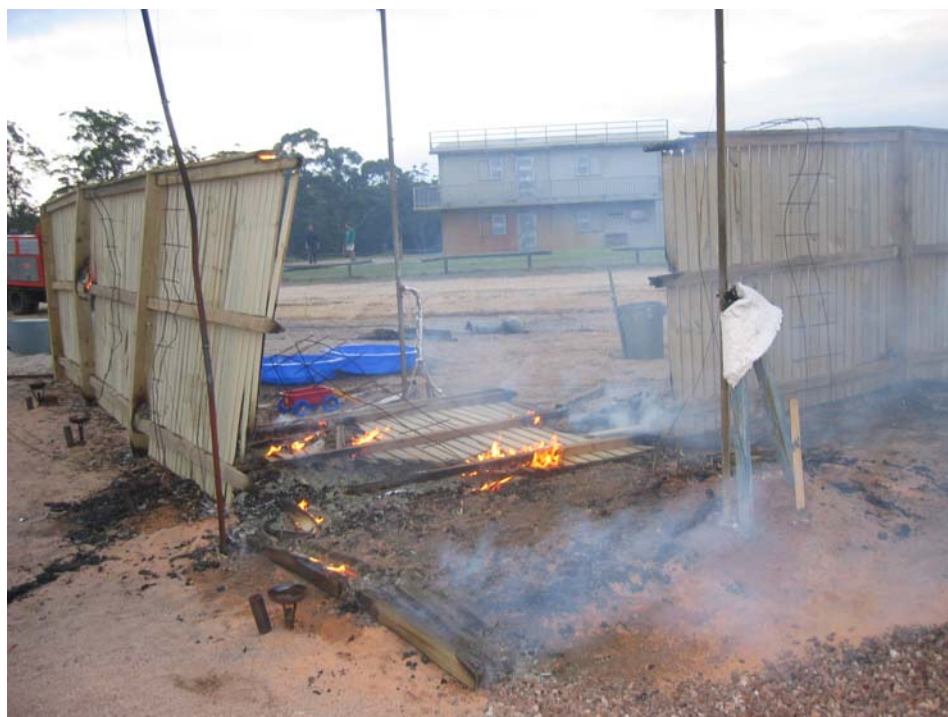
Flaming continued slowly at the edges of panels E and C with no significant further lateral flame spread. After a further hour there had been no significant further flame spread and the experiment was ceased.

Figure 27. Experiment 23 – leaf litter exposure of capped open paling treated pine fencing.
