# FIRE NOTE

ISSUE 70 NOVEMBER 2010

## RESIDENTIAL BOUNDARY FENCES IN BUSHFIRES: HOW DO THEY PERFORM?

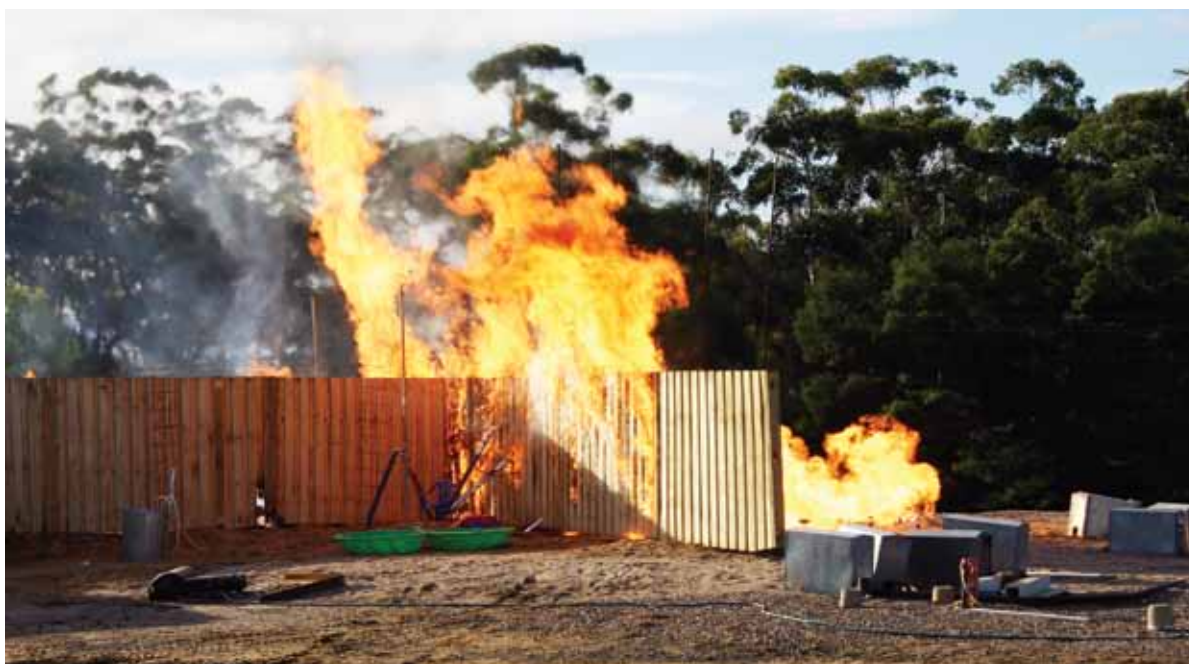
◀ Testing of different types of fencing was conducted at the NSW Rural Fire Service Experimental Testing Site at Mogo on the south coast of NSW in 2005.

The research project was conducted in the NSW Rural Fire Service Experimental Testing Site at Mogo on the south coast of NSW in 2005.

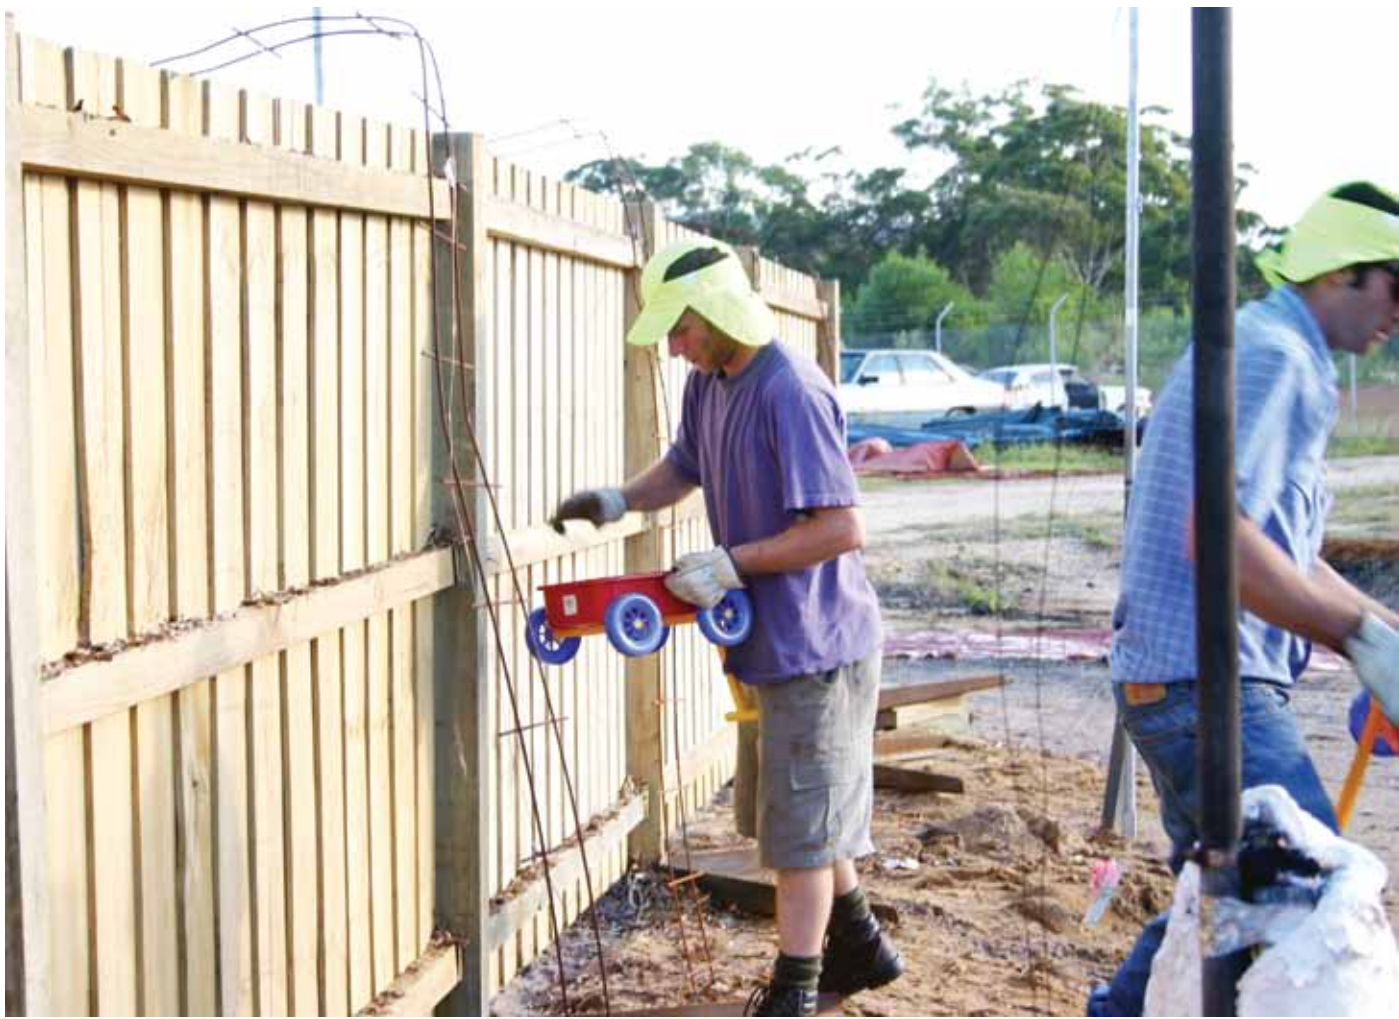
▲ Setting up timber fence for test burning.

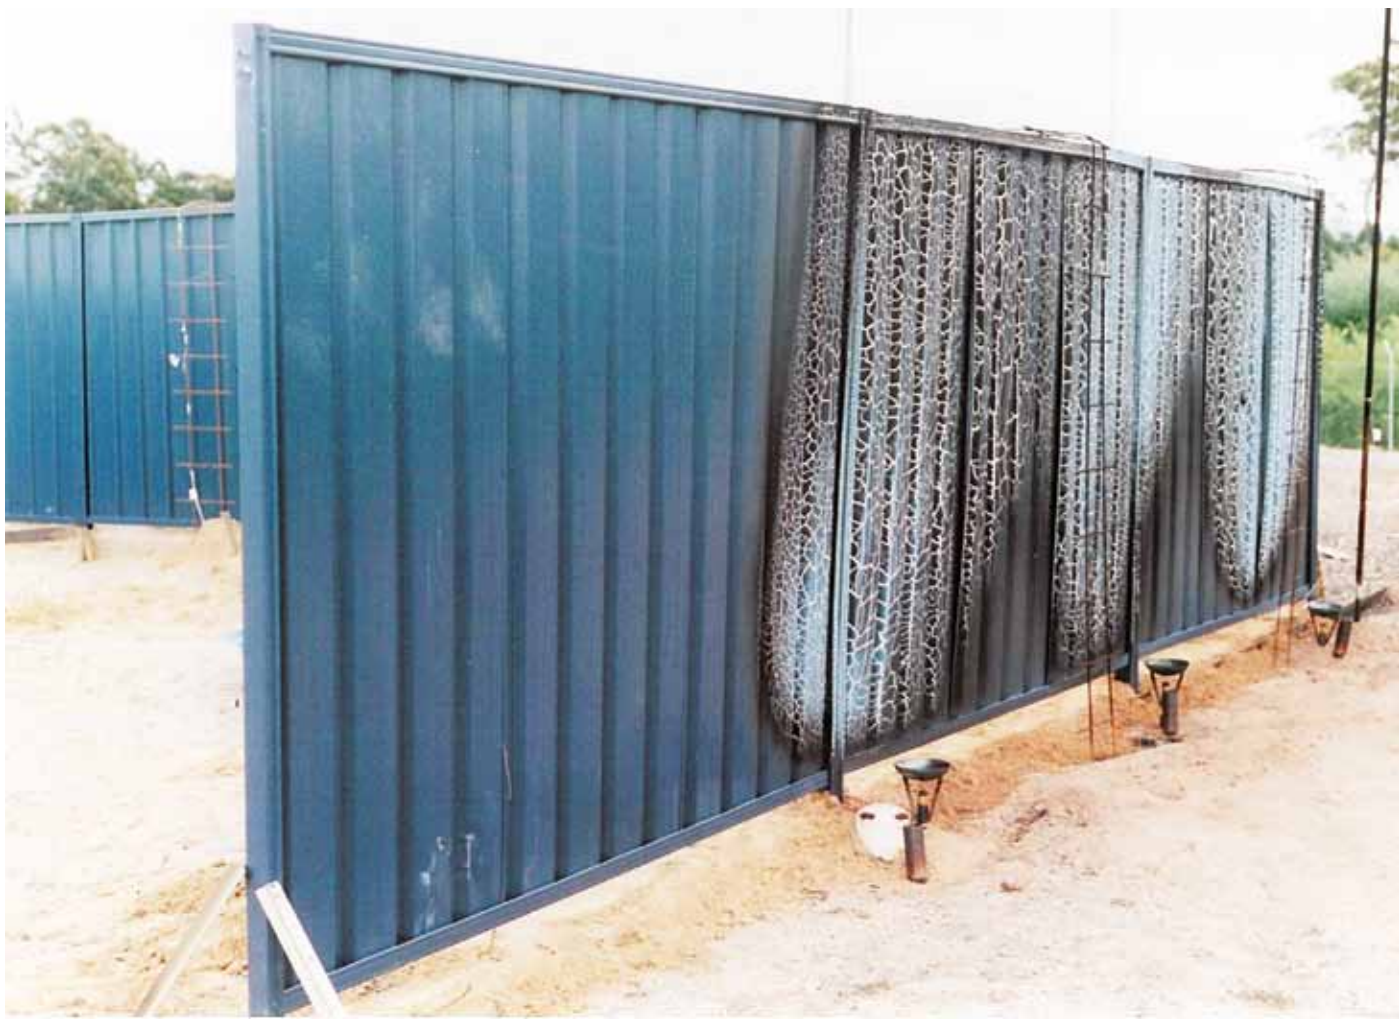
▲ A steel fence after testing at the Mogo site.

This had the best performance as it is a non-combustible material. It maintained structural integrity as a heat barrier under all experimental exposure conditions, and it did not spread flame laterally or contribute to fire intensity during exposure. The fencing reduced radiation levels within the fencing boundary to below 5 kW/m<sup>2</sup> immediately behind the fencing system during all radiation exposures, and reduced the radiant heat exposure on a structure nine metres from the fencing by at least a factor of two for the given fire size in the experiment.

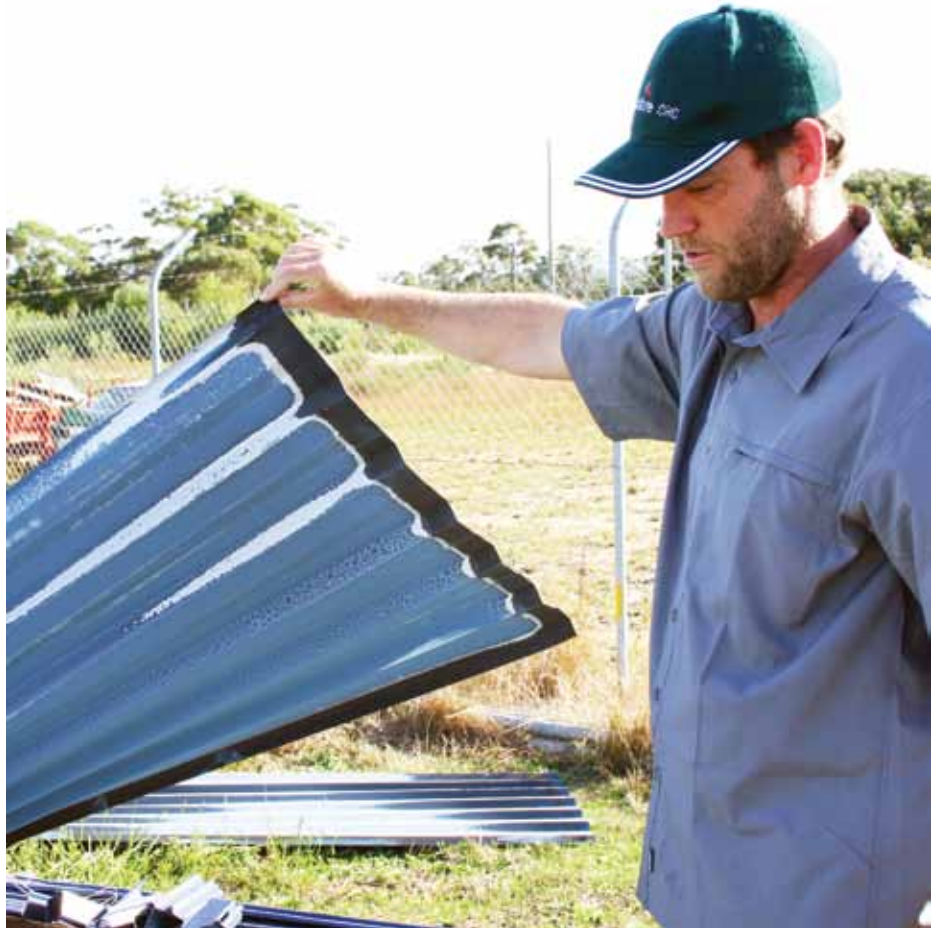
▲ Researcher Justin Leonard examines a fence after burning test at the NSW Rural Fire Service Hot Fire Training Facility.
