Tropical Cyclone Alfred: Insights and implications for future policy and practice

Dr Geoff Boughton, Dr David Henderson
Cyclone Testing Station, James Cook University

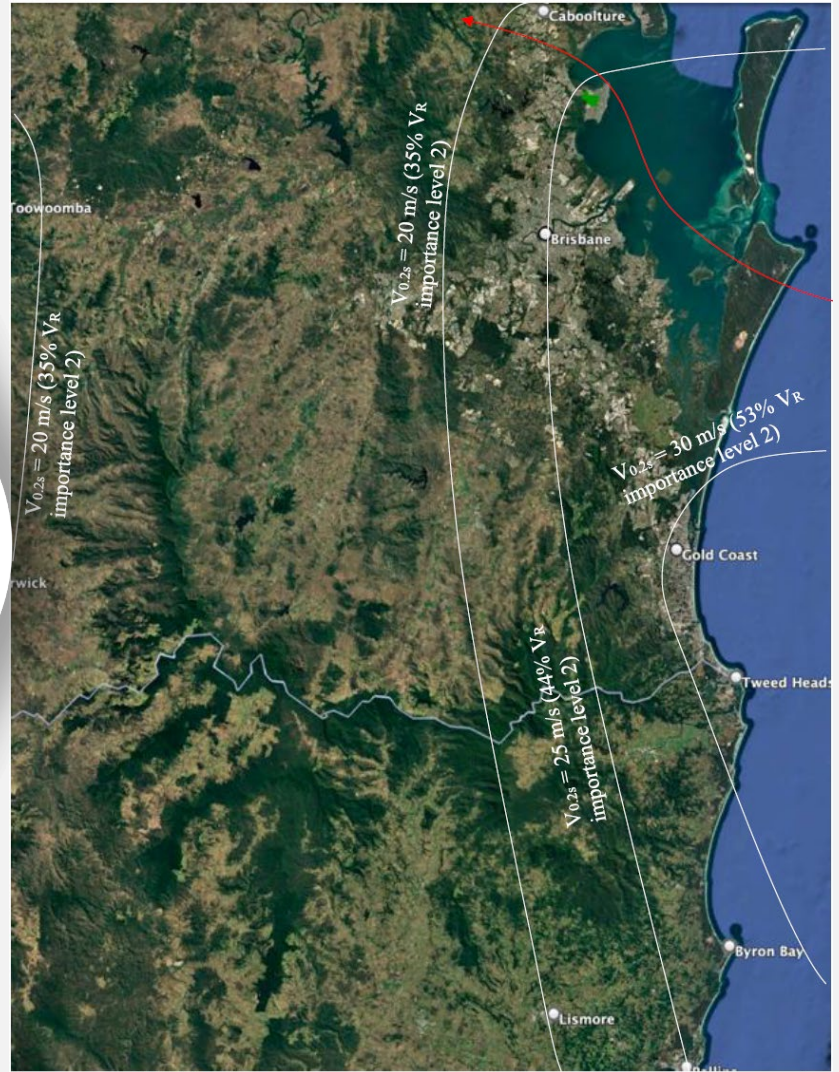
Figure 2-3 Wind field showing maximum 0.2 s gust wind speeds from reanalysis of anemometer data

Max gusts approx. 32 m/s (100 km/h)
Days of driving wind and rain

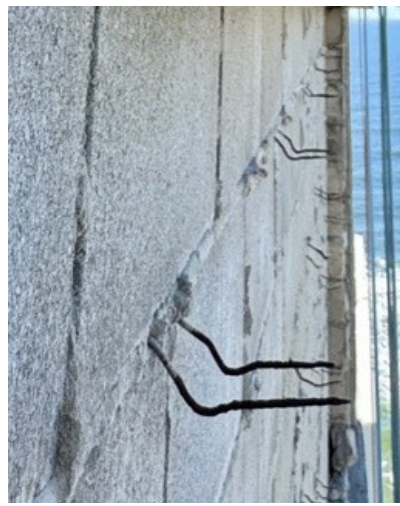
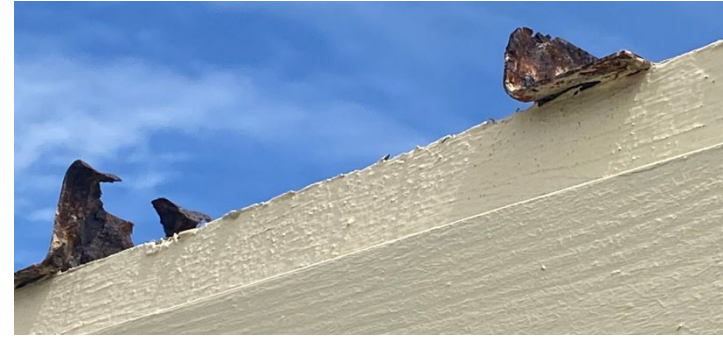
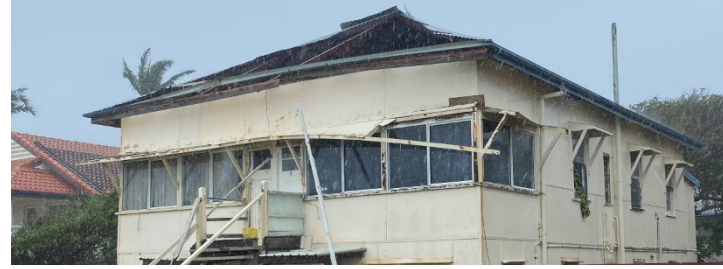
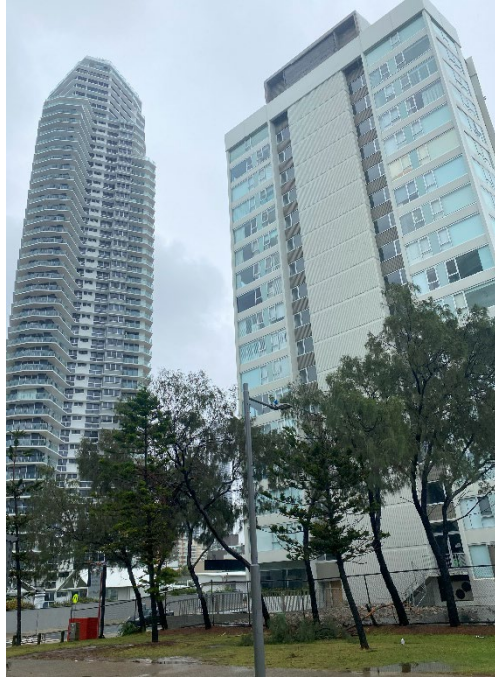
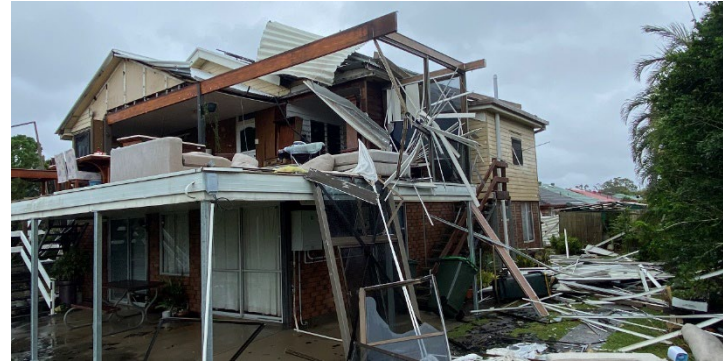
But found weak links

- Corrosion in steel
- Rot in timber
- Poor design
- Water ingress

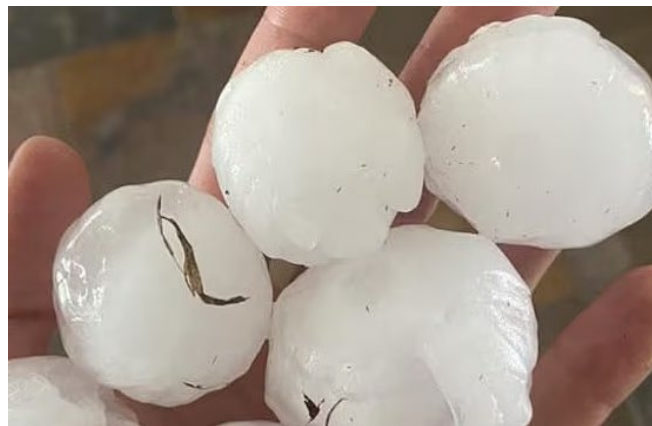
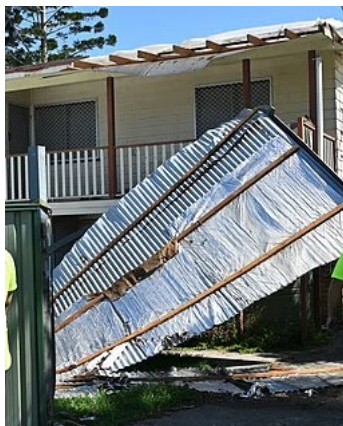
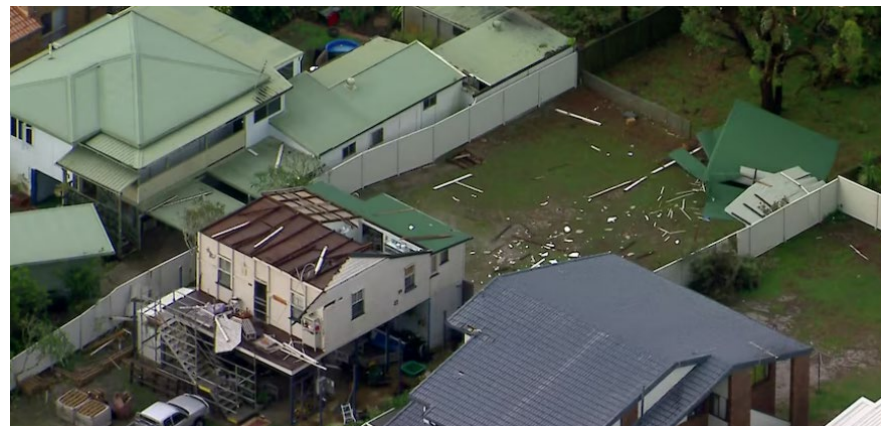
- Many events over 3 days
 - Giant hail
 - Trees down, power cuts
 - Roofs off, Loganlea and Bribie Island
