**Victorian 2009 Bushfire  
Research Response**

**Final Report**

### Building and land-use planning research after the 7<sup>th</sup> February 2009 Victorian bushfires Preliminary findings

Kilmore East – Murrindindi – Churchill – Bunyip –  
Maiden Gully

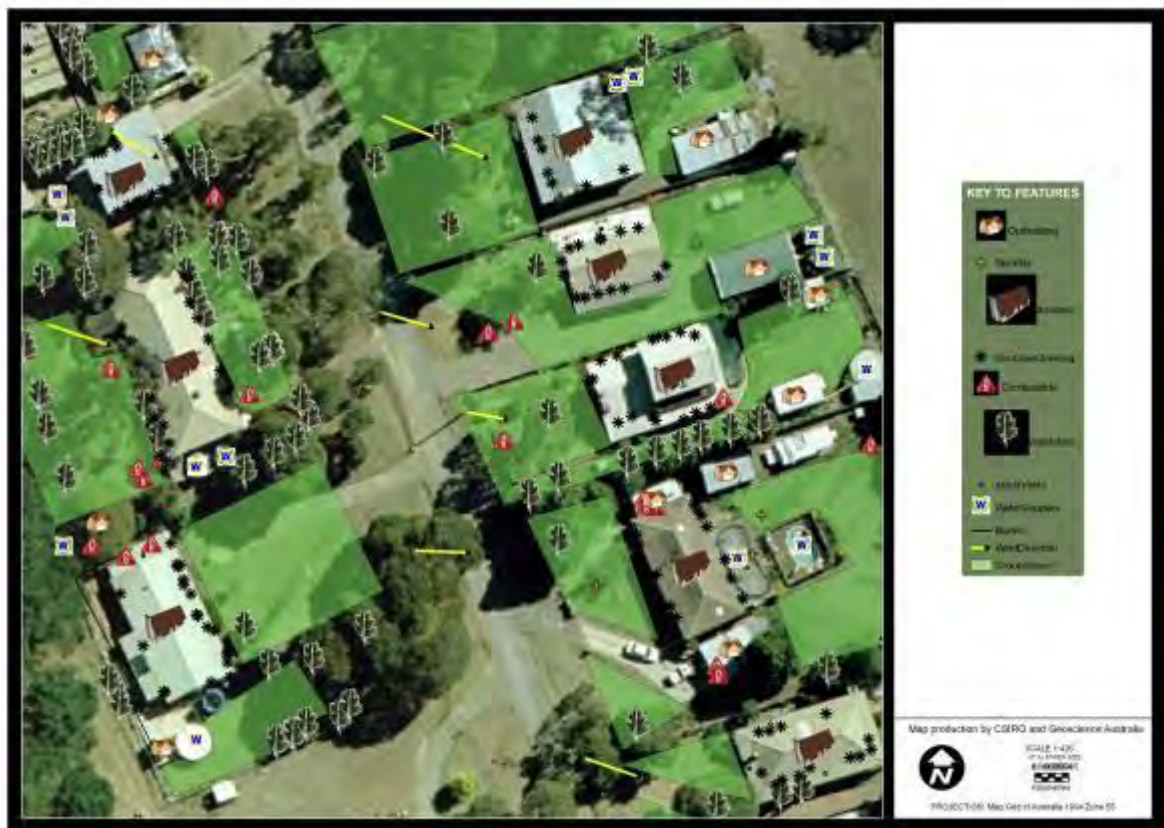
Figure 3 Example of land parcel with aerial picture and the virtual elements created during the field survey

below provides a summary of standard elements along with a description of how each element is displayed. The result is a comprehensive audit of the relevant element's spatial location, properties and condition. A comprehensive list of virtual elements and attributes is provided in Appendix B. Figure 3 below shows a land parcel with and without the virtual elements created during a field survey.

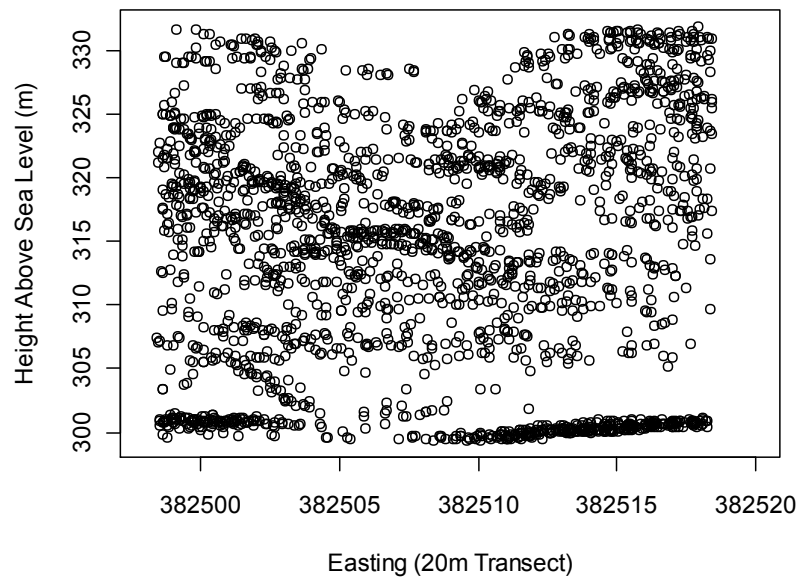
Figure 7 Distribution of LiDAR points in a sample transect. Lower points lie on or close to the ground; higher points are located within vegetation.

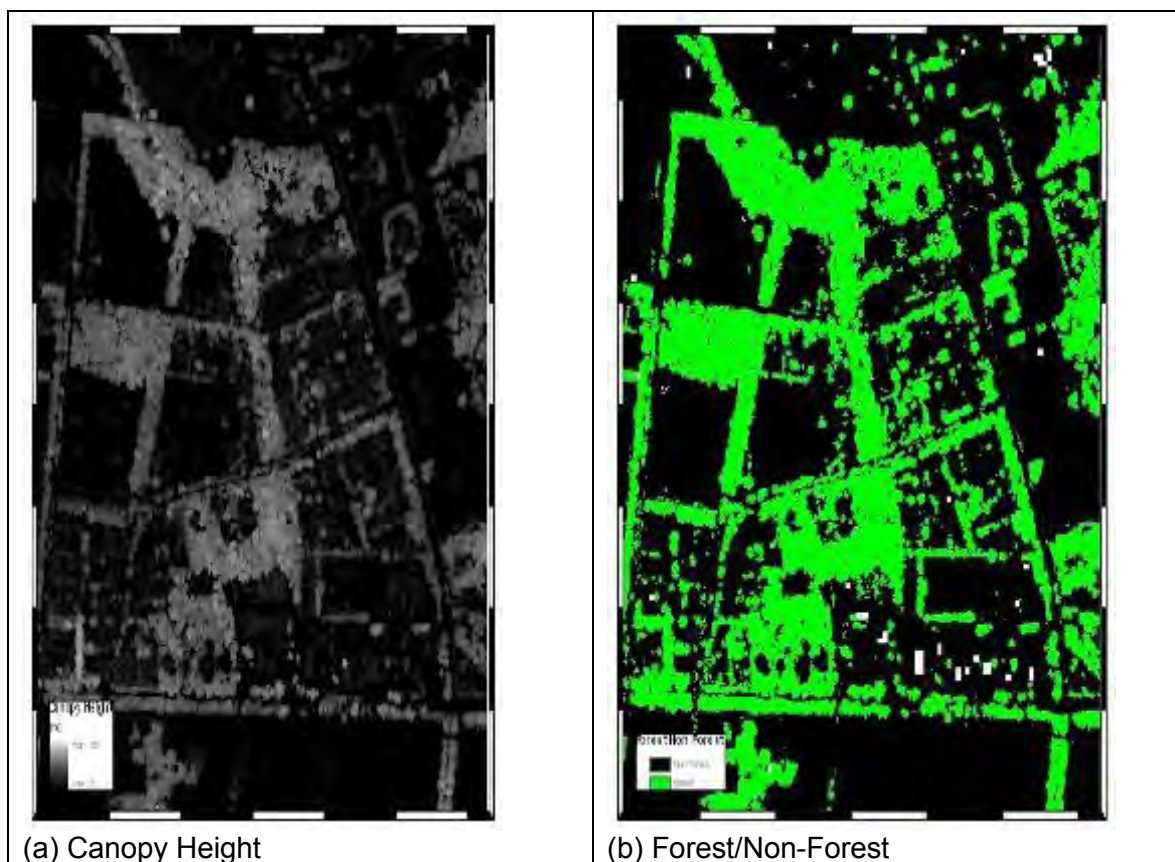
Figure 10 Canopy Height (a) is shown as a grey scale where the brightness of the image is related to the height of the highest return detected by the airborne LiDAR instrument. The derived Forest/non-forest layer (b) is simply a threshold of the canopy height layer, where image pixels with heights detected above 8 m are assigned as forest and shown in green. The remaining non-forest areas are shown in black.

The Forest/non-forest layers were produced at 2-m resolution for all three study areas. Each output cell was considered to contain forest if there were vegetation-classified points more than 8 m above the ground within the cell. This conforms to the Specht (1970) classification of non-shrub and grass strata. Figure 10 shows sample images for West Murrindindi showing (a) the canopy height surface, and (b) the resulting forest/non-forest layer. See the caption of this image for a description of the derivation of the forest/non-forest layer.

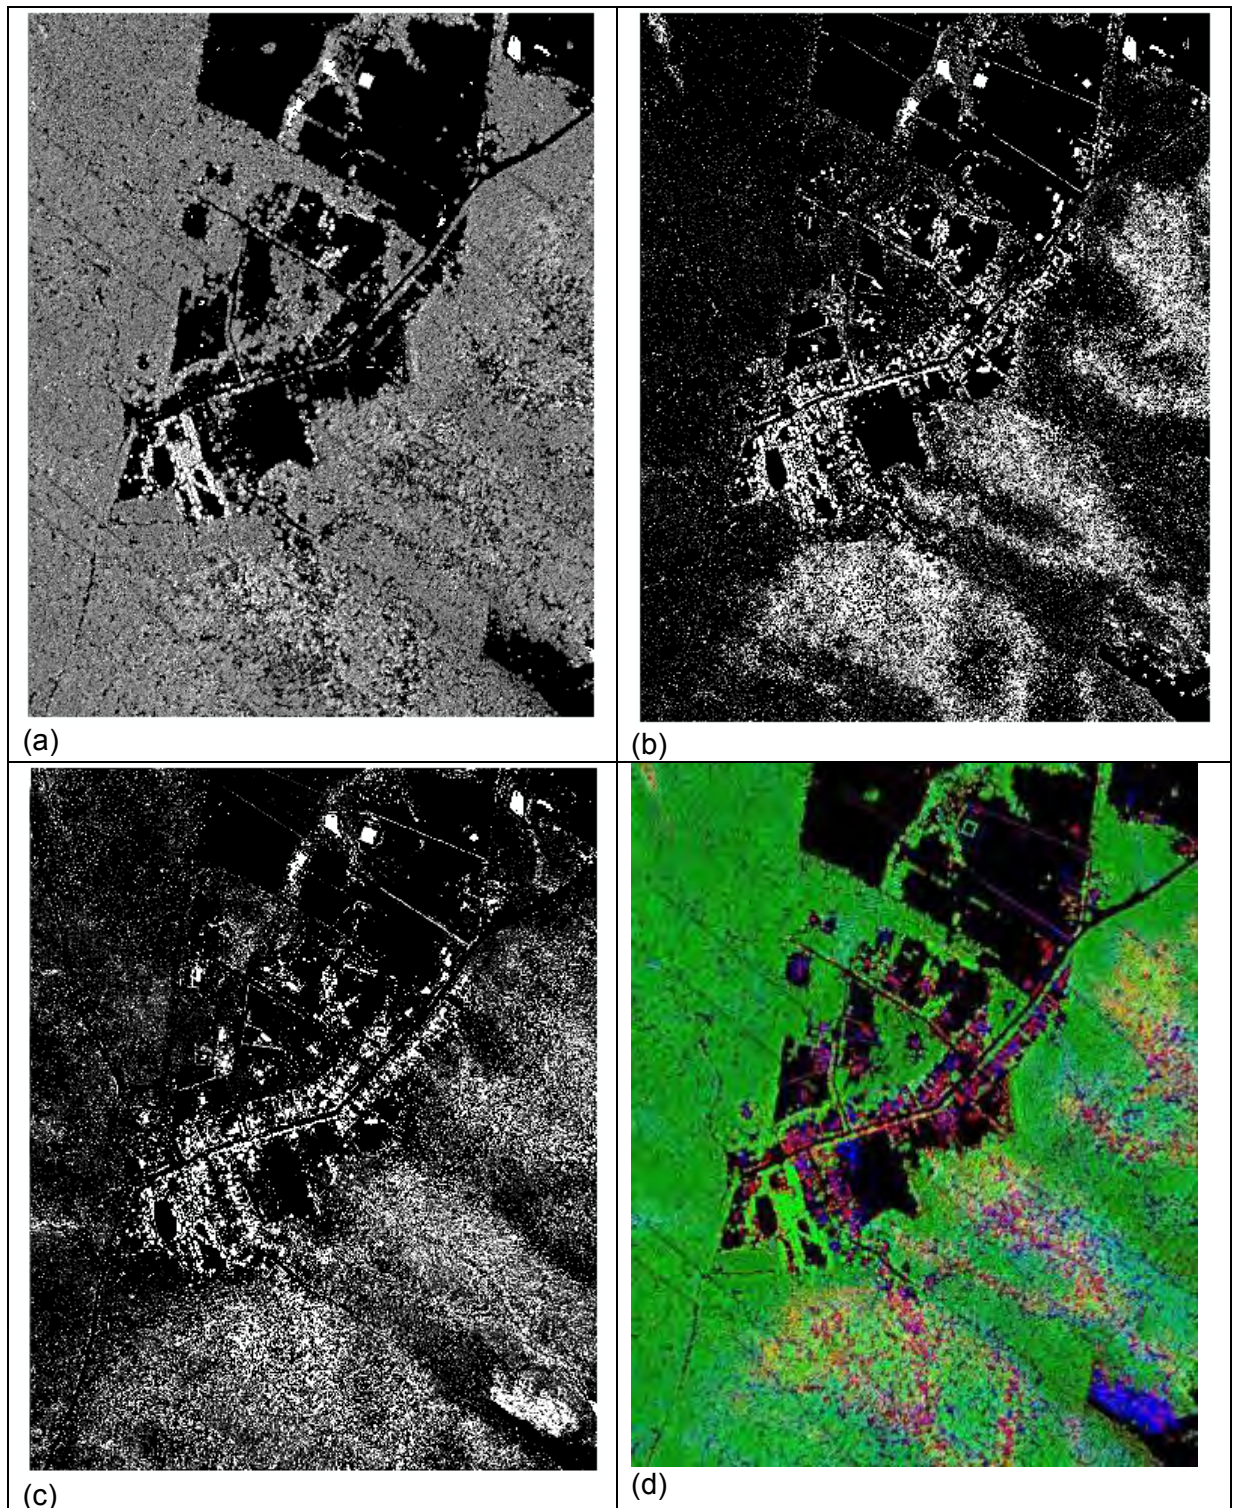
Figure 11 Percentage of cover by strata for Kinglake study region with (a) over-storey cover 8 m and above; (b) mid-storey cover (3–8 m); (c) understorey cover (50 cm–3 m); and (d) a false-colour image where the colours are mapped as follows: red (mid-storey), green (canopy) and blue (understorey).

The resulting cover by strata surfaces using these techniques for the Kinglake region (Pine Ridge Road study case) are shown in Figure 11.

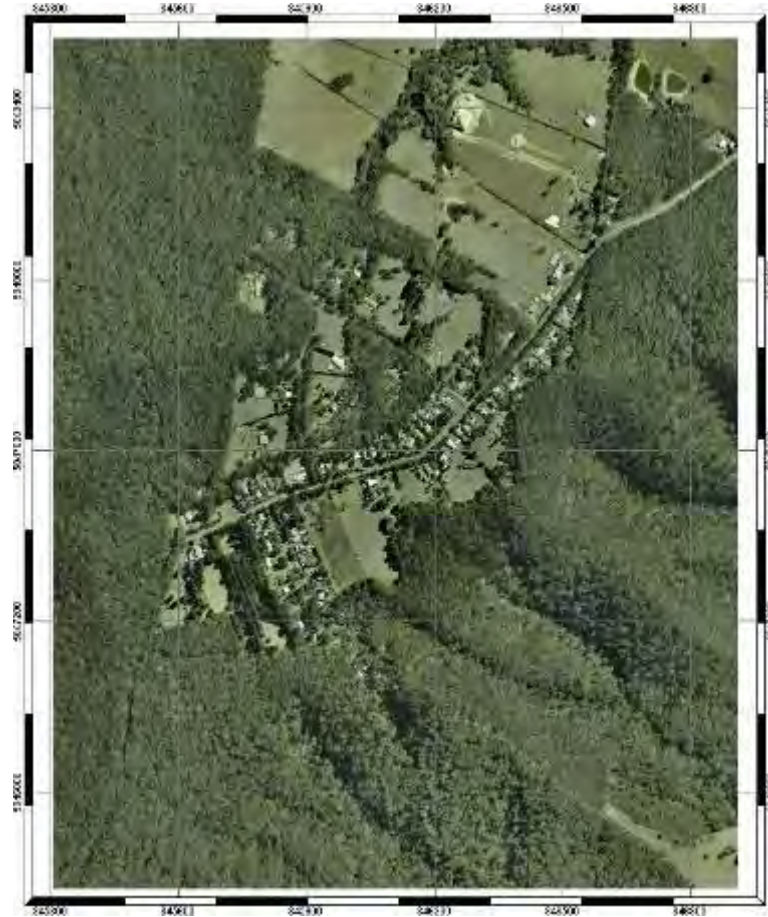
Figure 12 Pine Ridge Road subset of the pre-fire imagery provided by the DSE

High-resolution visible multispectral (blue, green, red) airborne imagery for the Shire of Murrindindi was made available through DSE. The data were acquired during 2006 and 2007 by United Photo & Graphics. The imagery includes three visible bands at a spatial resolution of 15 cm, and has been fully ortho-rectified and tiled into 1-km tiles. A subset of these data for the Pine Ridge Road study site is shown in Figure 12.

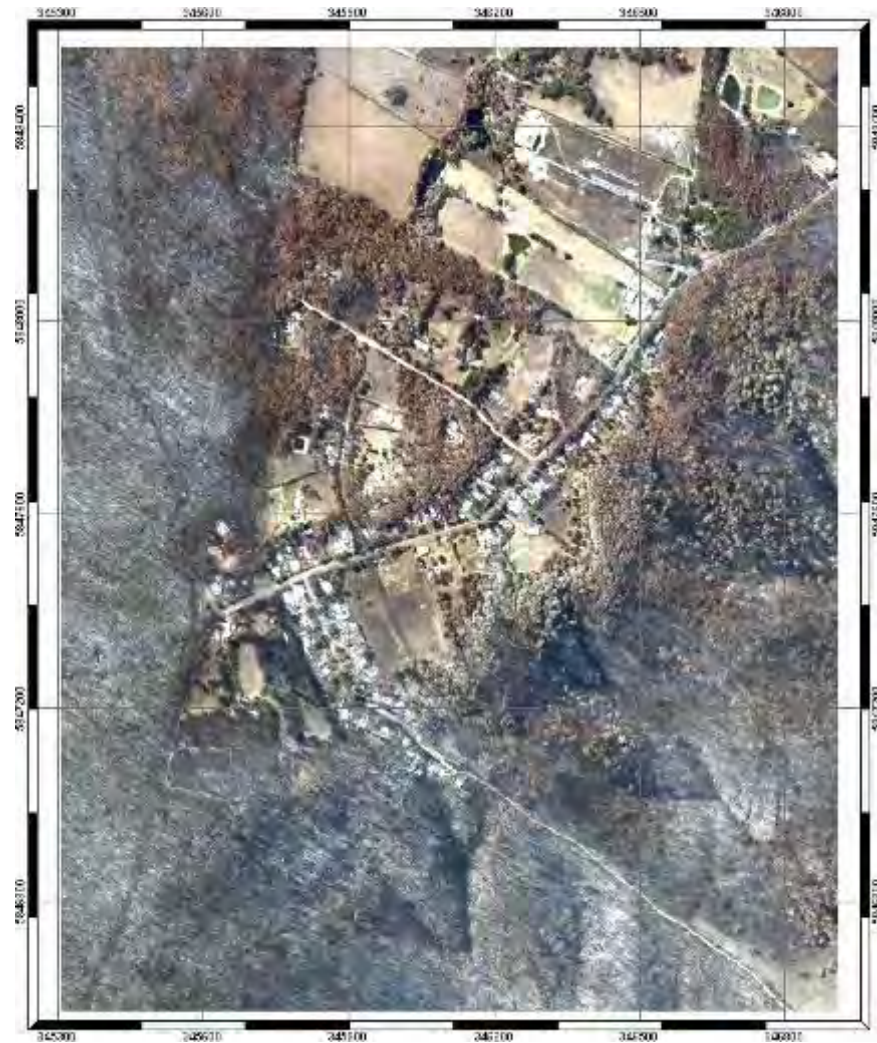
Figure 14 Pine Ridge Road subset of the post-fire imagery commissioned by the Victorian Police and provided by the DSE

The Pine Ridge Road subset of the post-fire imagery was also used to derive an indication of burn severity within the region (see Figure 14). Areas of forest, as defined by the LiDAR forest layer, were classified into broad severity classes:

- burnt – complete absence of foliage or undergrowth;
- scorched – scorched crowns, scorched foliage still connected;
- unburnt – green crown.

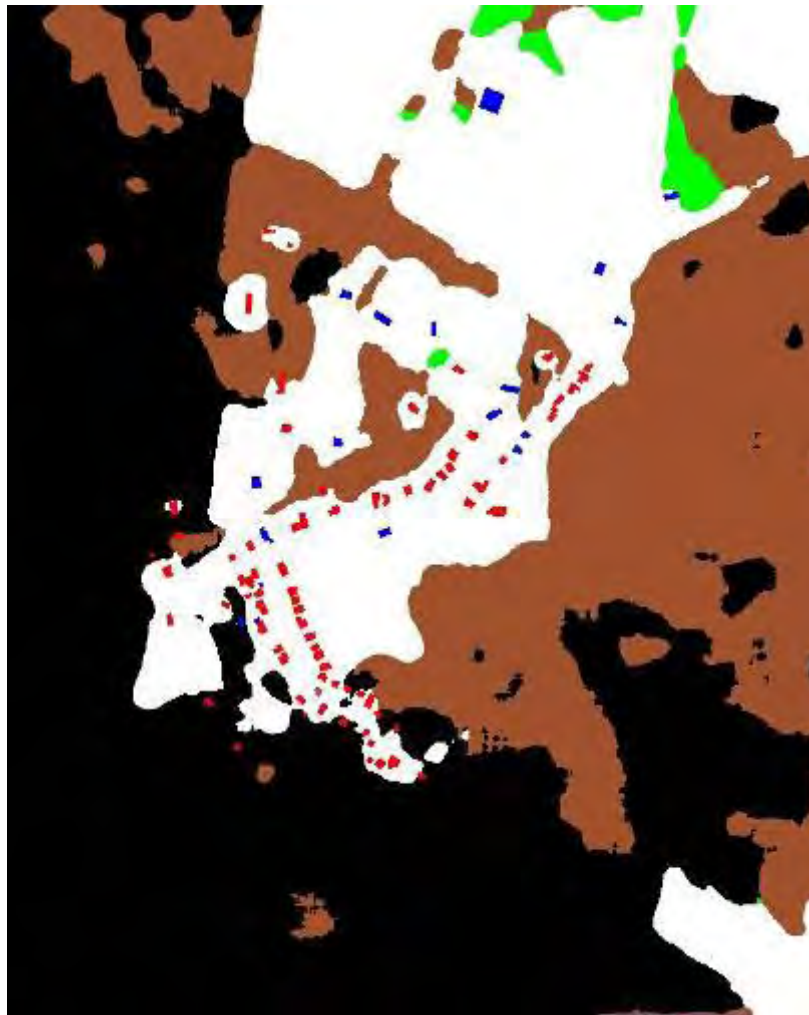
Figure 15 Burn severity classification of the Pine Ridge Road subset. Burn is shown in black, scorched in brown and unburnt in green. Burnt residential structures are shown in red and unburnt residential structures in blue (as described in Section 5.2.4). Areas in white are non-forest.

Classification was performed using a minimum-distance supervised classification of the imagery, using areas of the Pine Ridge Road subset image as training data. Significant confusion was apparent between unburnt and burnt classes, and a large number of unburnt polygons in the classified image were manually reassigned to the burnt class. Future work will logically utilise airborne near-infrared data that has recently become available and is expected to greatly reduce misclassification errors. The final burn severity classification is shown in Figure 15.

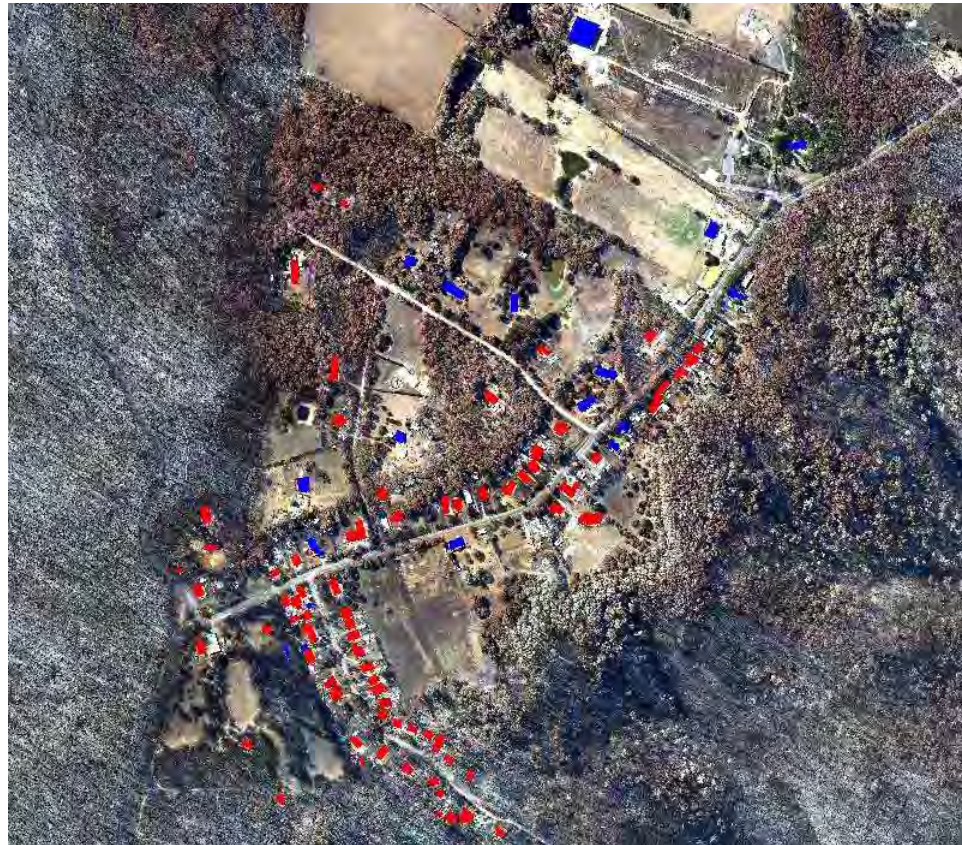
Figure 16 Distribution of burnt and unburnt structures in the Pine Ridge Road case study site area (red: burnt structures, and blue: unburnt structures)

Each structure was attributed with a structure type (residential, outbuilding or water tank) and a damage class (burnt, not burnt). This was done through subjective assessment of the pre-fire and post-fire imagery (see Figure 16). A single building was generally selected per property as the likely residential building. Factors influencing the decision included the size, location and roof type (gable, etc.). Other buildings within the property were assigned as outbuildings and circular shapes were attributed as water tanks. Burnt buildings were generally obvious through analysis of their change in appearance between the pre- and post-fire imagery.

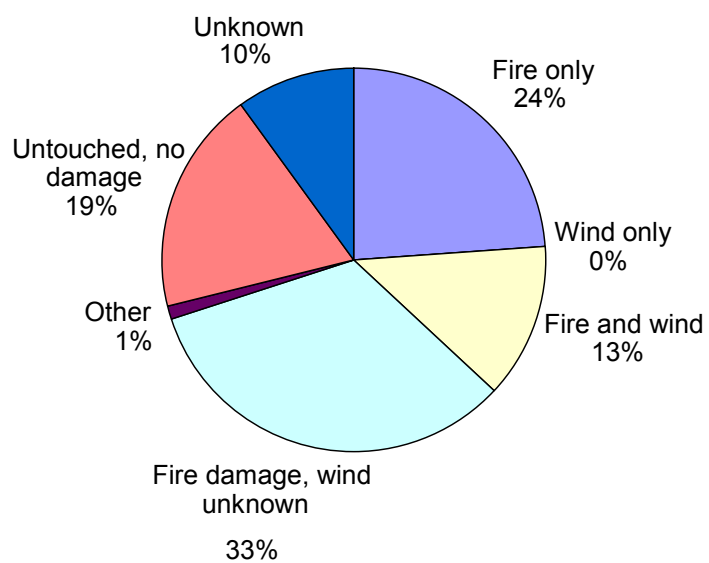
Figure 19 Likely cause of damage across all fire areas

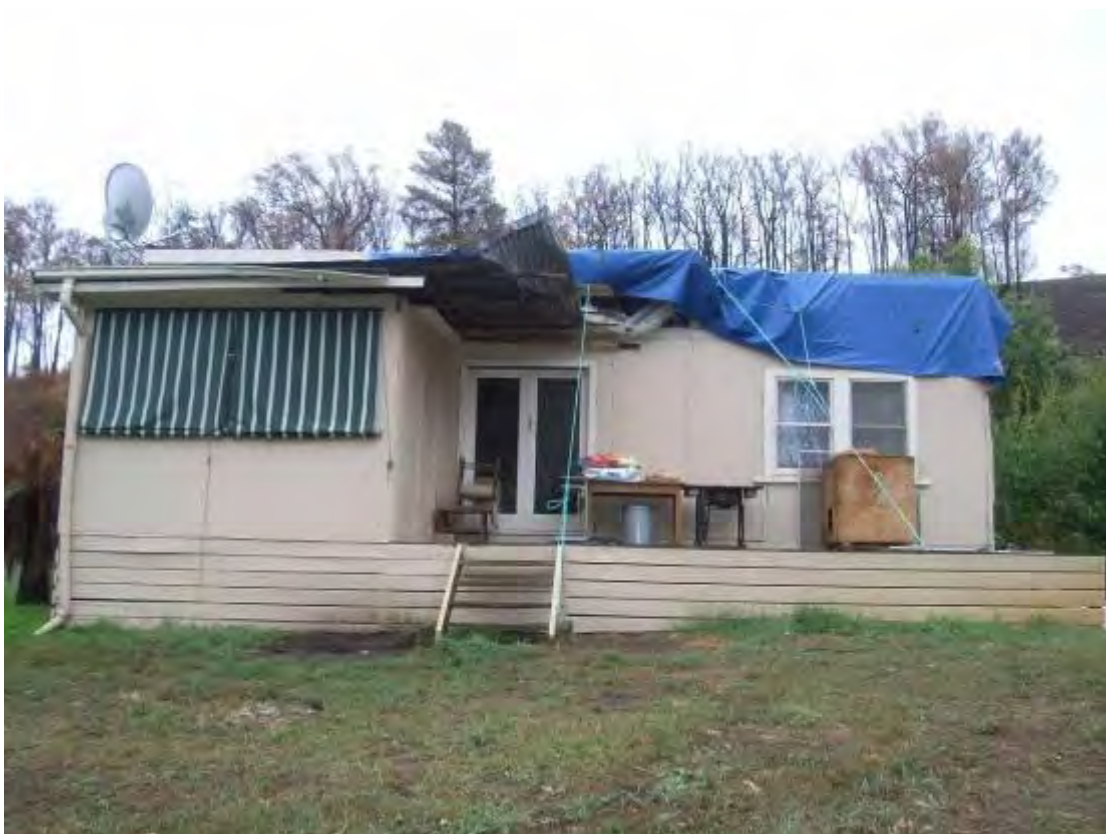
Figure 20 Example of house affected by wind only (Humevale, Kinglake West)

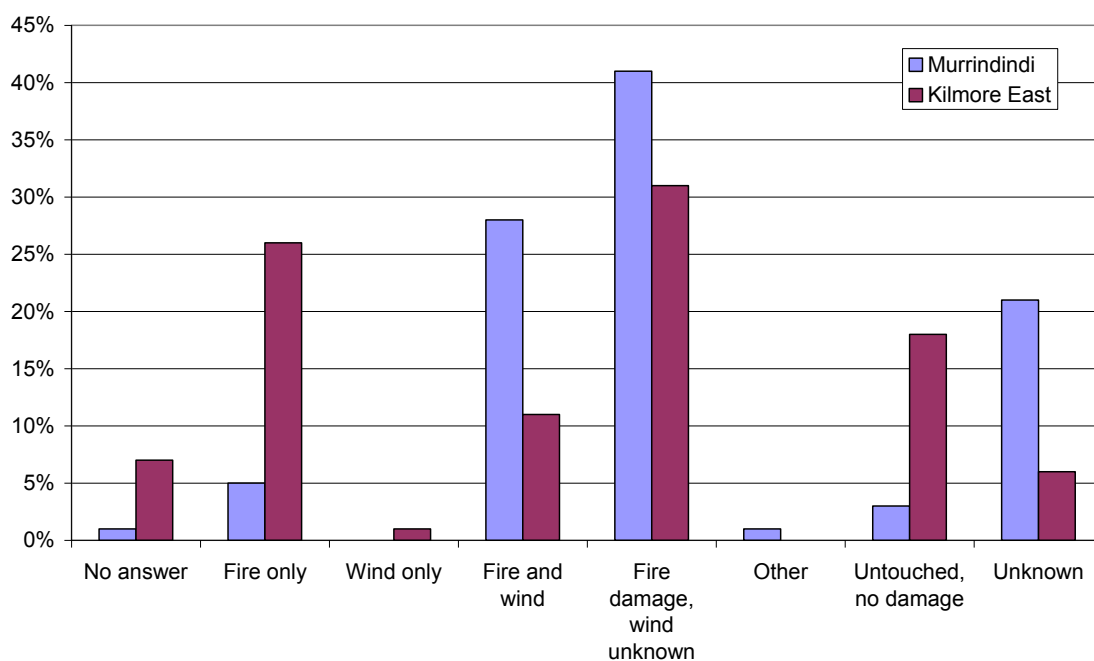
Figure 21 Likely cause of damage in Murrindindi and Kilmore East fire (percentage of houses surveyed)

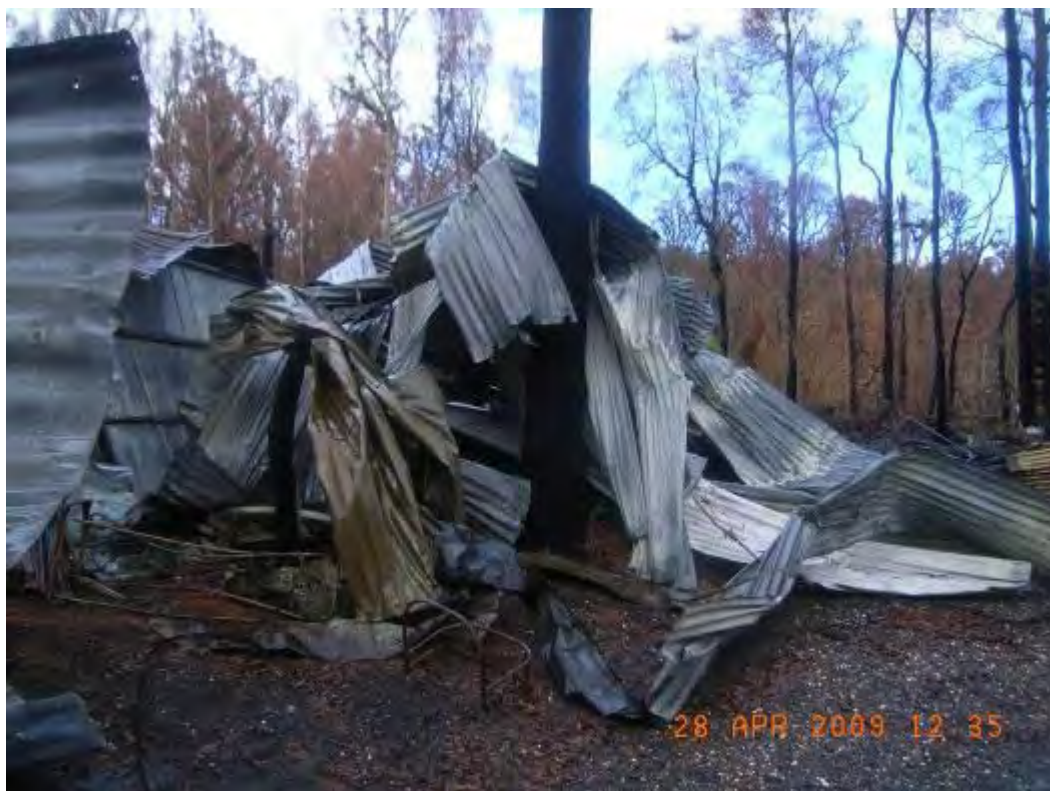
Figure 22 Example of observed wind influence in Marysville

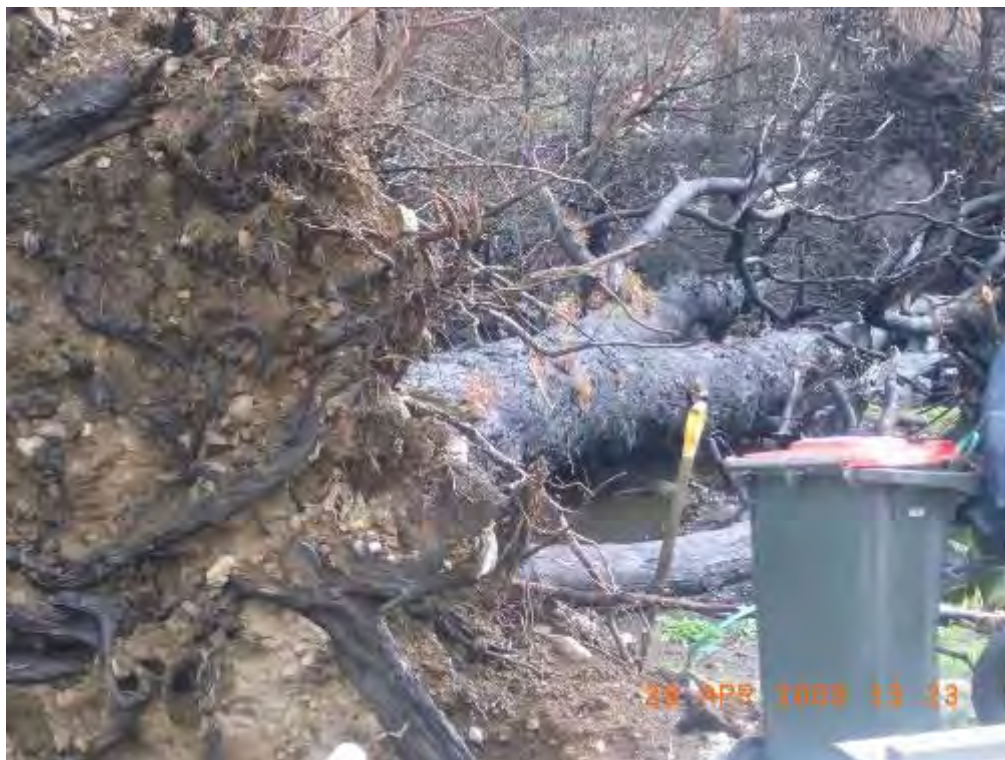
Figure 23 Example of wind impact in Marysville (tree blown down during the fire – comment from resident account)

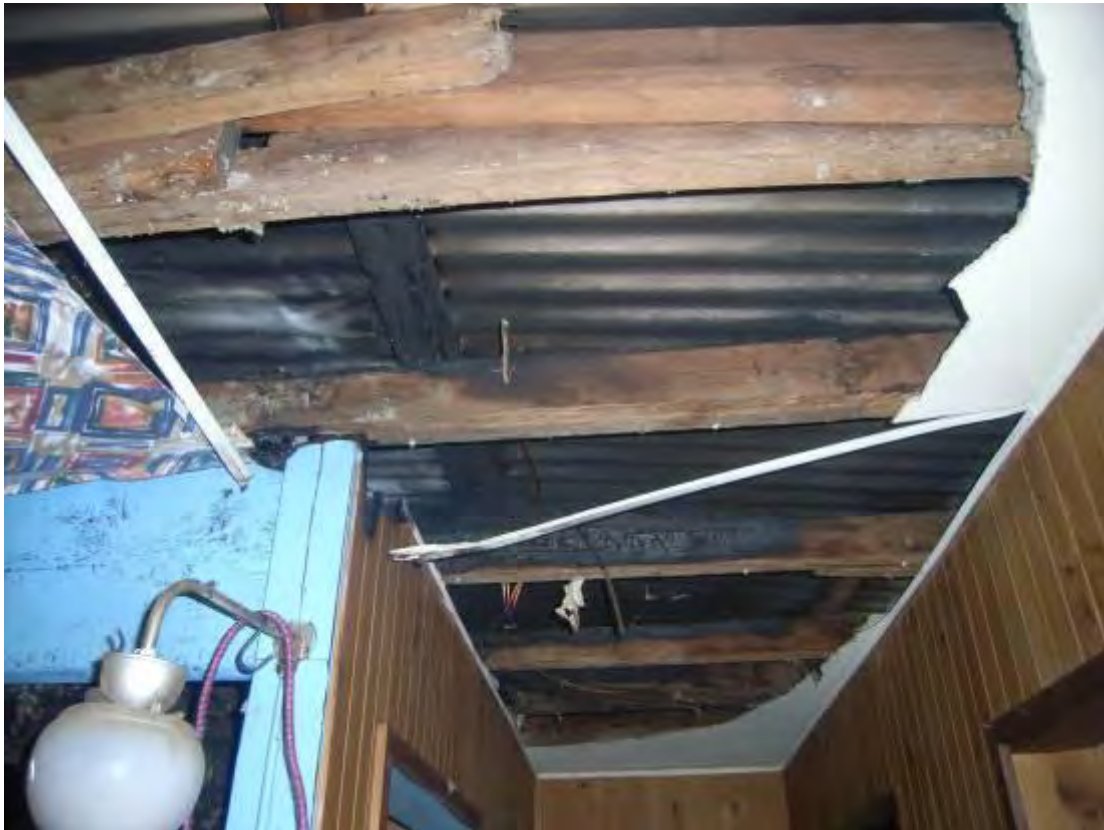
Figure 24 Example of ignition into roof noticed by the occupant several hours after fire front had passed

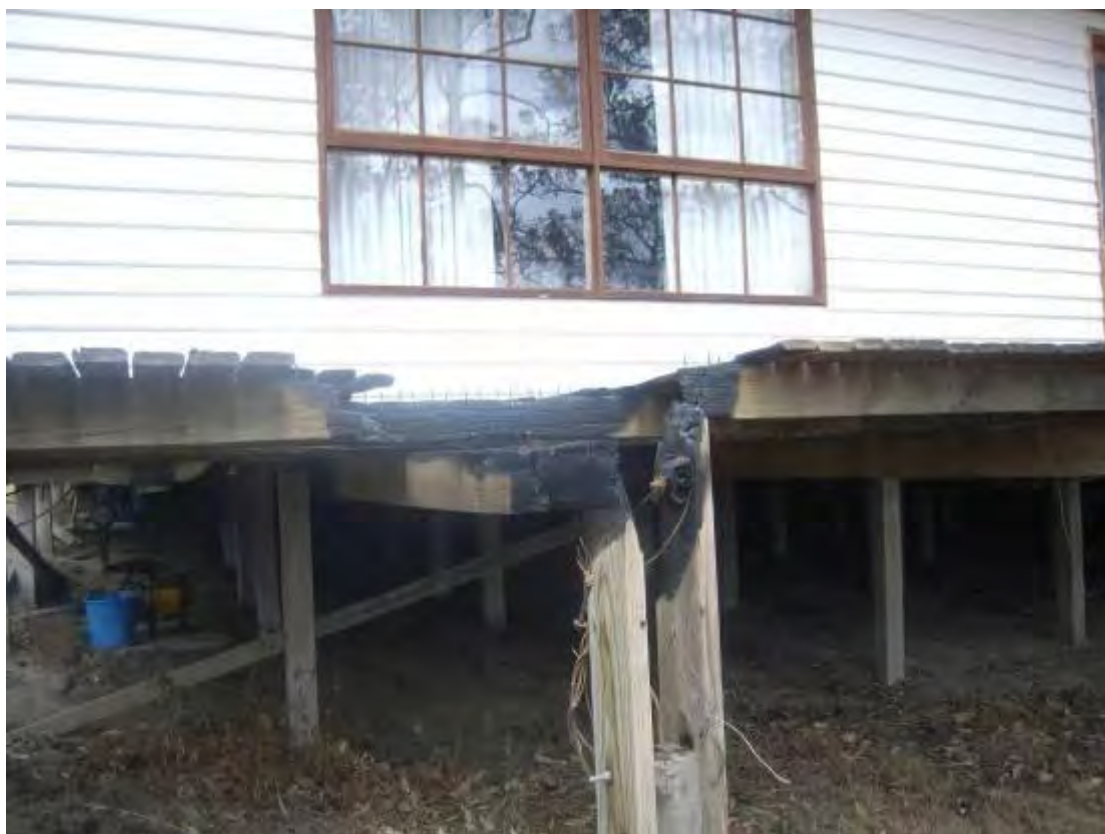
Figure 25 Example of deck ignition, spread and suppression

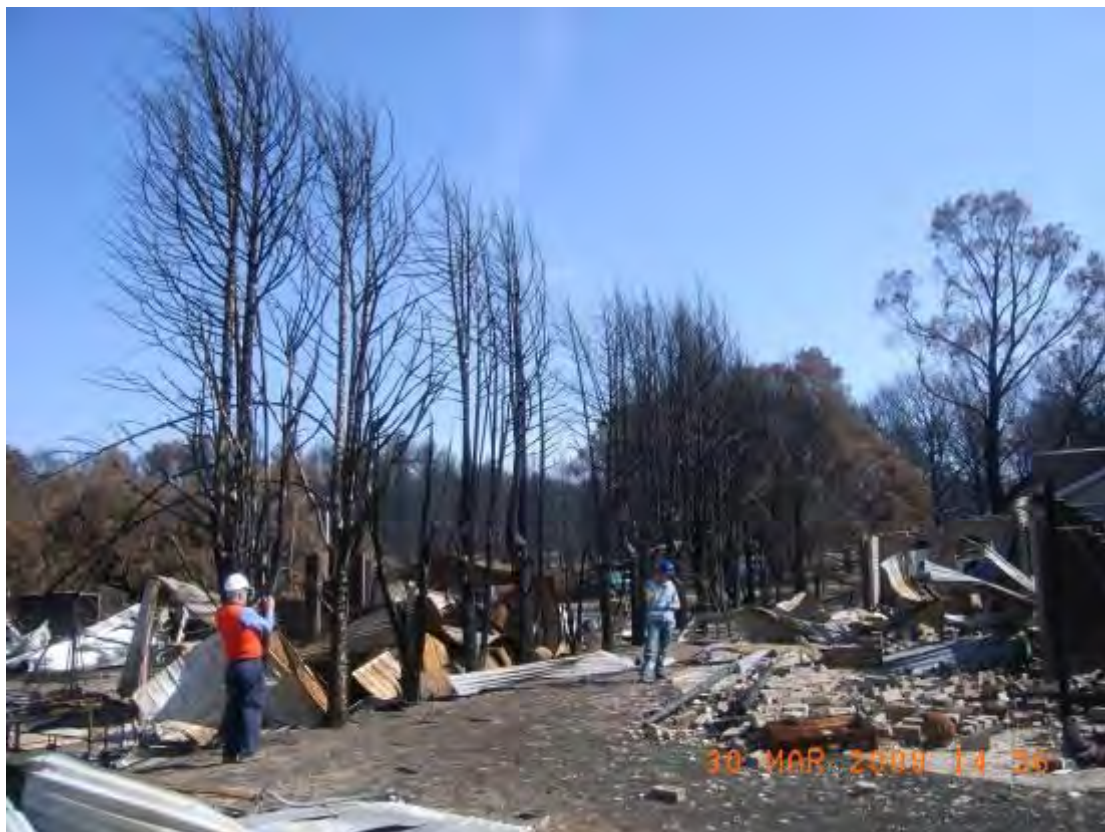
Figure 26 Example of vegetation heavily burnt close to structure (Pine Ridge Road, Kinglake)

Certain types of vegetation are particularly susceptible to fire. For example, cypress trees produce large quantities of fine dead material, which becomes very dry at times of high fire danger, and the intensity at which they burn may adversely impact structures in the vicinity. This was noted in the Canberra 2003 and Eyre Peninsula 2005 fires (Leonard & Bianchi 2005, 2006). Figure 26 shows an example of this from the Victorian fires.

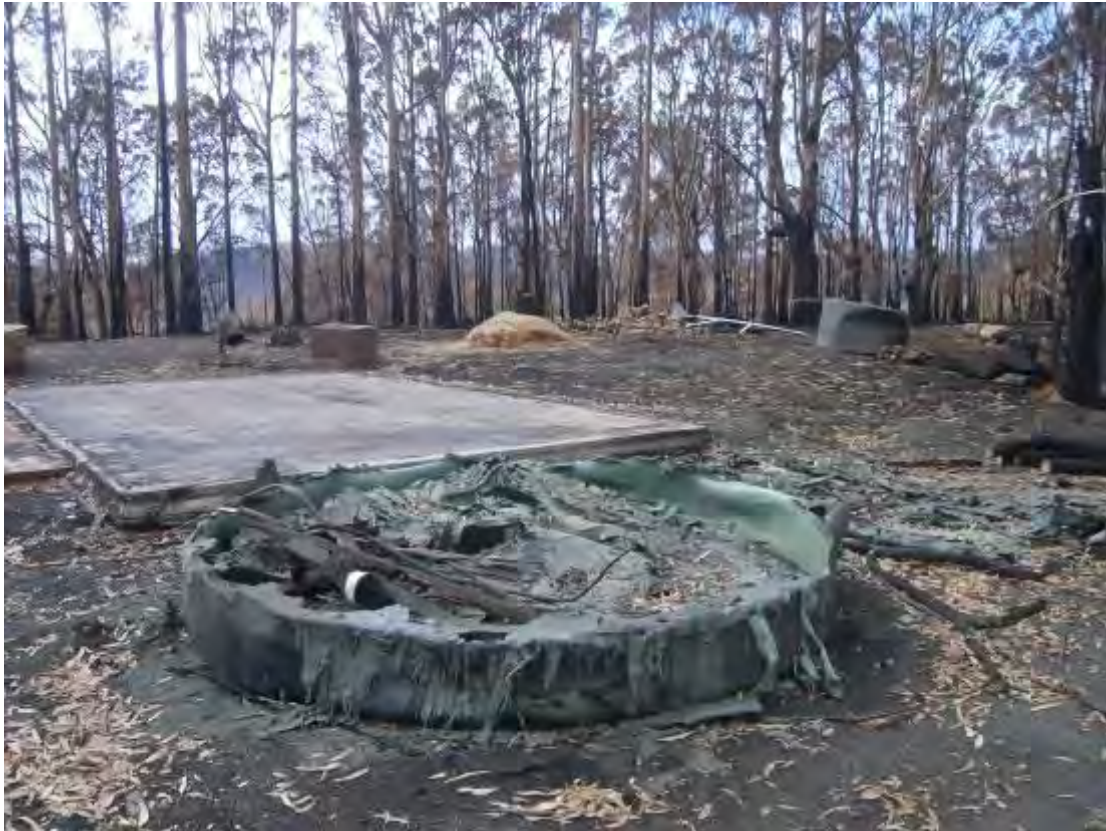
Figure 27 Example of polyethylene tank damage

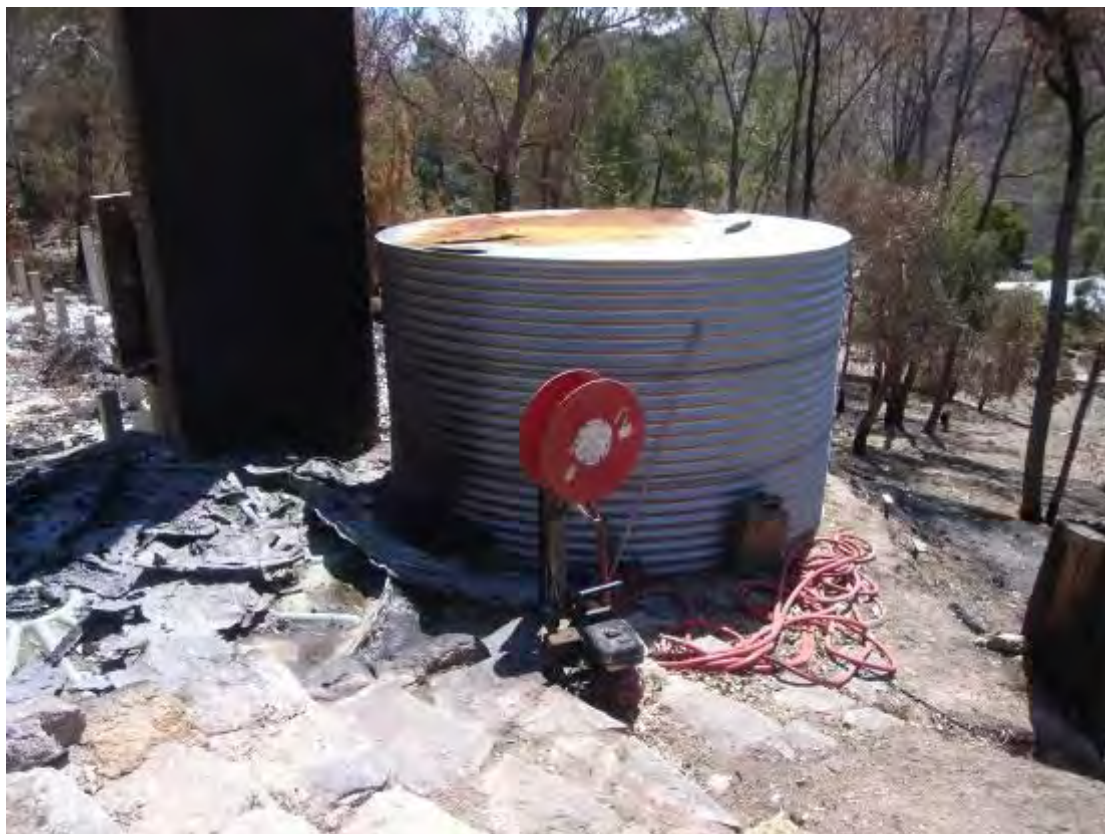
Figure 28 Example of damaged pump

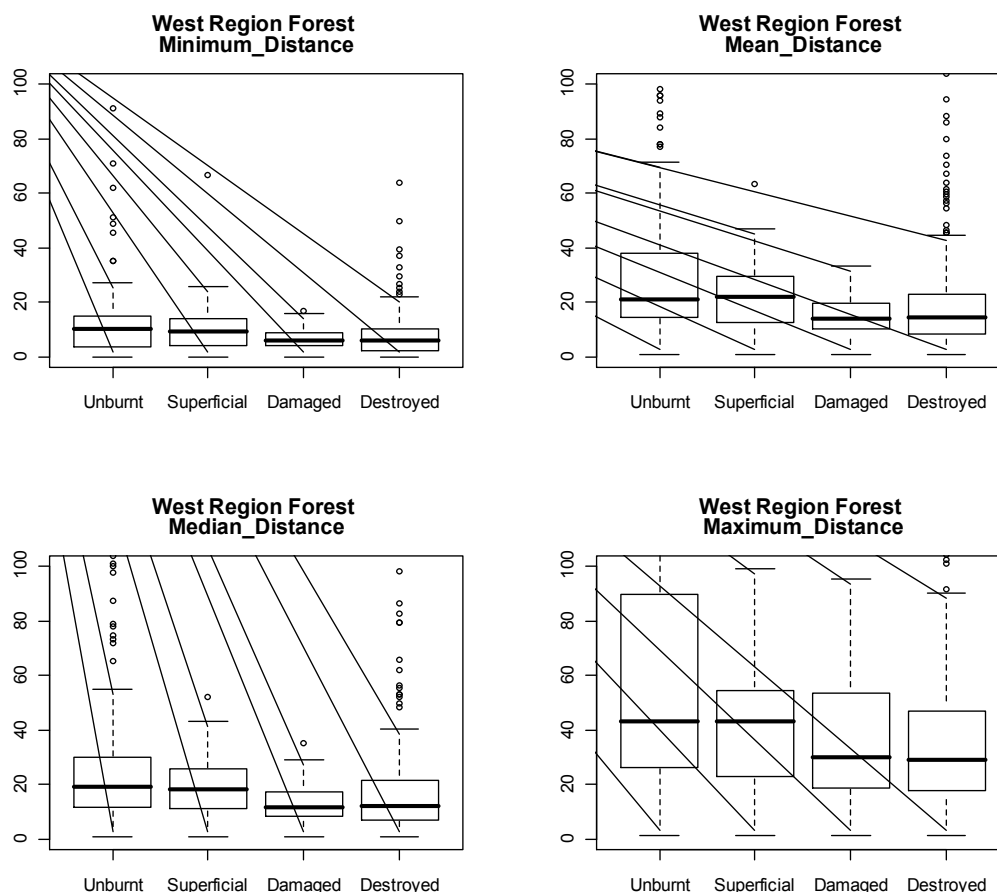
Figure 29 Distribution of minimum, mean, median and maximum distance (metres) to forest for residential structures in the West region (Murrindindi West) for the four residential structure damage classes

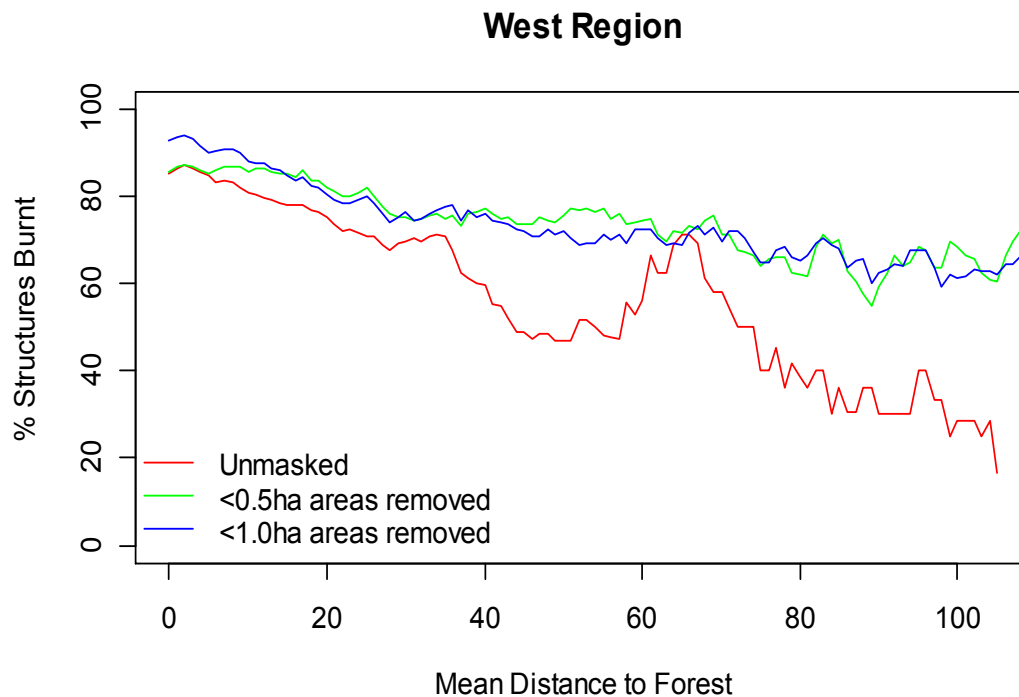
Figure 30 Percentage of residential structures burnt (damaged and destroyed) as a function of the distance to forest from house centroids in the Kilmore East area (Murrindindi West region). Red curve: unmasked data represent the original data extracted (forest with trees > 8m); the green curve is the forest layer with small areas of 0.5 ha subtracted; the blue curve is the forest layer with small areas of 1 ha subtracted.

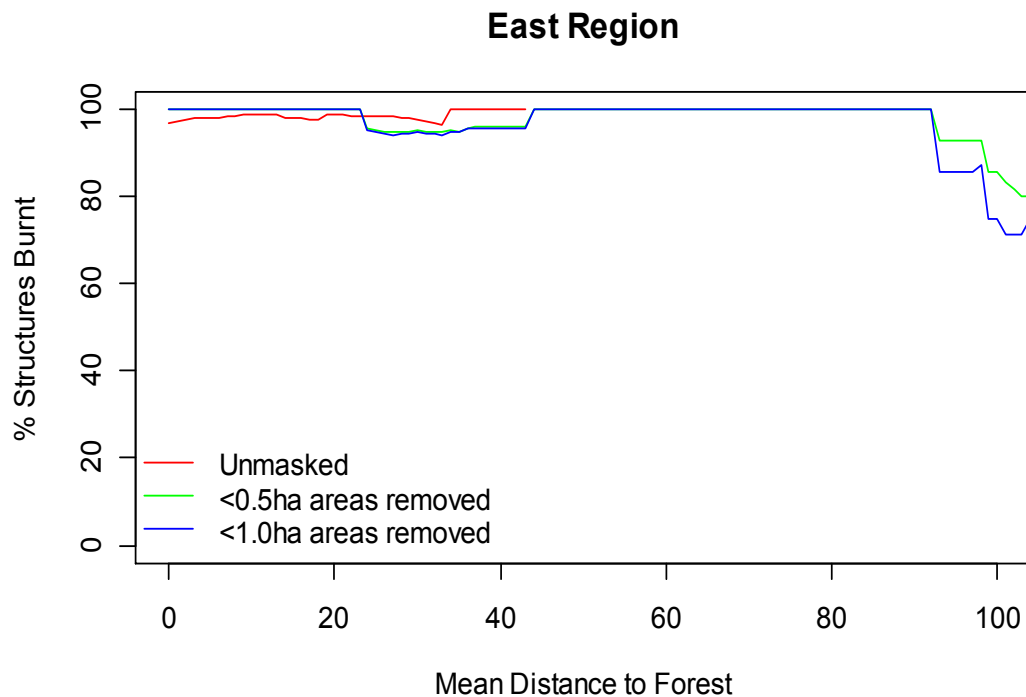
Figure 31 Percentage of residential structures lost (damaged and destroyed) as a function of the distance to forest from house centroids in the Murrindindi area (East region). Red curve: unmasked data represent the original data extracted (forest with trees > 8m); the green curve is the forest layer with small areas of 0.5 ha subtracted; the blue curve is the forest layer with small areas of 1 ha subtracted.

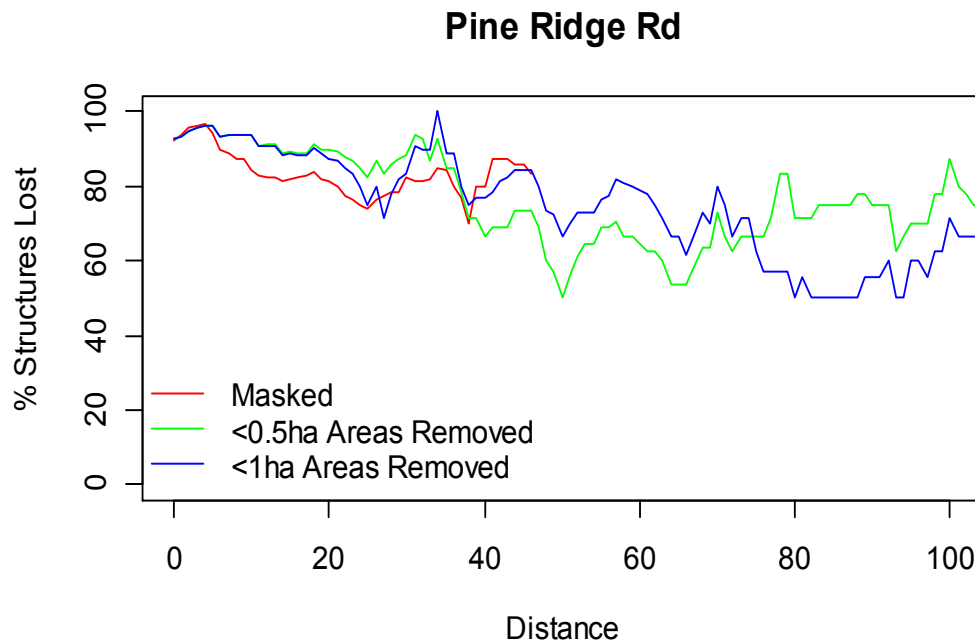
Figure 32 Percentage of residential structures lost (damaged and destroyed) as a function of the mean distance to forest from house centroids in the Pine Ridge Road area. Red curve: unmasked data represent the original data extracted (forest with trees > 8m); the green curve is the forest layer with small areas of 0.5 ha subtracted; the blue curve is the forest layer with small areas of 1 ha subtracted.

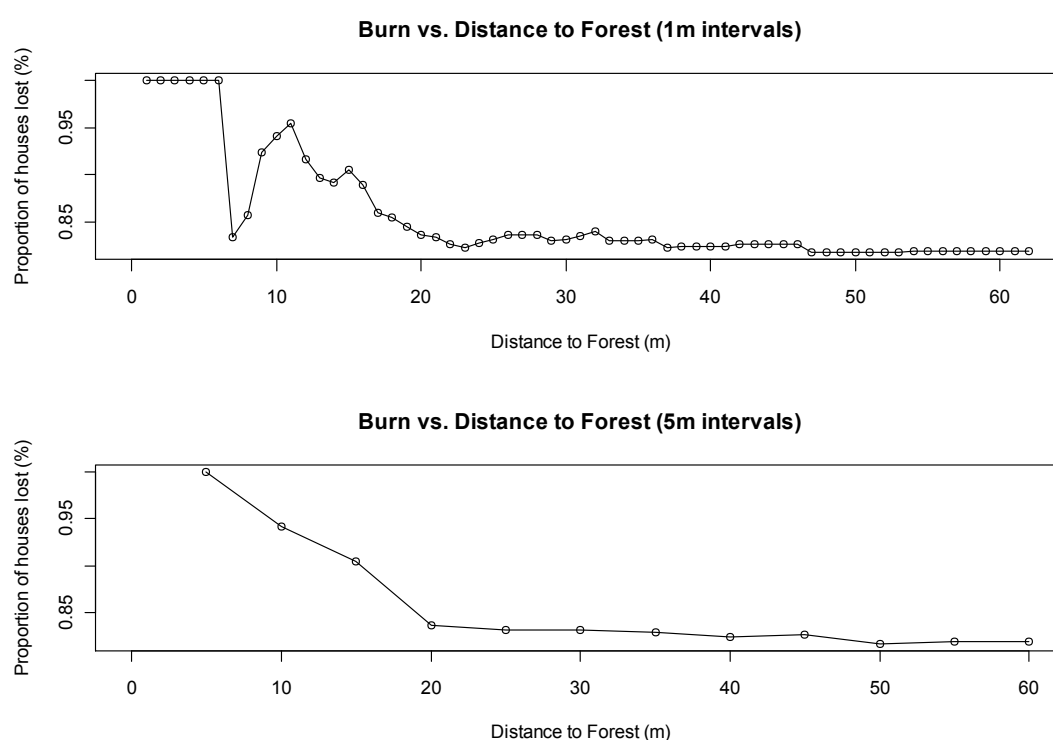
Figure 37 Proportion of house loss by distance to forest (Pine Ridge Road region)
