CMMT-2007-049

'Under-Flame' Fire Tests on Timber Decks

Report to Bushfire CRC

CSIRO - Manufacturing and Materials Technology Fire Science and Technology Laboratory

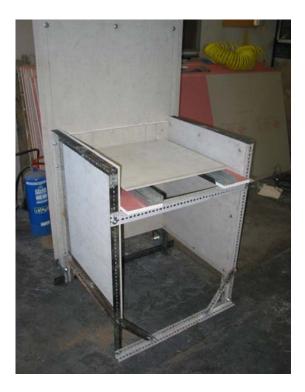
Figure 2-1 Frame for Supporting Deck (a piece of cement sheet is sitting on the steel channels where the deck is to be placed)

The tests were conducted using the American standard 12-7A-5 Part A Under-flame test [1]. The standard required the construction of a simple frame on which to support the deck test specimen (see *Figure 2-1*), above a 300 x 300mm sandbox burner producing a 80 kW fire. The frame is placed under an exhaust hood with instrumentation for measuring heat release. Both the sandbox burner and exhaust hood were available as part of the room fire test facilities (conducted to ISO 9705 [3]) at the Fire Science and Technology Laboratories at Highett in Melbourne.

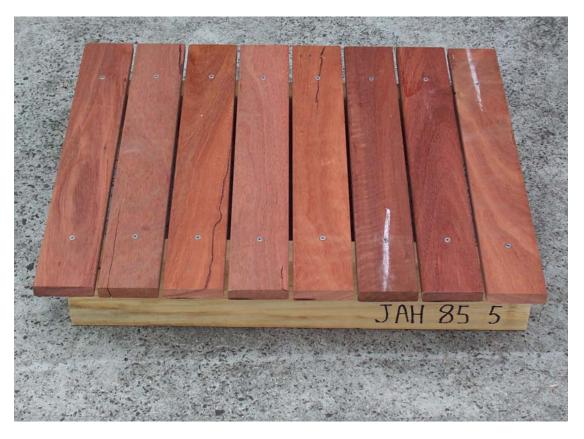
Figure 2-2 Typical Timber Deck Test Specimen

Test Specimen (see *Figure 2-2*):

- Timber deck 700mm (joist direction) x 600mm (decking board length)
- 2 x Radiata pine 150mm x 45mm joists spaced 405mm apart (360mm gap between joists)
- Decking boards connected to each joist by a single 65mm long screw with 5mm gap between boards.
- At the front end, the joist and the decking boards are flush while at the wall end the last decking board overlaps the edge of the joist by 25mm.

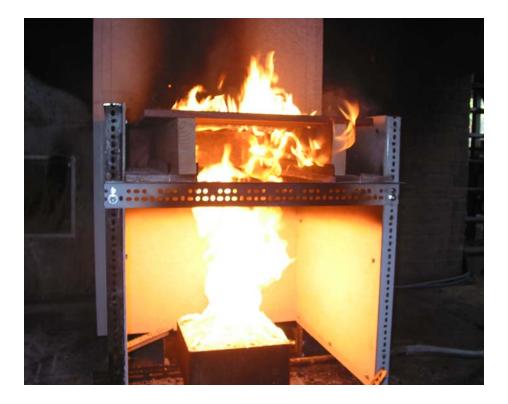
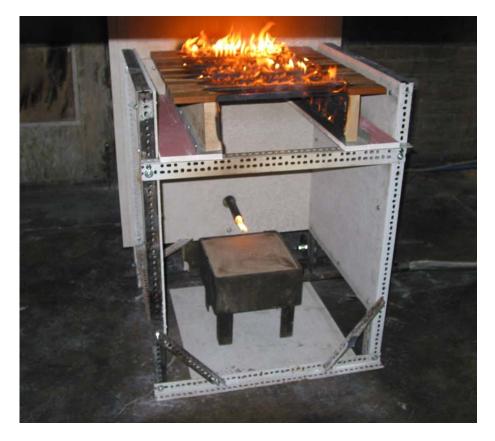
Figure 2-3 Under-Flame Test Rig

Test frame (see *Figure 2-3*):

- Framing for holding the deck 690mm above a 300mm x 300mm sand box burner measured to the underside of the decking boards.
- Open front and lined sides and back with 200mm gap at the base to allow for air flow to the burner. The height of the sides are approximately the same level as the top of the deck. The height of the back is 2400mm. In plan the frame is U shaped with dimensions approximately 700mm x 700mm.
- Steel channels support the joists along the bottom edge leaving only the inside face of the joist and the underside of the decking boards between the joists exposed to the flames.
- A non combustible plinth board the same depth as the joist and fastened to the back wall provides a support on which the 25mm overlap on the last decking board can rest.

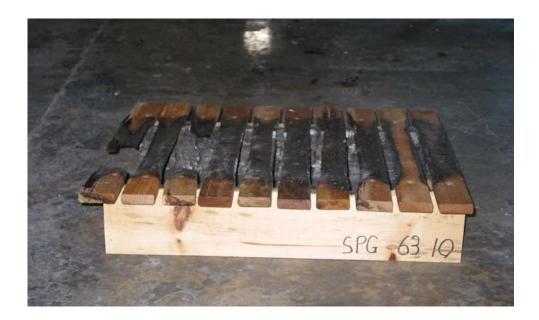
Figure 3-1 A Typical Deck after Testing

The initial tests were conducted at the specified burner output of 80 kW. However at this level it became obvious that all of the decks would fail both the heat release and structural criteria (see *Figure 3-1*). As a result, four of the initial 10 decks (Nos 3,5,6 and 8, see *Table 3-2*) were tested at either 60 kW or 70 kW to determine at what level they might pass. However all four decks failed the heat release criteria having peak heat releases greater than 115 kW (i.e. 270 kW/m^2 and assuming a 700mm x 610mm deck area) while the two decks tested at 70 kW failed the structural requirement as well. The peak heat release values from the tests are given in *Table 3-2*. Photos of the 4 test specimens tested at the reduced burner output are shown in *Figure 3-2* and *Figure 3-3*. The test record sheets containing plots of the heat release are given in Appendix B.

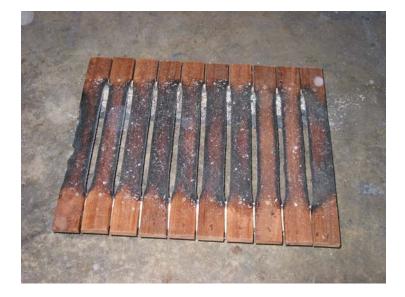
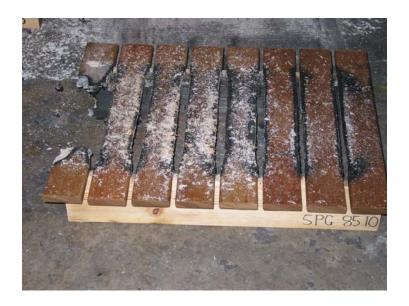
(a) Deck No 6

(b) Deck No 8

Figure 3-2 Decks tested with 70kW burner

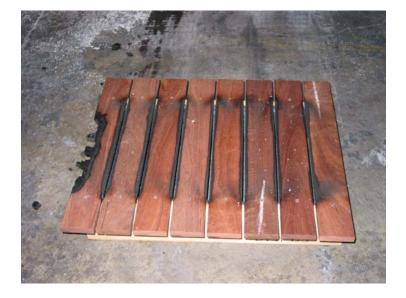
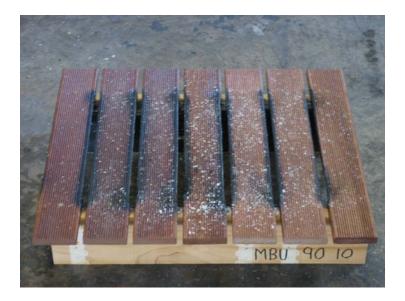
(a) Deck No. 3

(b) Deck No. 5

Figure 3-3 Decks tested with 60kW burner

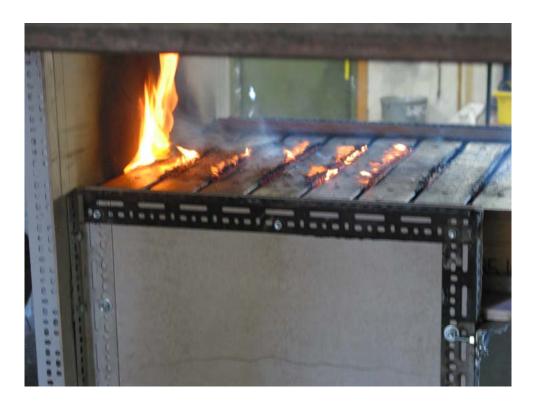
Figure 3-4 Plinth detail causes severe heat load on adjacent wall

- The plinth detail has a major effect on the combustion of the decking board next to the wall. In all tests the gap between the plinth and the decking board acted as a chimney for the flames to ignite the board then as a heat trap to incubate the fire. This resulted in a high heat load on the wall adjacent to the deck as shown in *Figure 3-4*.

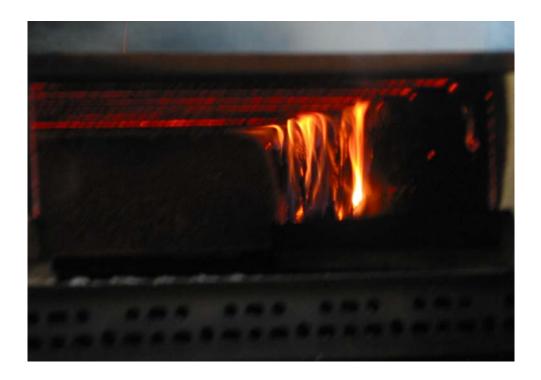
Figure 3-5 Heat from the burning pine joists impinging on the decking

- The heat from the burning pine joists increase the combustion on the adjacent decking (see *Figure 3-5*).

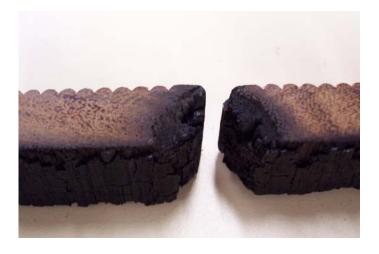
Figure 3-6 Tapered burn pattern on edge of decking boards

The second series of tests looked at improving the performance of the decks by replacing the board next to the wall with a steel section, using steel joists, a 23° C and 50% RH condition environment and, in one case, a 30° tapered edged board. The later change originating from the burn pattern evident in the first series of tests where the edge of the boards burn in a tapered pattern as shown in *Figure 3-6*. A comparison of the tapered board used and a previously burnt square edged board is shown in *Figure 3-7*.

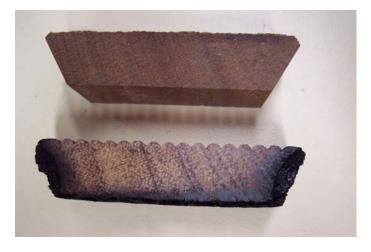
Figure 3-7 Comparison of tapered edge and burnt square edged board

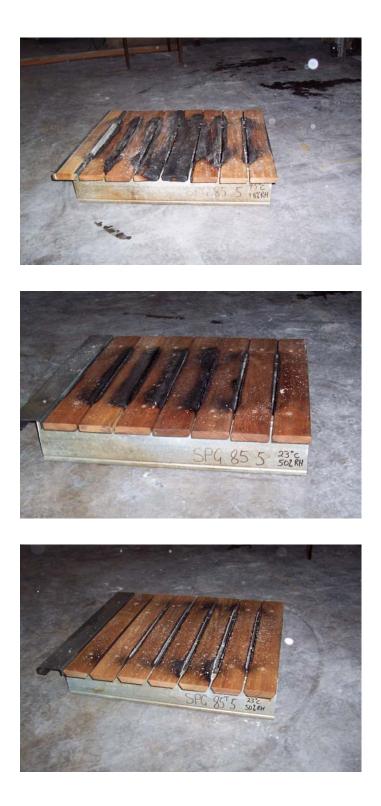
Figure 3-8 Second Series Timber Deck Test Specimens (from top: Nos 11,12 & 13) After Testing

- To prevent the detail around the plinth causing a high heat load on the wall by replacing the last board with a steel section (see *Figure 3-8*).
- During the first series of tests the pine joists were observed to add significantly to the heat loading on the decking boards.
- The easing of the conditioning requirements from 45 °C and 18% RH to 23° C and 50% RH is in line with the recommendations in the Draft AS 1530.8.1 Bushfire Test Method.
- Using a tapered edge board may reduce the heat concentration in the gap between the boards.

The peak heat release results of the tests are given in *Table 3-3*. After test photos of the decks are shown in *Figure 3-8*.

While the results indicate a large improvement in the performance, a close analysis indicates that the test conditions were different between the first and second series of tests. An analysis of the data including video records indicates that the strength of the pilot flame was different between the two series of tests. The second series of tests was conducted with a stronger pilot flame resulting in some of the main burner flame being blown out the front of the deck and reducing its impact. Hence the results are not reliable.
