# **Window and Glazing Exposure to Laboratory-Simulated Bushfires**

**Report to the Bushfire CRC**

Confidential CMIT Doc. 2006–205

**May 2006**

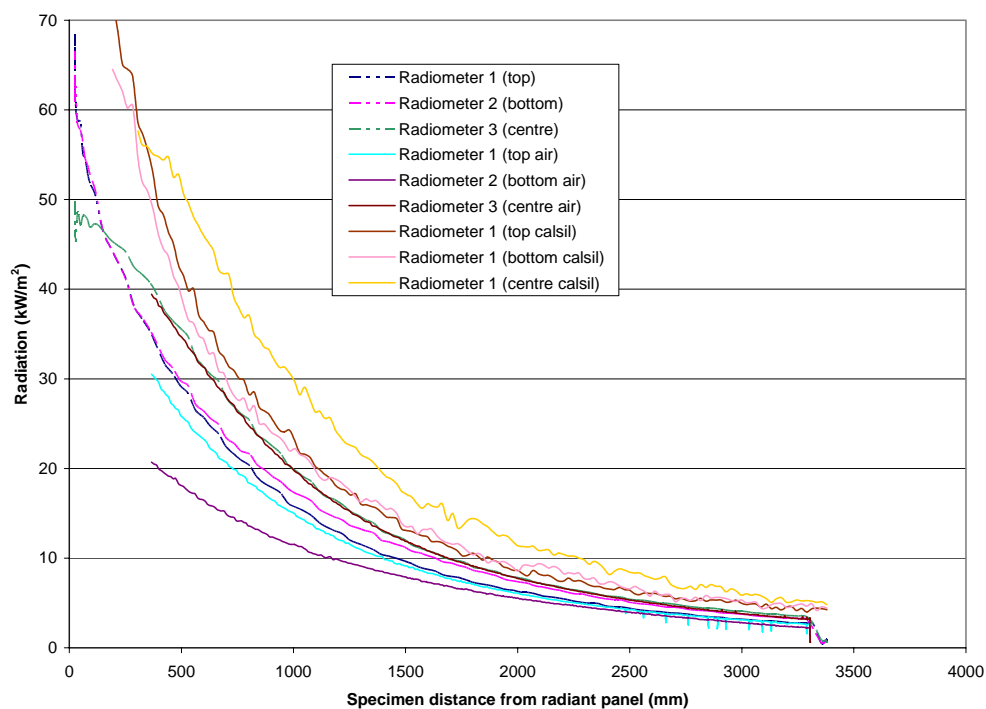
*Figure 11. Radiation versus specimen distance from panel – in glass, calsil and in air.*

Figure 11 shows the data from all three methods used for radiation characterisation. This outlines some interesting results. All radiometer responses for when comparing radiations profiling with glass in place diverge as the radiation level increases.

The three highest curves are using calcium silica board which have higher radiation readings than for the other methods. Calsil board, 30 mm thick was used and on heating it holds more heat within the material as opposed to glass which allows for some radiation transmission through the glass. This can also be seen in Figure 11 by the higher starting radiation measured

at a displacement of 3800 mm as opposed to the other methods. The gradual heating of the calsil board creates convection currents which give all radiometers a higher convective component in measurement. Also as the calsil board gets closer to the panel it changes colour from white through tan to brown. This then has the effect of changing the conductive and reflective qualities of the board's face. The darker the colour of the board the more radiation it will absorb creating greater convective radiation and then at close proximities the board then creates a feedback system with the panel, both feeding from each other and this can be seen in the deviation of the radiations at set distances in Figure 11. The results for calsil board deviate markedly from air and glass in place radiations.

When using glass as a calibration surface the central radiometer output mapped very consistently whether the glass was in place or not. This allows the second method without a glazing element in place being a suitable instrument check.

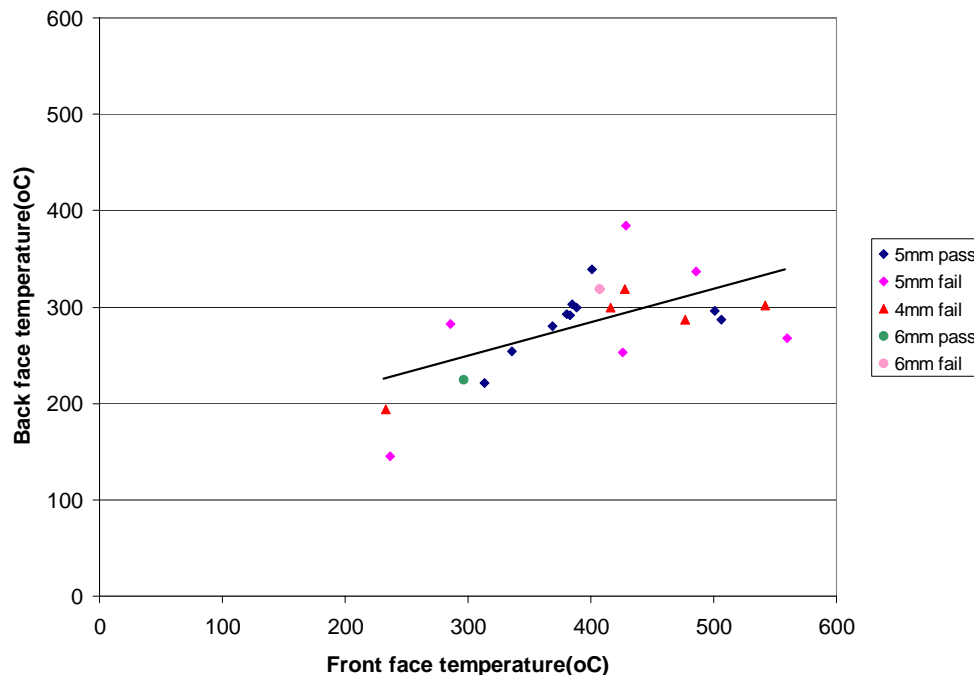
Figure 19. Peak front and back face temperatures of toughened glass.

The effect of frame flaming on glazing failure in these experiments, did not appear to have a direct correlation to pass or failure of the glassing element. Figure 19 shows front and back face temperatures for passes and failures. A linear trend line through the data shows a wide spread of data and that there is no real trend here.

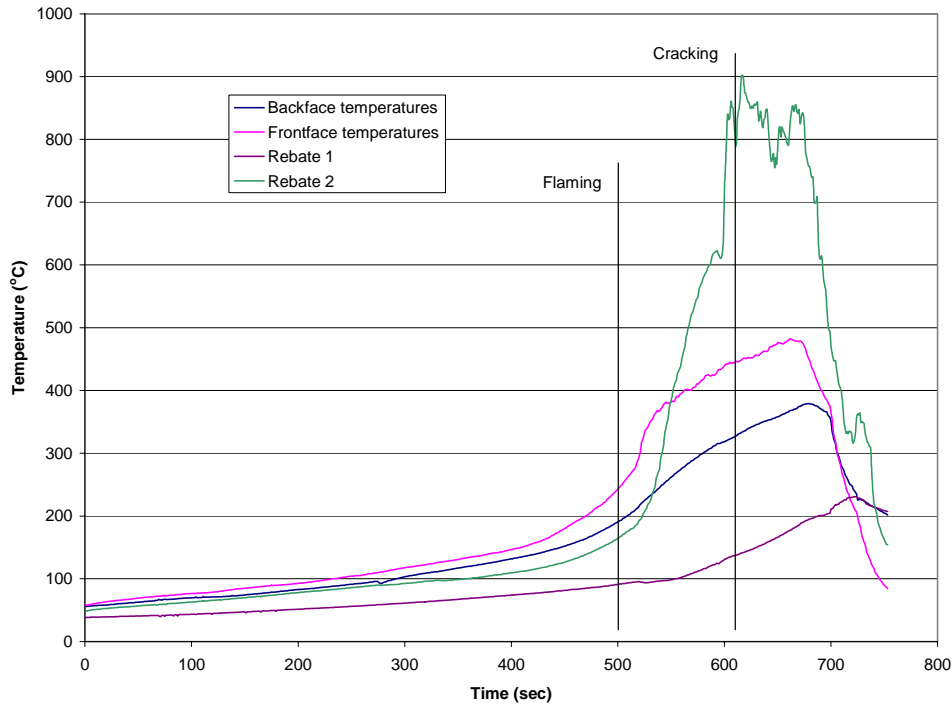
Figure 20. Typical 6 mm glazing temperatures (specimen 6TTFB40S).

Figure 20 reports the results from window temperatures measured on 6 mm toughened glass in a timber frame which was tested up to 40 kW/m<sup>2</sup>.

Data plotted is the average front face temperature, back face temperature and the two rebate temperatures.

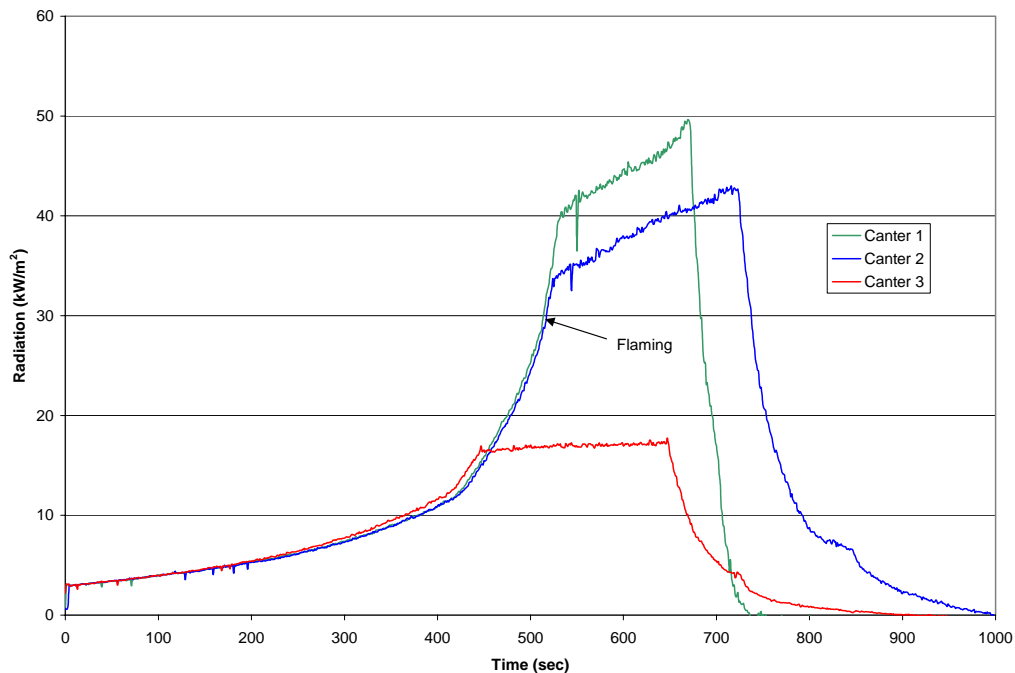
Figure B4. Radiation measured in Canter tests (Radiometer 2 – low).

The Canter 3 test was continued after glass cracking to observe the spread of cracking and potential fall out of glazing. Glazing stayed intact and cracking continued around the edges of the glass, in particular in the region between where the film had shrunk or fallen away and the edge of the frame.

Figure B4 shows the radiation levels measured below the glazing in the non-flame zone. The rapid increase of temperature from flaming in the Canter 1 and 2 tests can be seen.

It is important to note that the radiation measured was total radiation as measured by the total flux meters, and radiative and convective components cannot be separated. The rapid increase in the heat flux measured highlights the input from convective radiation.
