**RESEARCH AND INVESTIGATION INTO THE
PERFORMANCE OF RESIDENTIAL BOUNDARY
FENCING SYSTEMS IN BUSHFIRES**

**Report to
BlueScope Steel Limited**

**CSIRO Manufacturing & Infrastructure Technology
Fire Science & Technology Laboratory
Bushfire Research**

April 2006

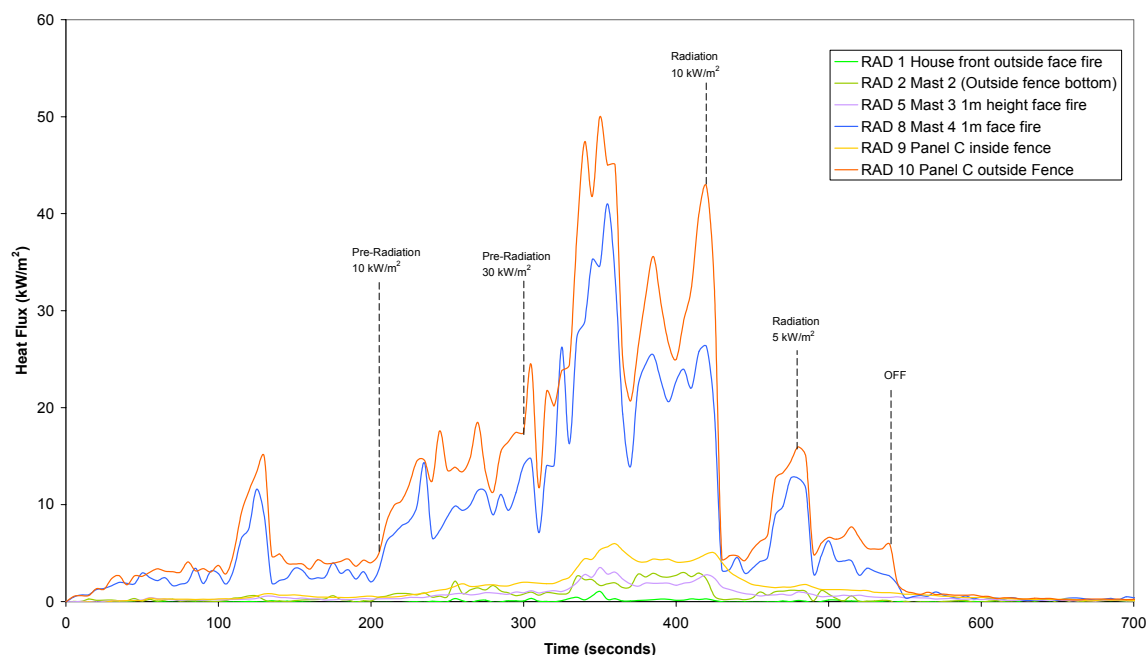
Figure 28. Experiment 12 – heat flux measurements for pre-radiation exposure of COLORBOND steel fencing.

Figure 28 demonstrates the typically good performance of COLORBOND steel fencing as a radiant heat barrier under pre-radiation exposure. At fencing panel C, which was directly exposed, the peak heat flux on the front face of the fencing was 63 kW/m^2 , whilst at the back face it was 4 kW/m^2 . At 1 m back from the burner grid the peak heat flux at radiometer (RAD) 8 outside the fencing was 41 kW/m^2 , whilst inside the fencing at RAD 5 it was 3.5 kW/m^2 . At a distance of 9.4 m from the burner grid (near the simulated building) the peak heat flux at RAD 2 outside the fencing was 3 kW/m^2 , whilst at RAD 1 inside the fencing it was 1 kW/m^2 . The critical heat flux for ignition of many typical combustible elements is $>20 \text{ kW/m}^2$. In all pre-radiation experiments the COLORBOND succeeded as a radiation barrier, maintaining heat flux levels within the fencing boundary below 20 kW/m^2 at all times.

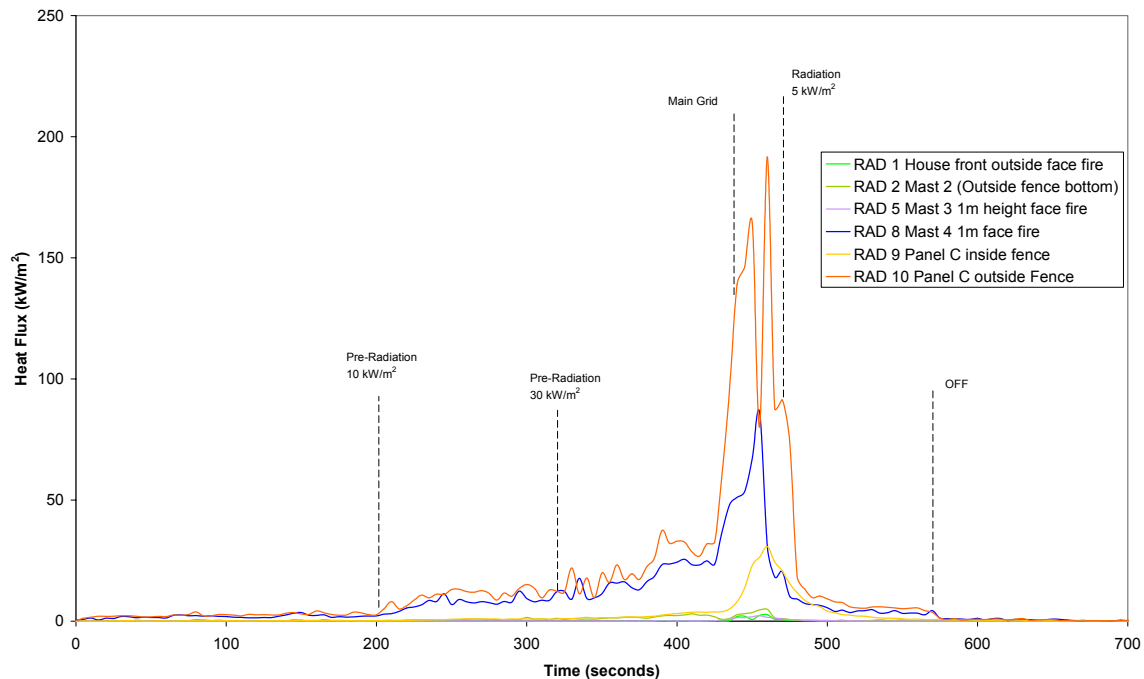
Figure 29. Experiment 13 – heat flux measurements for flame immersion exposure of COLORBOND steel fencing.

Figure 29 demonstrates the typically good performance of COLORBOND steel fencing as a radiant heat barrier under flame immersion exposure. At panel C, the front face of the fencing was immersed in flames resulting in a peak heat flux well in excess of the heat flux meters' accuracy limit of 100 kW/m^2 , whilst at the back face the peak heat flux measured was 31 kW/m^2 . At a distance of 1 m back from the burner grid the peak heat flux at RAD 8 outside the fencing was also in excess of the accuracy limit of 100 kW/m^2 , whilst inside the fencing at RAD 5 it was 21 kW/m^2 . At a distance of 9.4 m from the burner grid (near the simulated building) the peak heat flux at RAD 2 outside the fencing was 5 kW/m^2 , whilst RAD 1 inside the fencing it was 3 kW/m^2 . The burner flames were higher than the fencing and some limited flames penetrated under fencing and through separated joints, and thus objects inside the fencing received radiant heat directly from flames. However, the view factor in which the object saw of the flames was significantly reduced by the fencing. The fencing also shielded against direct flame contact and convective heat. Although heat fluxes inside the fencing exceeded 20 kW/m^2 , the likelihood of ignition was significantly reduced by the fencing and there was no damage or ignition of the play equipment or simulated building.

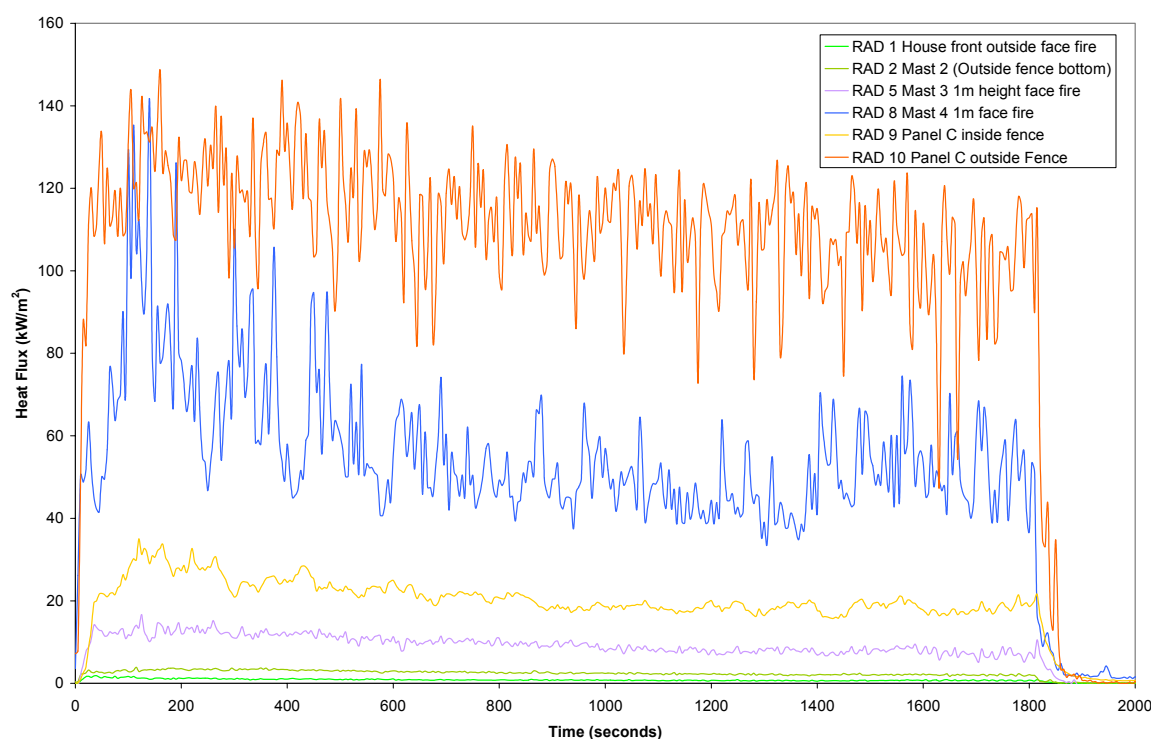
Figure 30. Experiment 17 – heat flux measurements for structural fire exposures of COLORBOND steel fencing.

Figure 30 demonstrates the typically good performance of COLORBOND steel fencing as a heat barrier under structural fire exposure. Fencing front face heat flux was not measured to avoid damage to instruments from prolonged flame immersion. However, the peak heat flux at the back face was 35 kW/m^2 . At a distance of 1 m back from the burner grid, the peak heat flux at RAD 8 outside the fencing was in excess of the measurement range of 100 kW/m^2 , whilst inside the fencing at RAD 5 it was 17 kW/m^2 . At a distance of 9.4 m from the burner grid (near the simulated building) the peak heat flux at RAD 2 outside the fencing was 4 kW/m^2 , whilst at RAD 1 inside the fencing it was 2 kW/m^2 . As the heat exposure was prolonged there was some melting of the play equipment in these exposures. However, there was no ignition of the plastic (except for Experiment 14 due to poor fencing construction) and there was no damage to the simulated building. Thus, the fencing significantly reduced the likelihood of fire spread and asset damage within the fencing boundary.

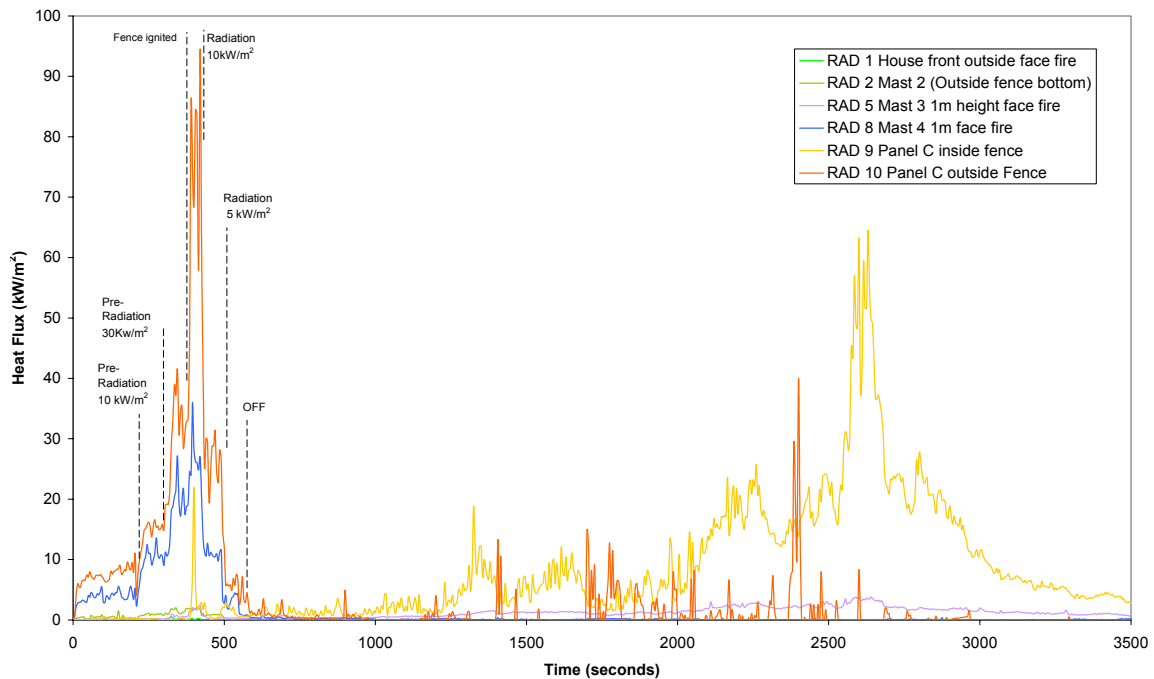
Figure 31. Experiment 19 – heat flux measurements for pre-radiation exposure of closed paling hardwood fencing.

Figure 31 demonstrates the performance of hardwood fencing as a heat barrier under pre-radiation exposure. During the burner exposure the fencing front face peak heat flux was 95 kW/m^2 , whilst at the back face it was 22 kW/m^2 . However, after the burners were turned off the fire at the corner grew and a peak of 65 kW/m^2 was measured at the back face. At a distance of 1 m back from the burner grid the peak heat flux at RAD 8 was 36 kW/m^2 , whilst inside the fencing at RAD 5 it was 3.8 kW/m^2 . Similar observations were made in Experiment 6 where the open paling fencing showed a similar level of performance. At a distance of 9.4 m from the burner grid (near the simulated building) the peak heat flux at RAD 2 outside the fencing was 2.1 kW/m^2 , whilst at RAD 1 inside the fencing it was 0.5 kW/m^2 . There was no damage to objects within the fencing boundary. This demonstrates that under pre-radiation exposure a hardwood fencing performs well as a heat barrier, with some risk of flame propagation to elements immediately adjacent to the fencing boundary.

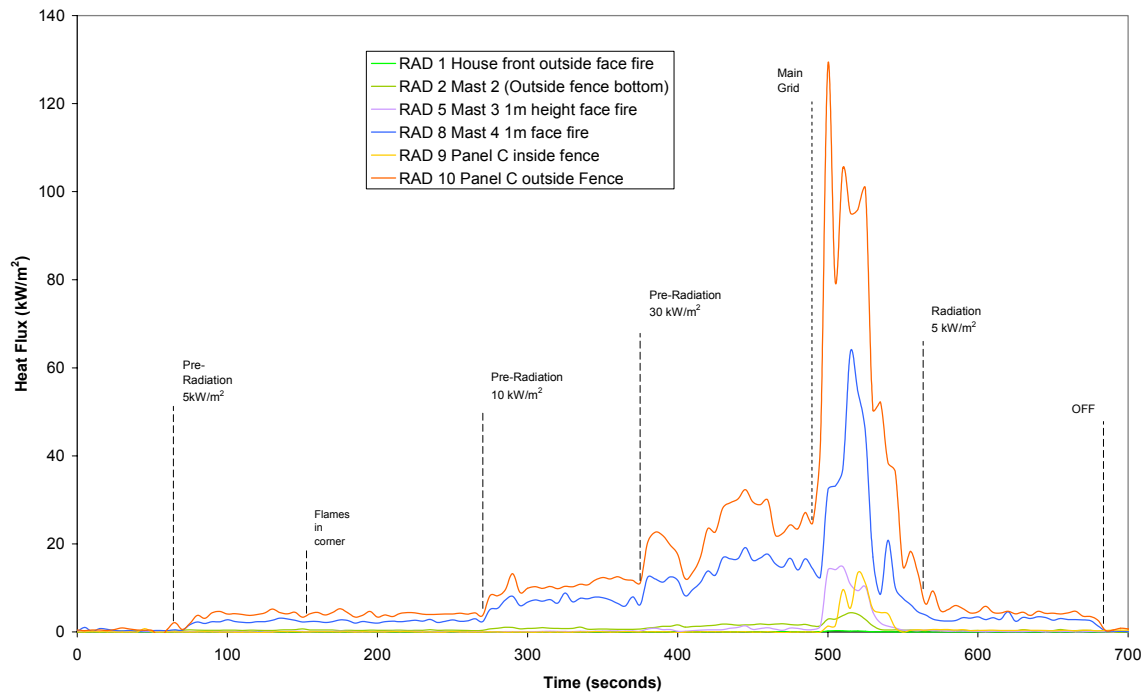
Figure 32. Experiment 20 – heat flux measurements for flame immersion exposure of closed paling hardwood fencing.

Figure 32 demonstrates that with flame at the outside of the fencing, the peak heat flux at the rear face of the fencing was 13 kW/m^2 . There was no damage to play equipment or the simulated building and no lateral flame spread, indicating that hardwood fencing will reduce the likelihood of fire spread into the fencing boundary given a flame immersion exposure. In contrast, open paling hardwood fencing provided little barrier during the flame immersion phase of the exposure, and flames were observed to flow through the fencing structure, providing extreme radiation and flame contact to the play equipment and instrumentation immediately behind the fencing. Once the flame and radiation abated in Experiment 7, flame propagation was again observed to cease. Figure 33 shows the lack of flame attenuation exhibited by open paling fencing systems, with RAD 9 tracking closely to the incident radiation, with radiation measured 1 m within the fencing boundary reaching 50 kW/m^2 .

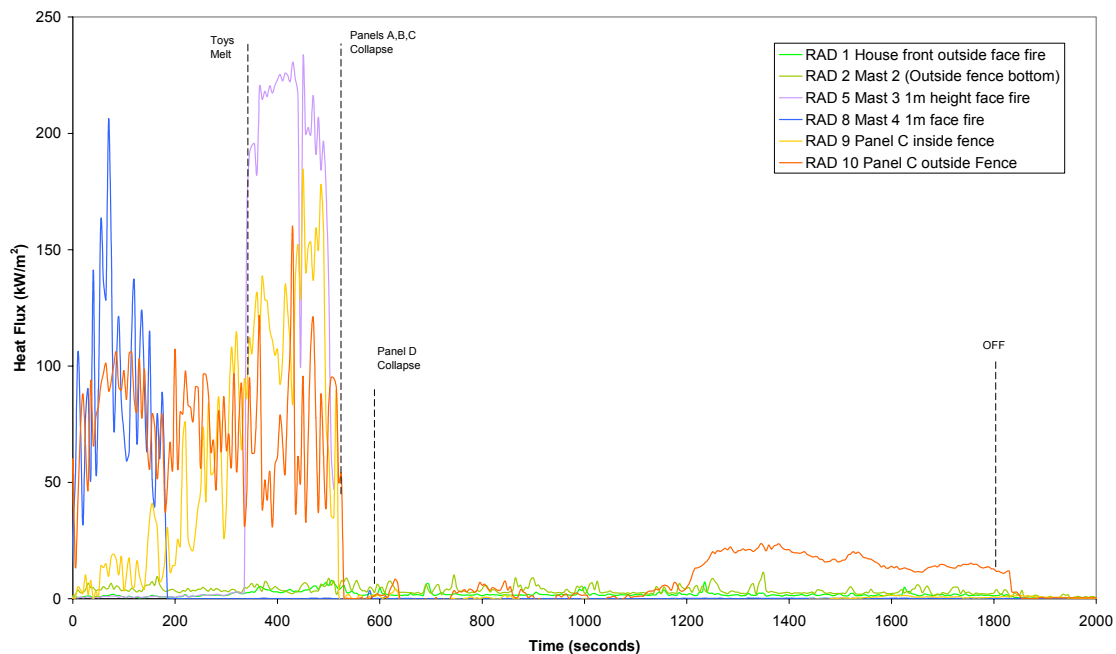
Figure 34. Experiment 22 – heat flux measurements for structural fire exposure of closed paling hardwood fencing.

Figure 34 shows that the hardwood fencing initially performed as a heat barrier. However, due to the prolonged external flame exposure, palings started to burn through at 5:30. At that time, the heat flux 1 m behind the fencing rapidly increased from 4 kW/m^2 to $>100 \text{ kW/m}^2$, resulting in melting and ignition of the play equipment. In all cases, the heat flux at the simulated building did not exceed 8 kW/m^2 , resulting in no damage to the building. Over the 30-minute burner exposure there was no significant lateral flame spread along the fencing. No observations were made to determine if continued smouldering over a very long period would result in slow lateral spread, however this experiment demonstrated that the risk of hardwood timber fencing wicking fire to other combustibles is low under the defined experimental conditions.

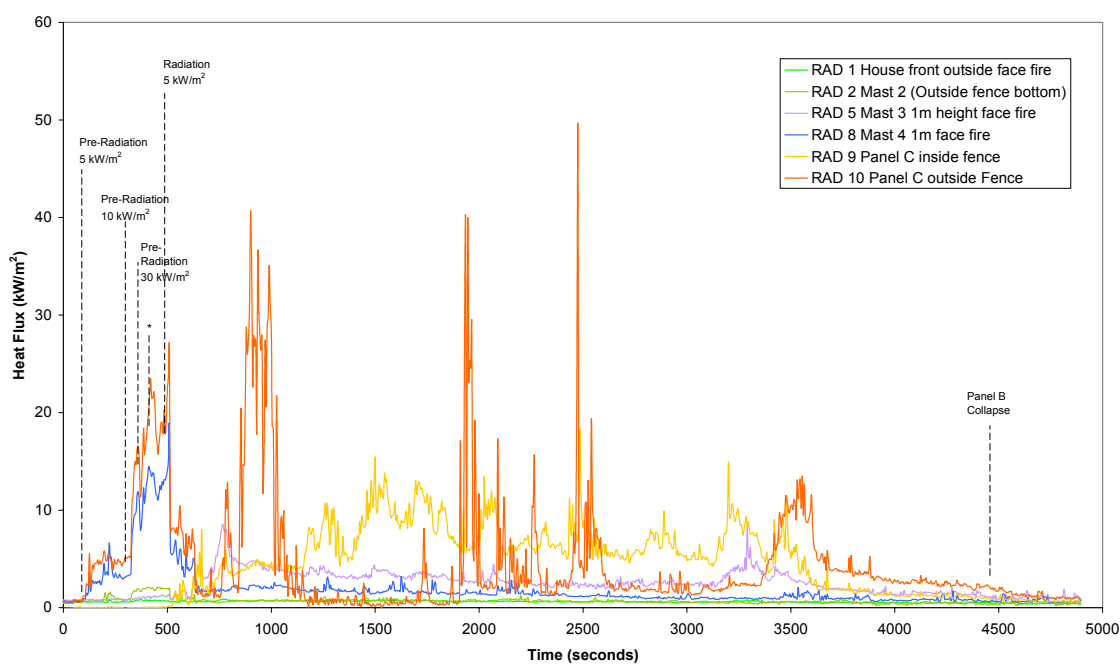
Figure 35. Experiment 9 – heat flux measurements for pre-radiation exposure of closed paling treated pine fencing.

Although the resulting heat fluxes at the inside of the fencing boundary were not extremely high, the collapse of the burning fencing as the fire spread along it, increased the likelihood of fire spread to other combustible items. Various instruments showed the sporadic peaks and localised flame intensity following the radiation exposure. Under these exposures virtually all of the timber would eventually be consumed.

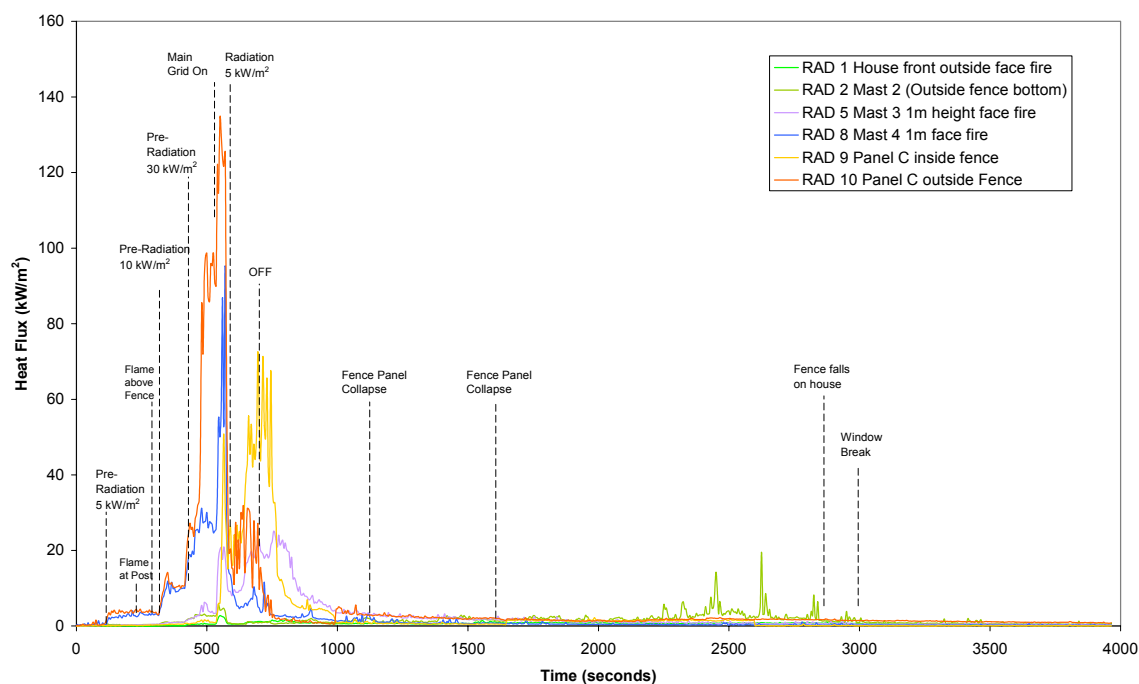
Figure 36. Experiment 22 – heat flux measurements for flame immersion exposure of closed paling treated pine fencing.

Figure 36 demonstrates that once the palings burnt through, heat flux at the rear face of the fencing increased to $>60 \text{ kW/m}^2$ and the heat flux 1 m behind the fencing increased to 25 kW/m^2 . This demonstrated a high likelihood of fire spread into the fencing boundary. Of particular note also is the incident radiation imposed in the house front face at around 2500 seconds, which provided compelling experimental evidence of the thermal exposure provided by fencing combustion in close proximity to a structure (note that plain glass windows are likely to break at radiation levels $>12.5 \text{ kW/m}^2$).

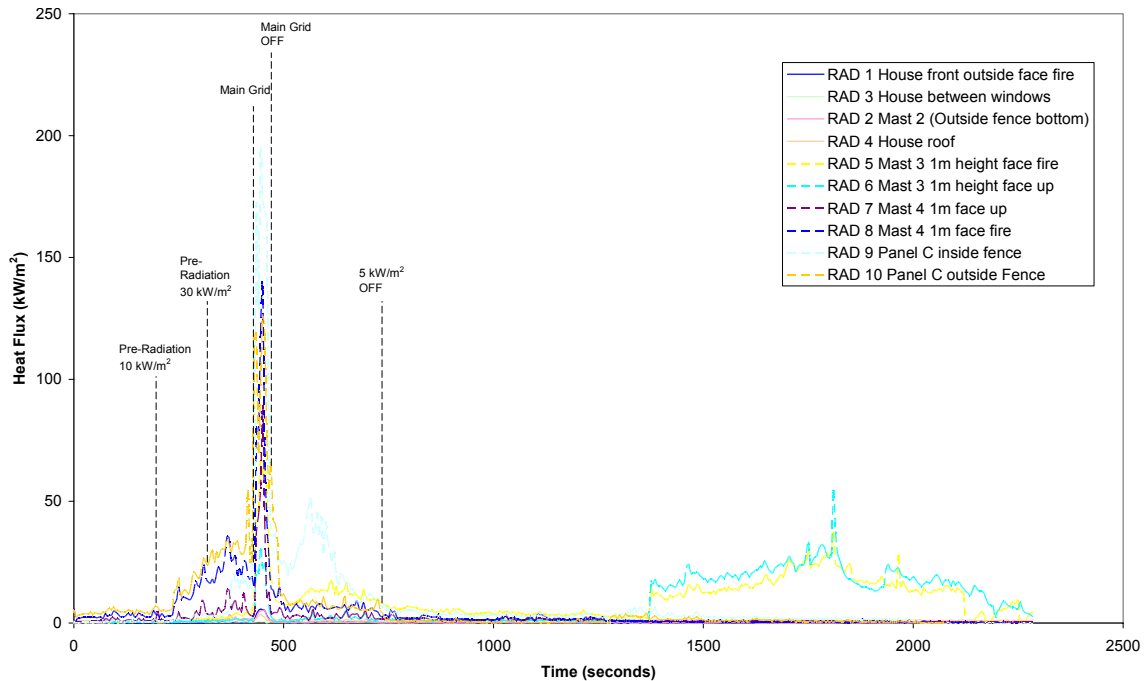
Capped open paling treated pine fencing showed no improvement in performance, exhibiting an even lower barrier to the initial radiation load. Figure 37 shows examples of this where RADs 5 and 6 experienced full flame immersion during the flame exposure period.

Figure 37. Experiment 10 – heat flux measurements for flame immersion exposure of capped open paling treated pine fencing.
