Doc CMIT--2006-206

HOUSE FIRE SPREAD, AN INVESTIGATION – GULGONG NSW

Report to Bushfire CRC

March 2006

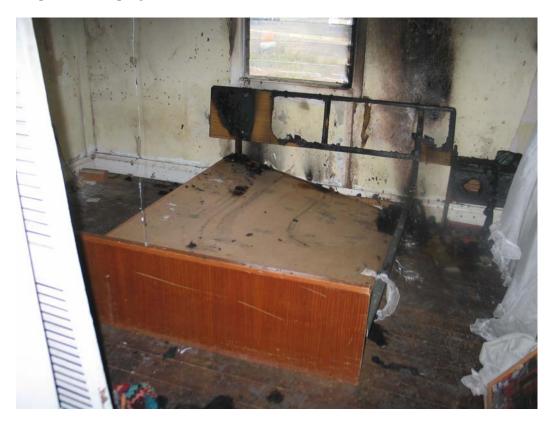
With damage to most rooms, the best room with windows intact was chosen, Bedroom 1, outside which the radiometer/thermocouple poles were erected.

Figure 12. Fuel load of Bedroom 1 prior to house burn. Note window in background which had measurement poles on its outside.
